Conservation Practices

There are 167 conservation practices listed in the National Handbook of Conservation Practices. The table below summarizes some of the most common practices that can be interpreted from large-scale aerial imagery.

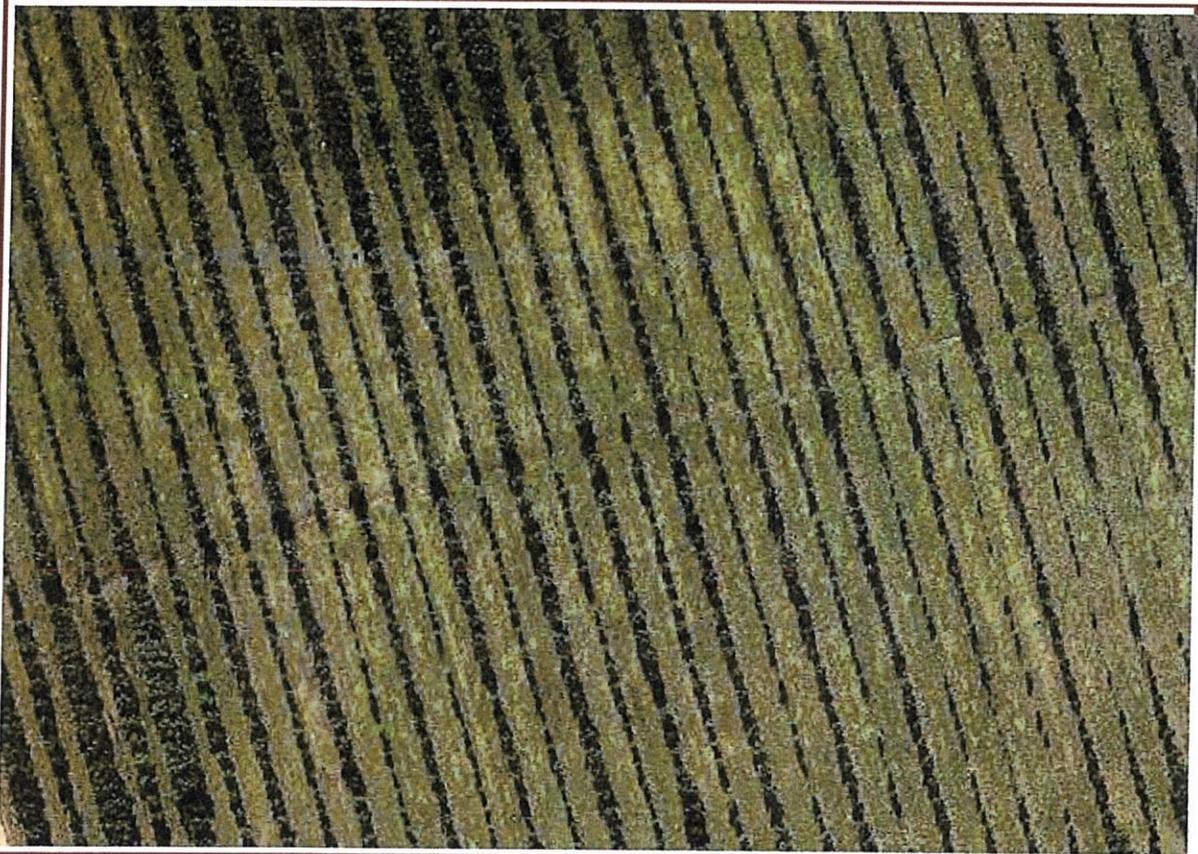
Alley Cropping

Alley cropping in Dawson County, Texas. Image courtesy of USDA, NRCS.

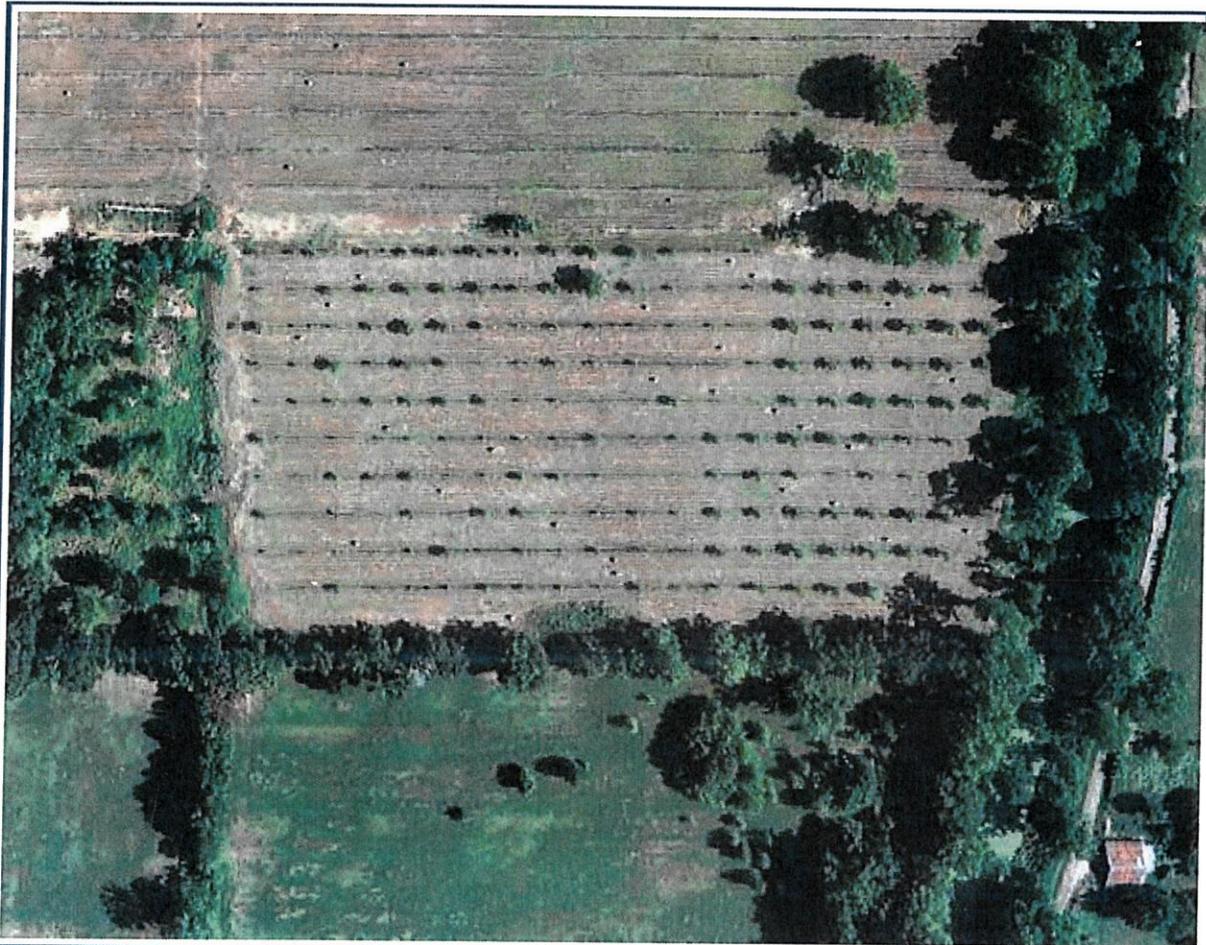
Alley Cropping

Alley cropping in Grant County, Louisiana. Image courtesy of USDA, NRCS.

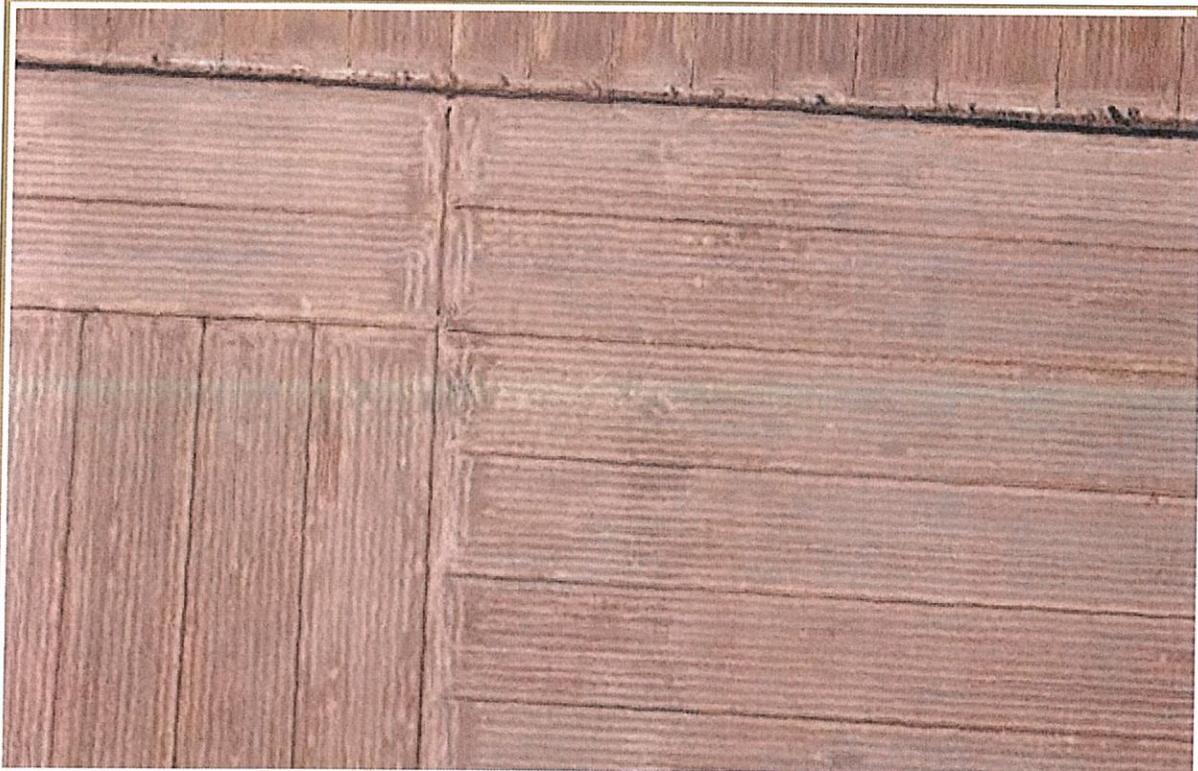
Bedding Preparation

Bedding preparation in Beaufort County, North Carolina. Image courtesy of USDA, NRCS.

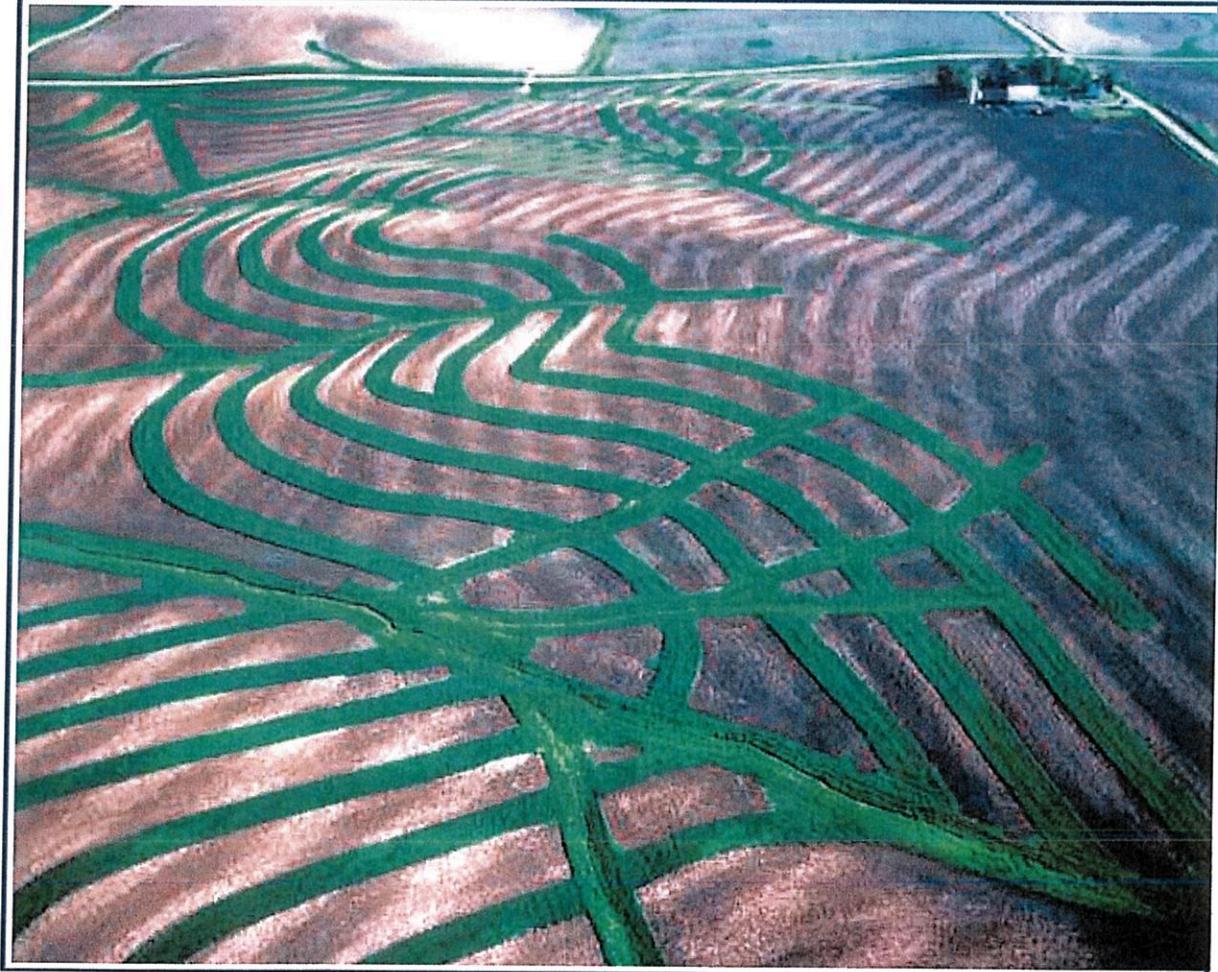
Contour Buffer Strips

Contour buffer strips in Iowa. Images courtesy of USDA, NRCS.

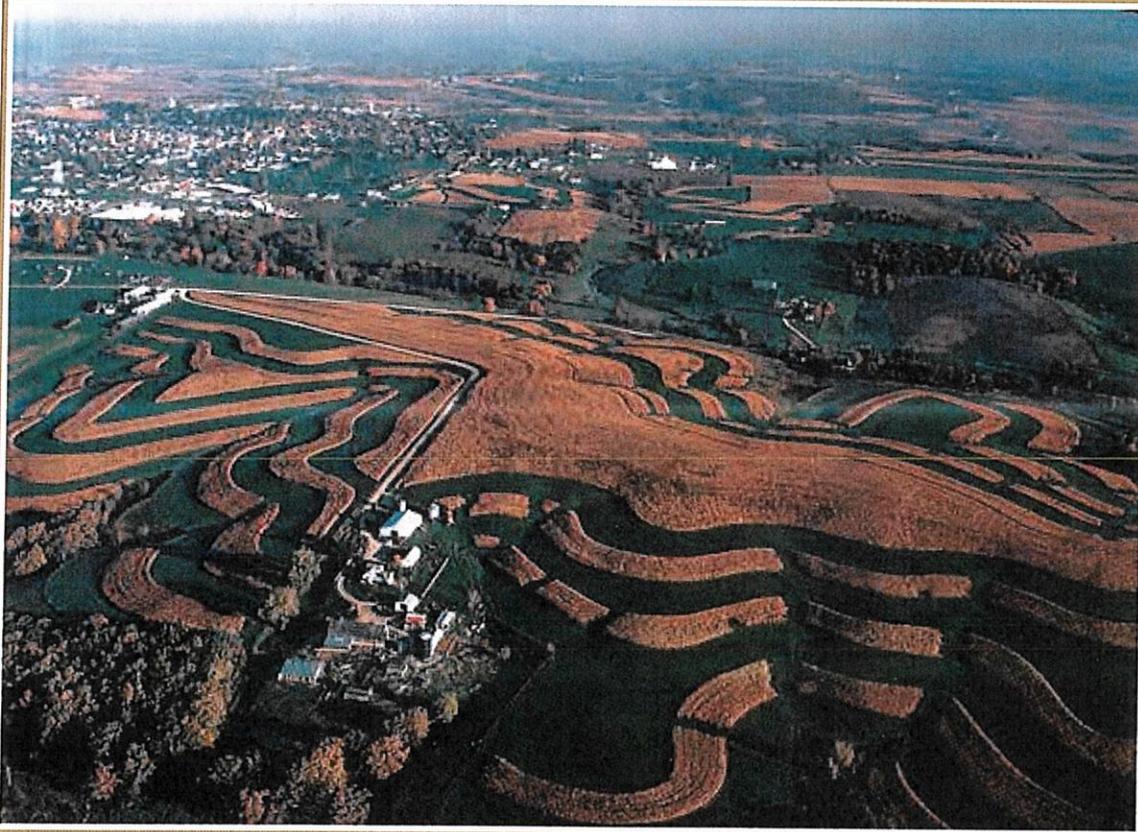
Contour Stripcropping

Contour stripcropping in Iowa. Image courtesy of USDA, NRCS.

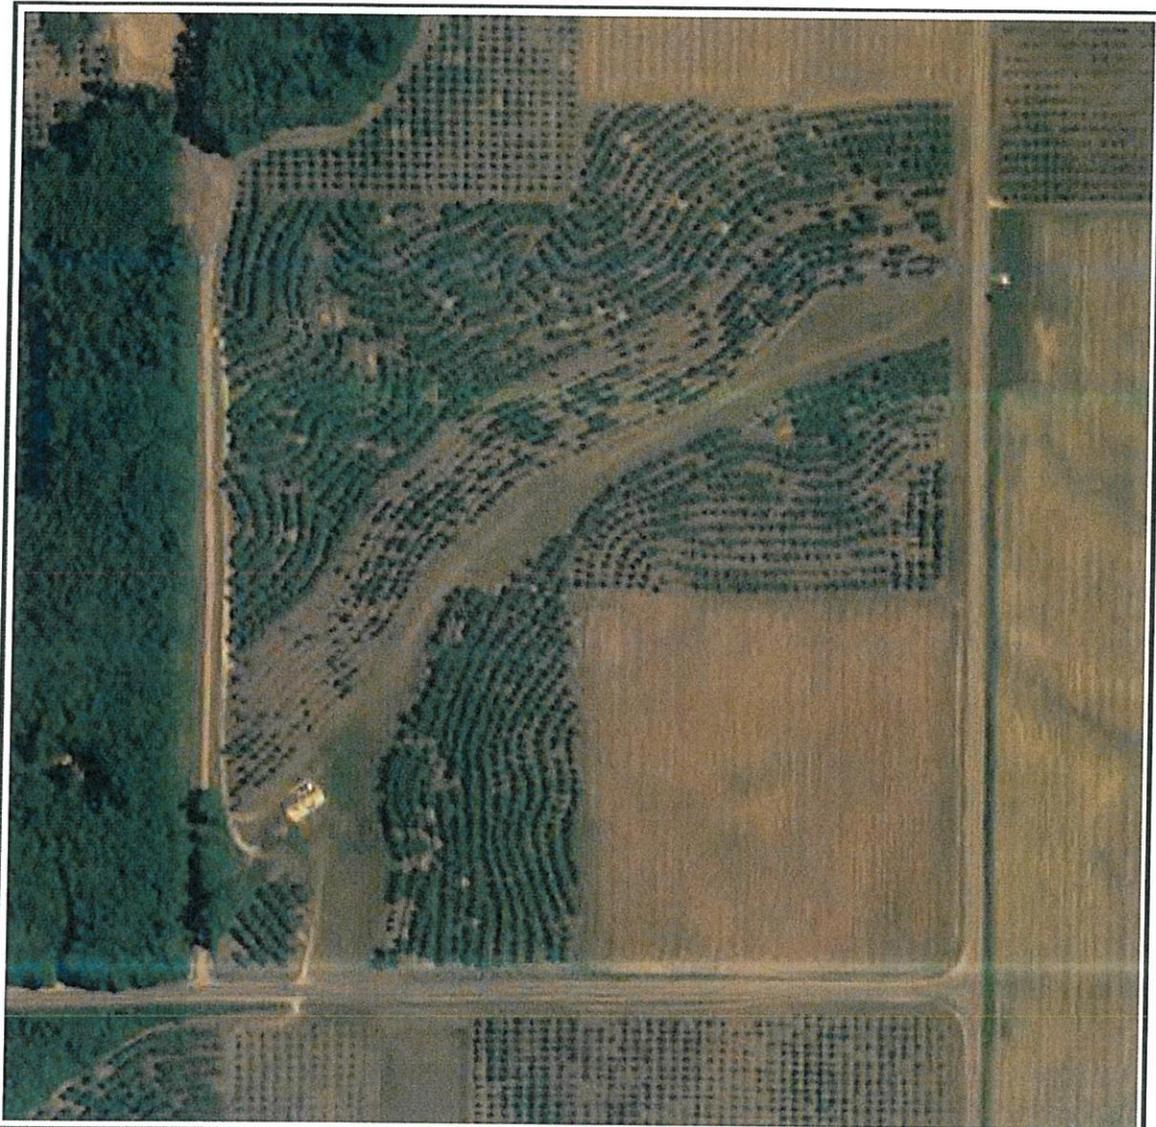
Contour Planted Orchards

Contour planted orchards in Leelanau County, Michigan. Image courtesy of USDA, NAIP.

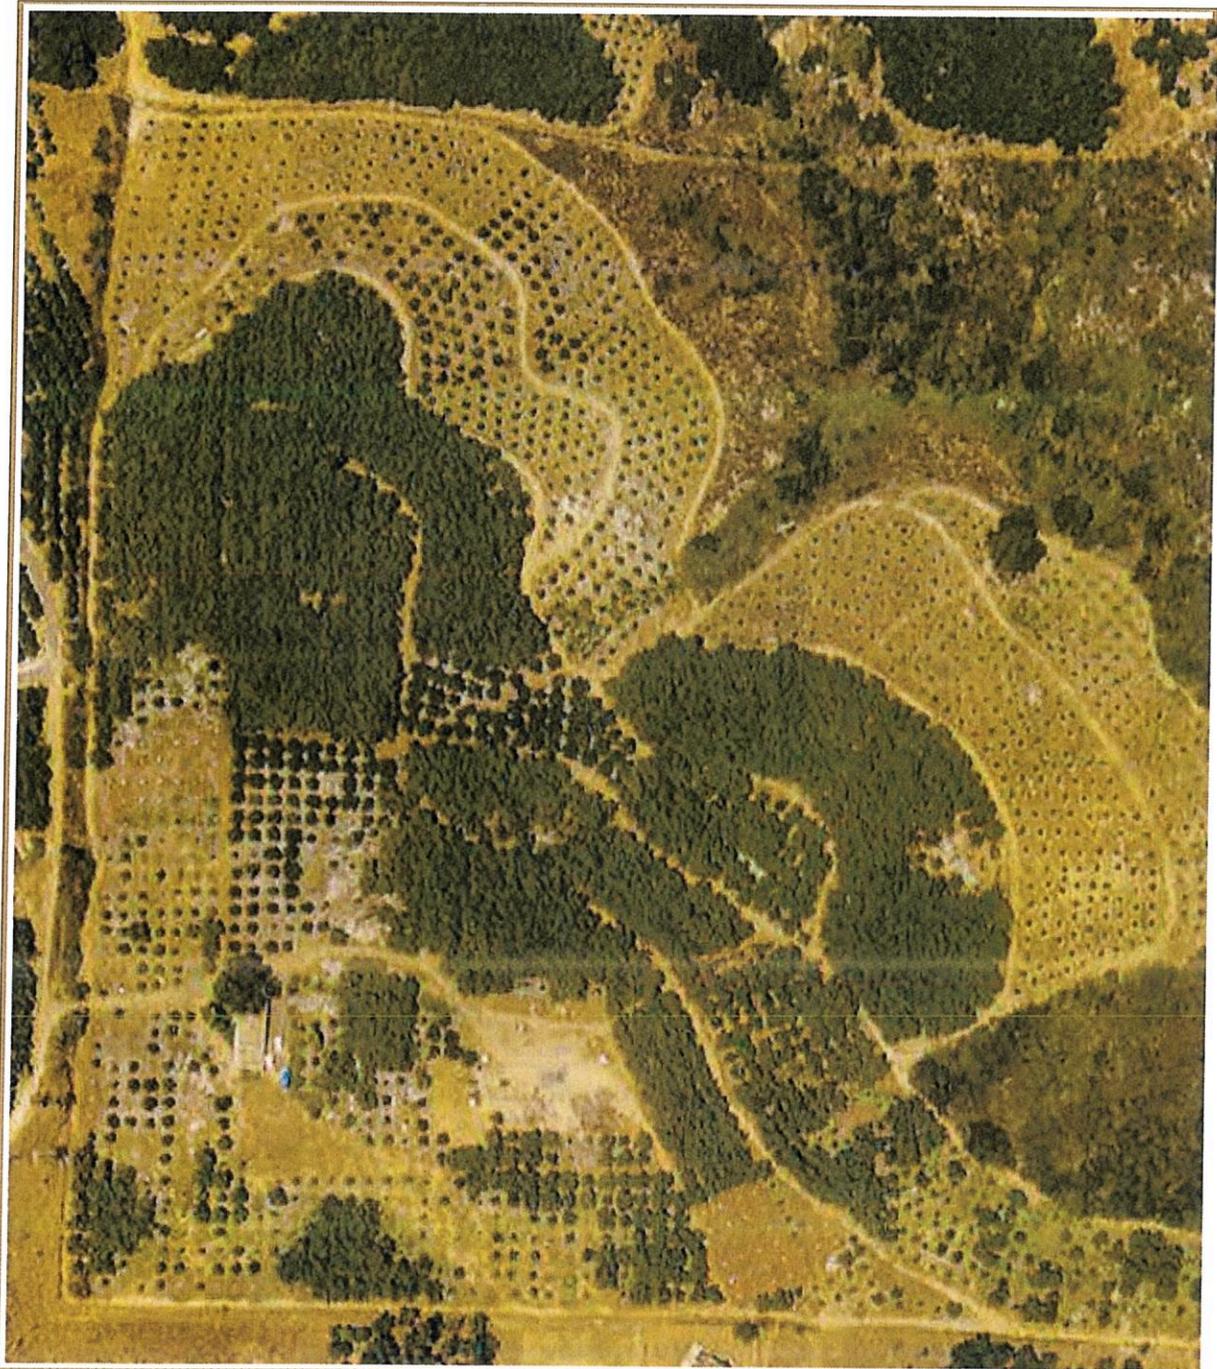
Contour Planted Orchards

Contour planted orchards in California. Image courtesy of USDA, NRCS.

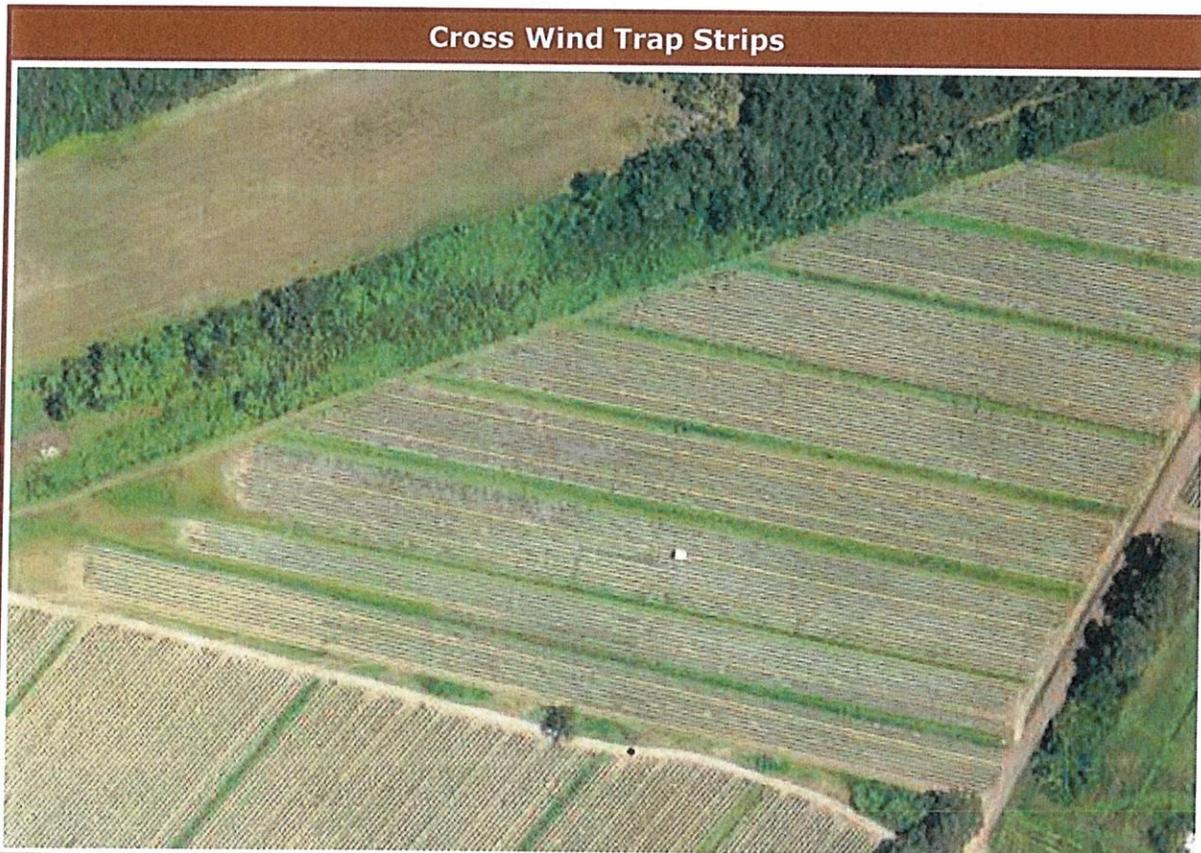
Cross Wind Trap Strips in Charleston County, South Carolina. Image courtesy of USDA, NRCS.

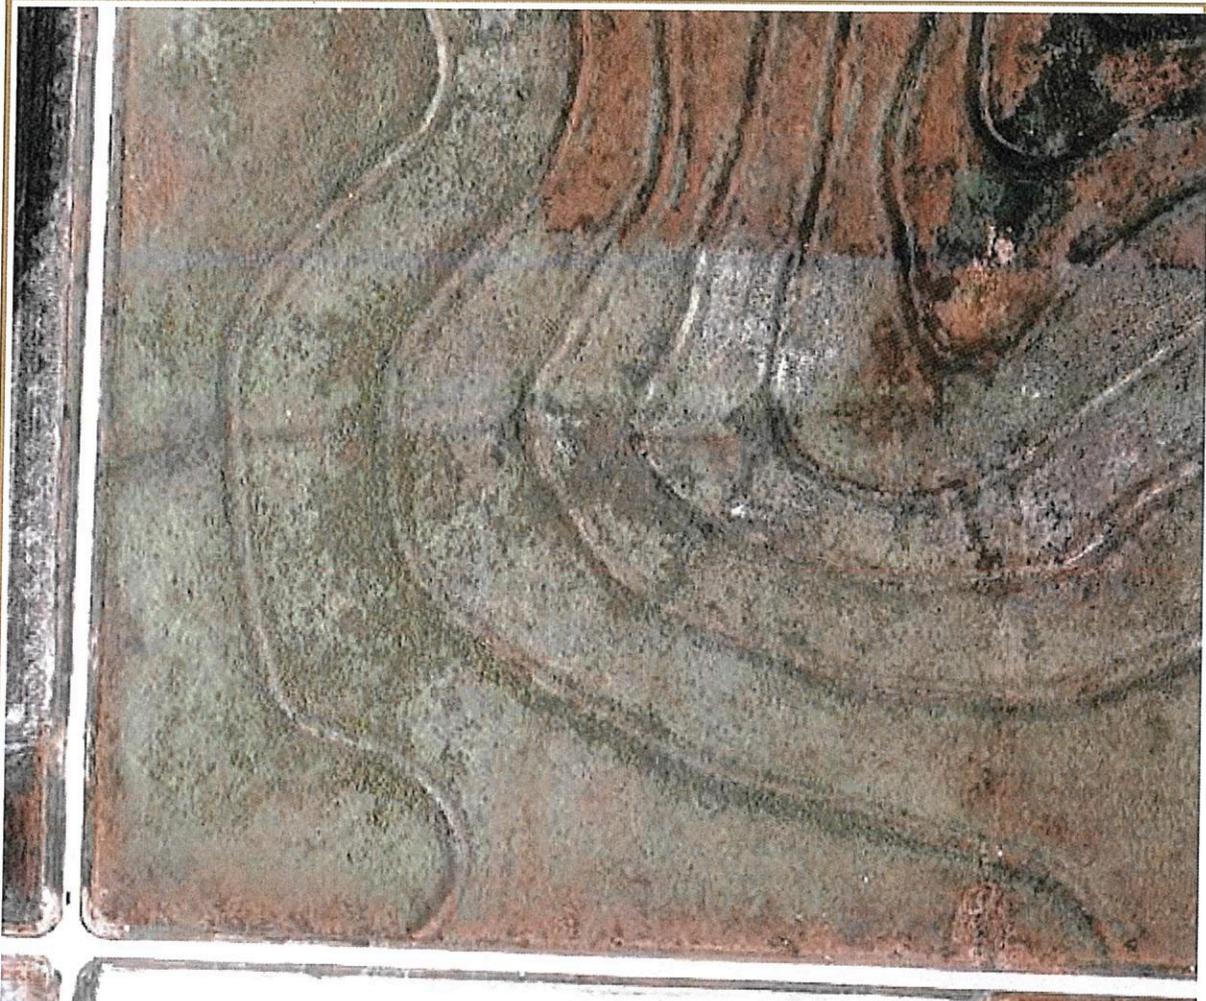
Diversions

A series of diversions in a field in Grant County, Kansas. Image courtesy of USDA, NRCS.

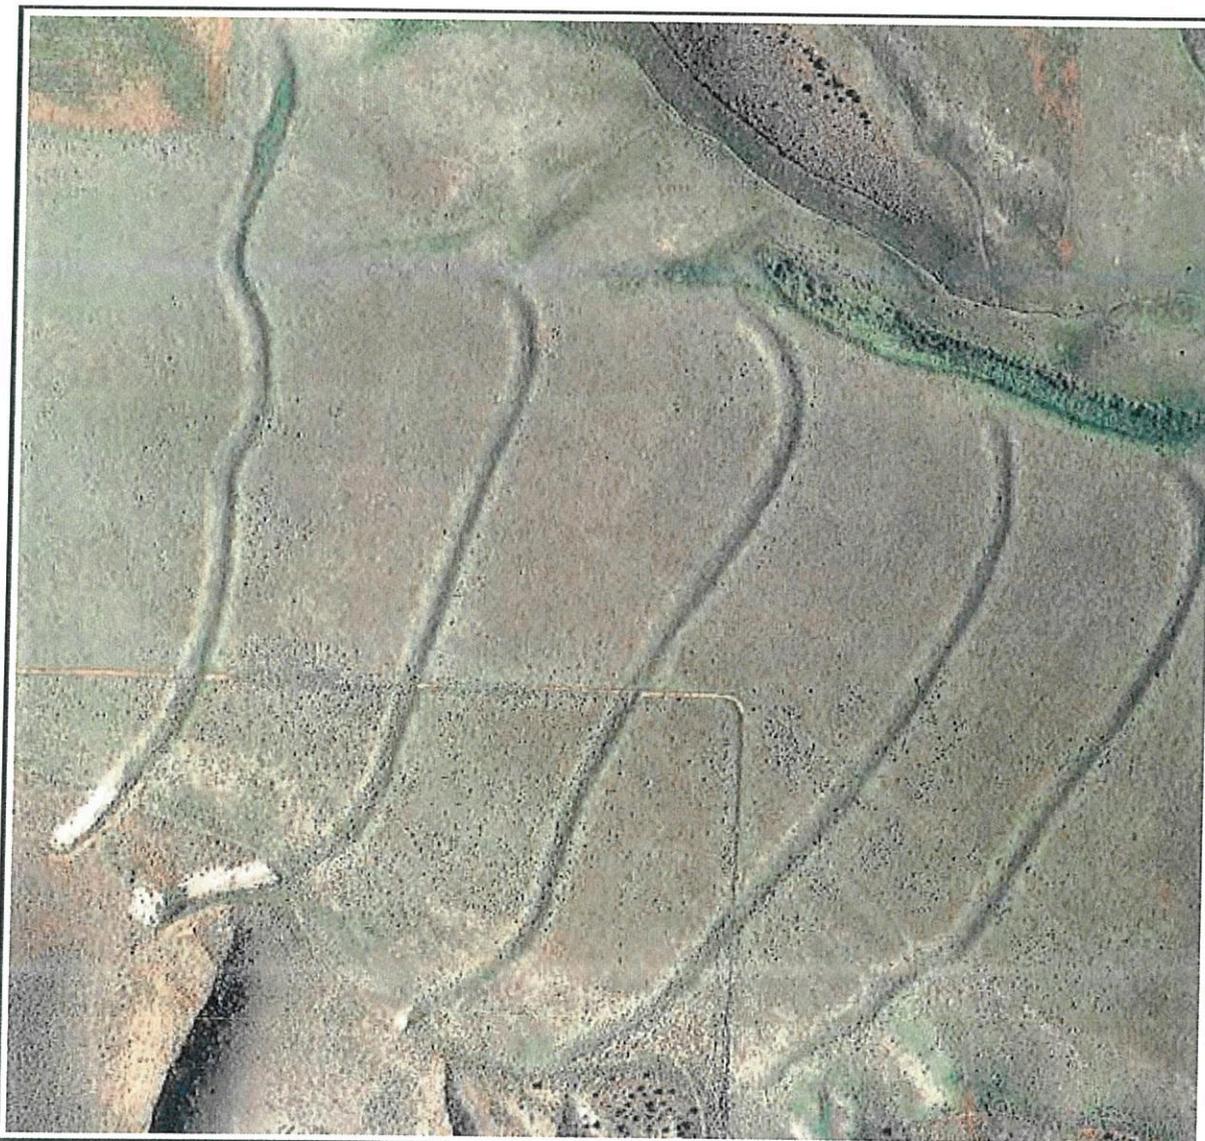
Diversions

A series of diversions in a field in Power County, Idaho. Image courtesy of USDA, NRCS.

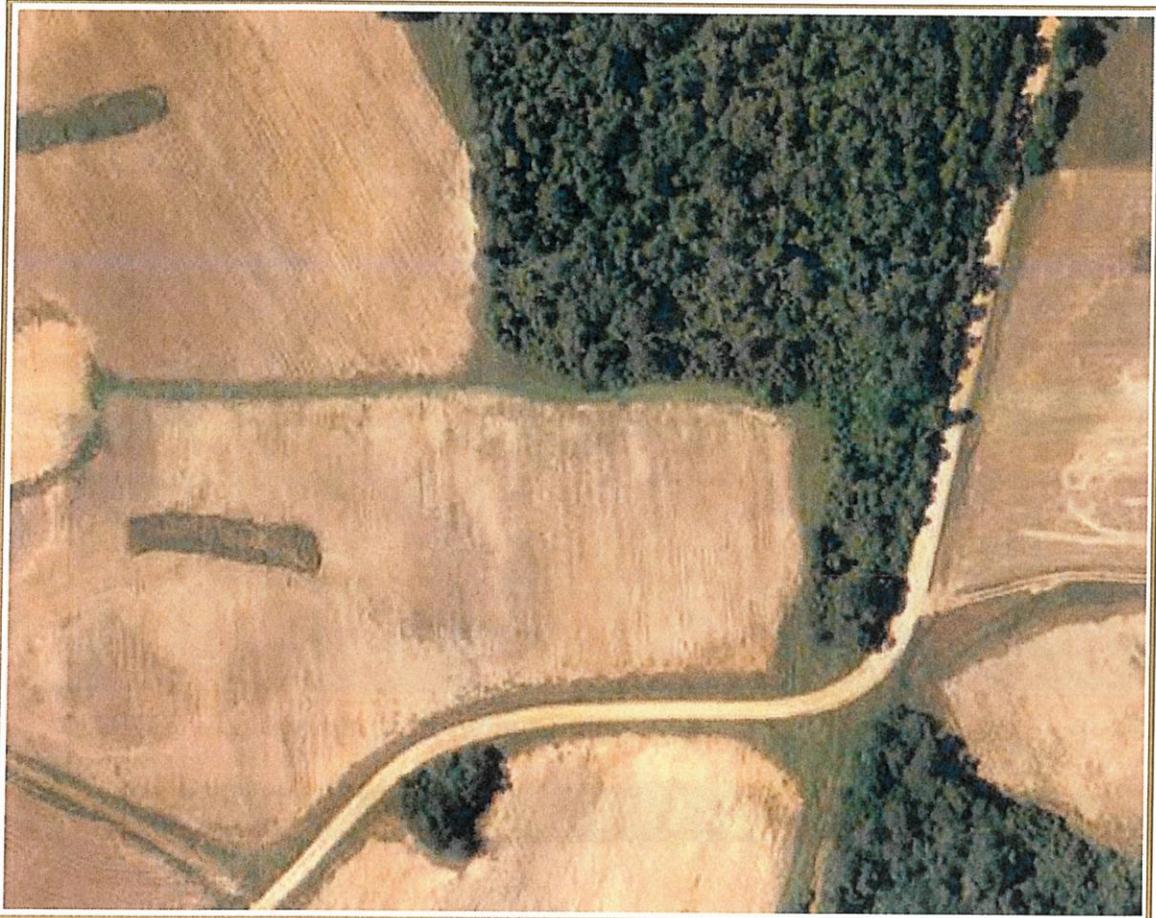
Field Border

Field border in Chambers County, Alabama. Image courtesy of USDA, NRCS.

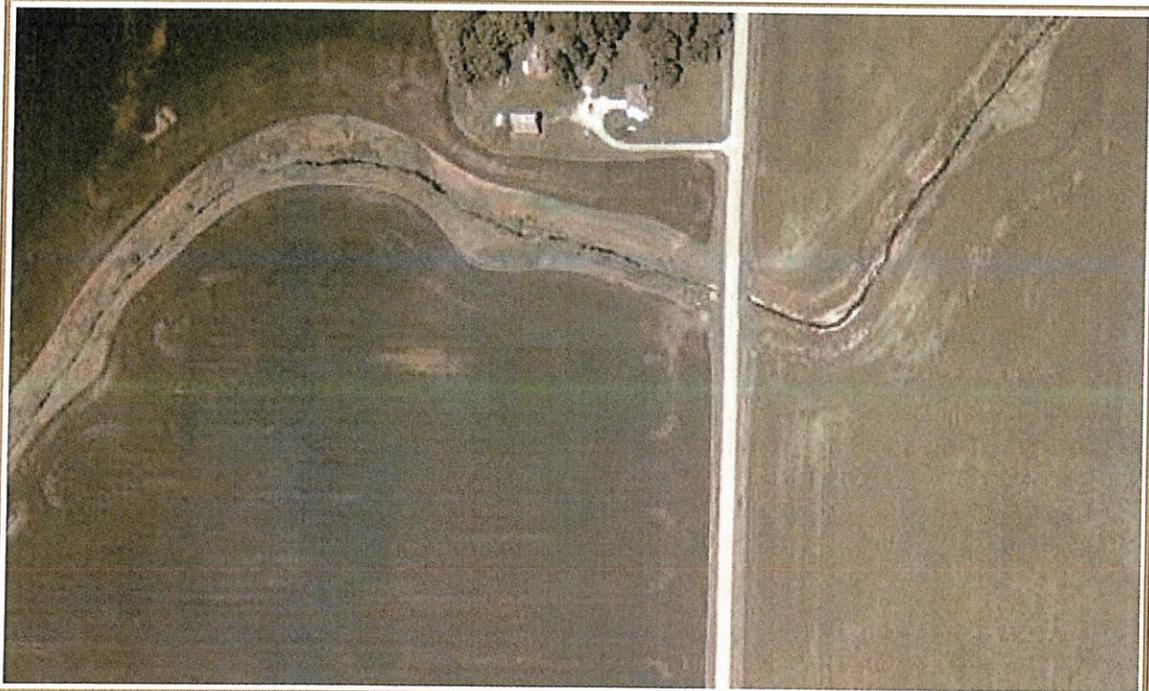
Filter Strip

Filter strip protecting a small stream in Wright County, Iowa. Image courtesy of USDA, NRCS.

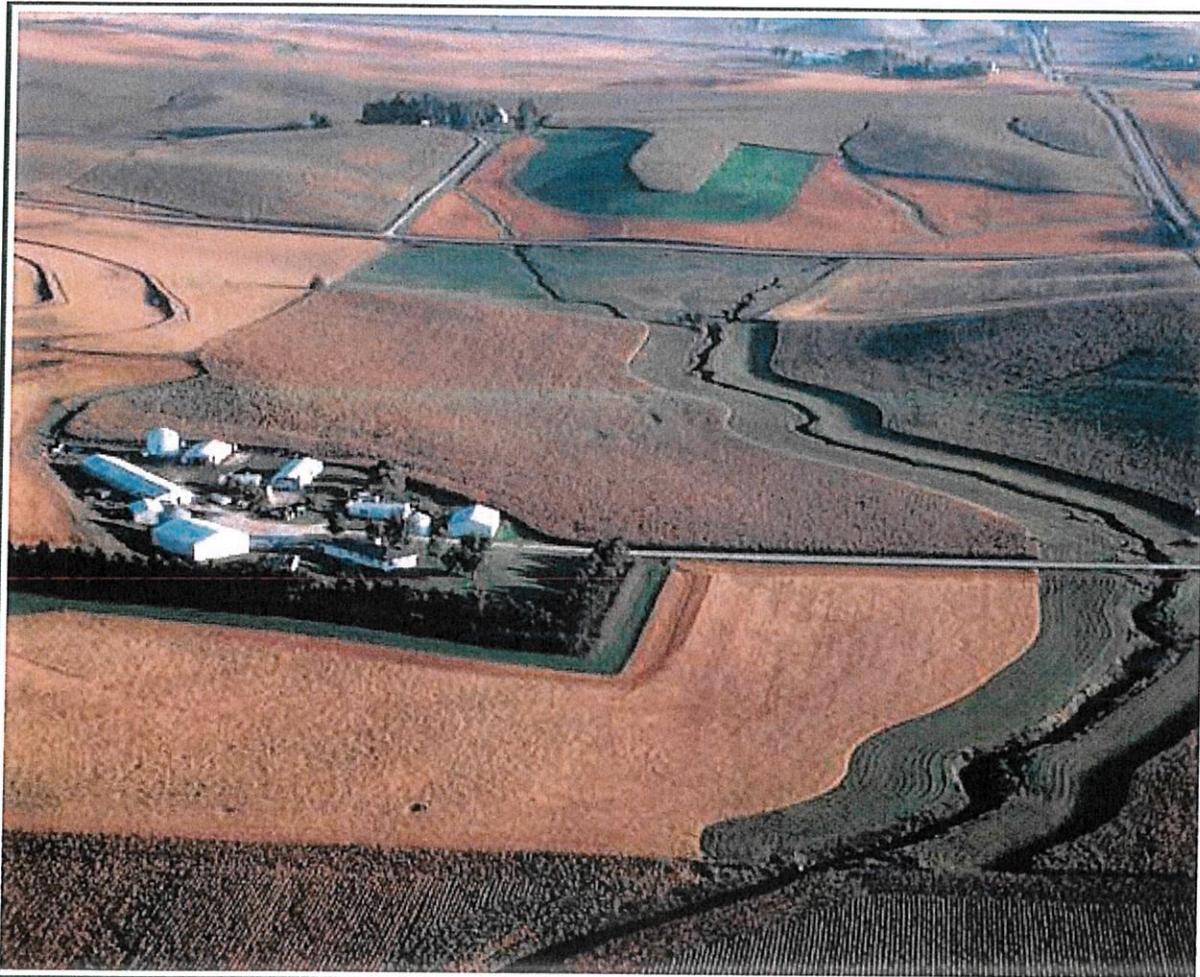
Grass Filter Strip

Grass filter strip in Carroll County, Iowa. Image courtesy of USDA, NRCS.

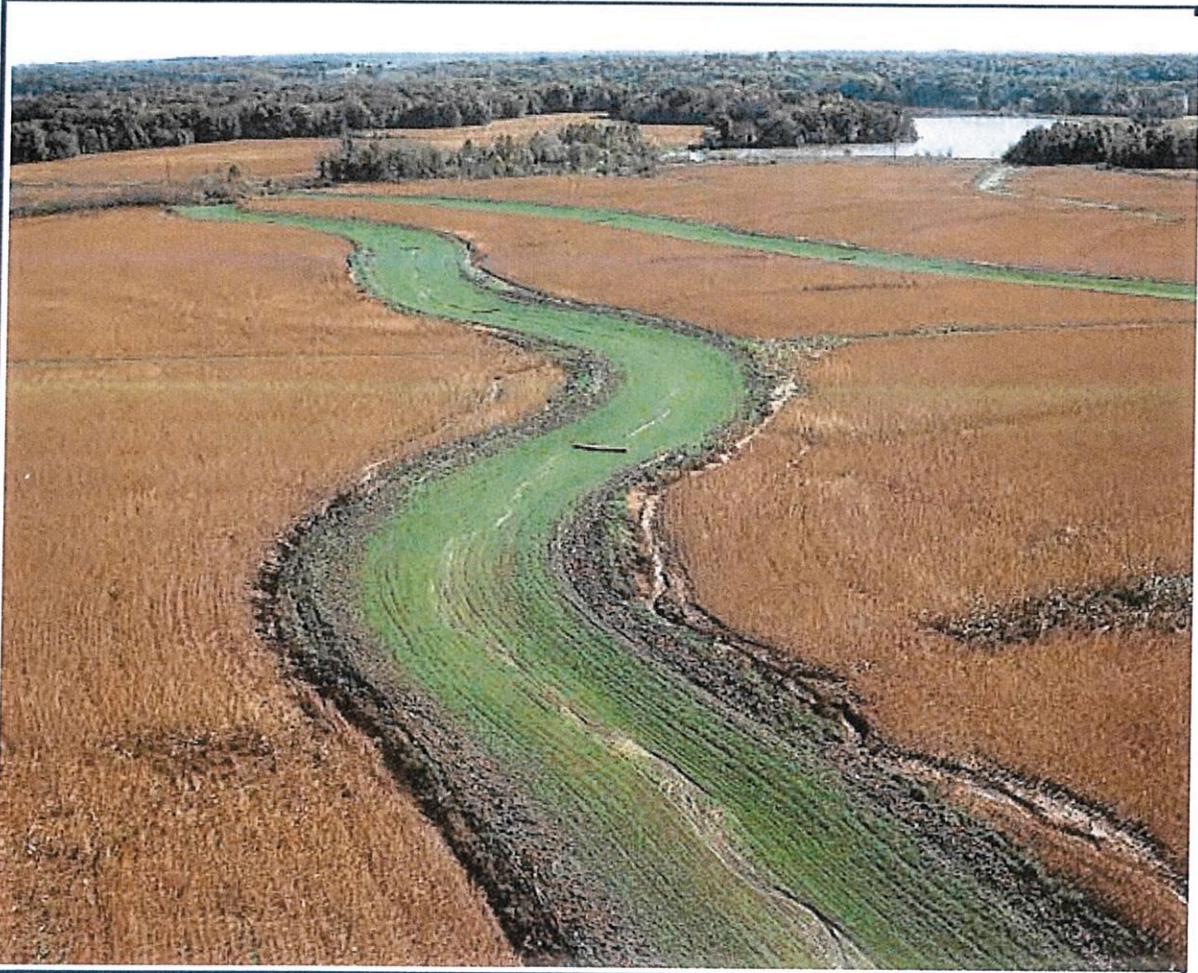
Grassed Waterway

Grassed waterway in southern Missouri. Image courtesy of USDA, NRCS.

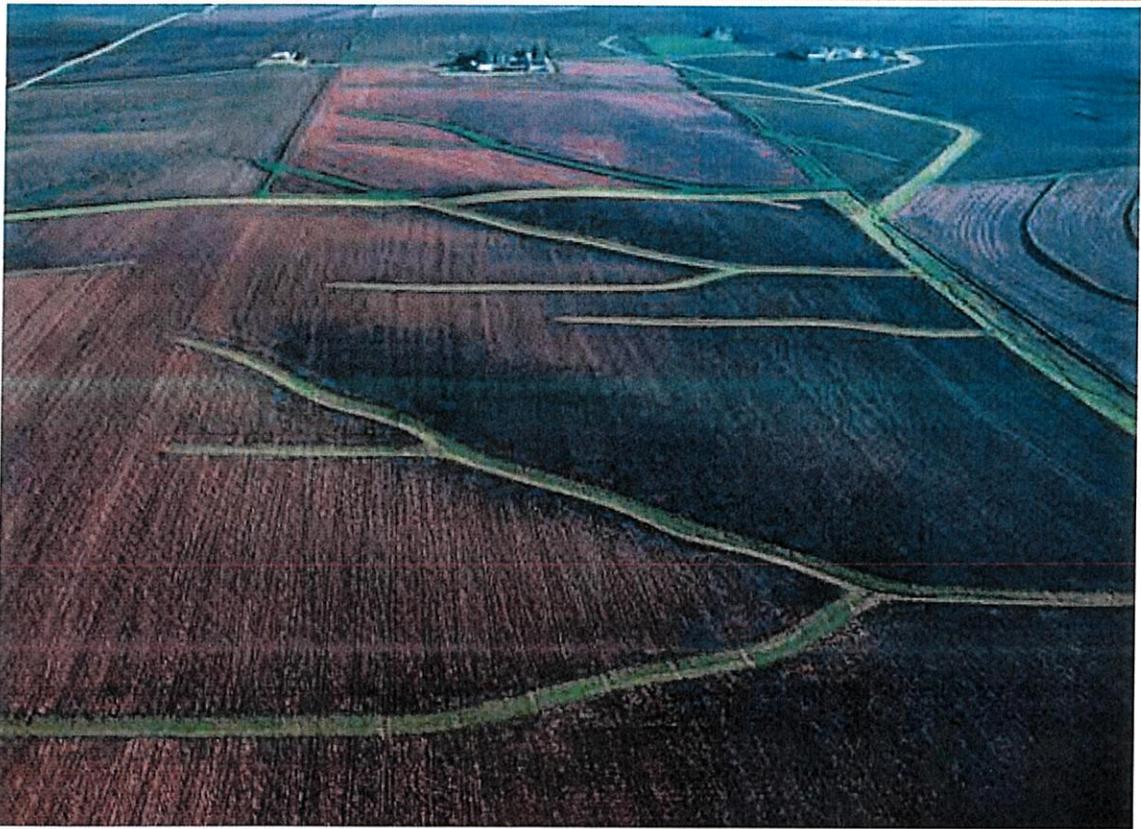
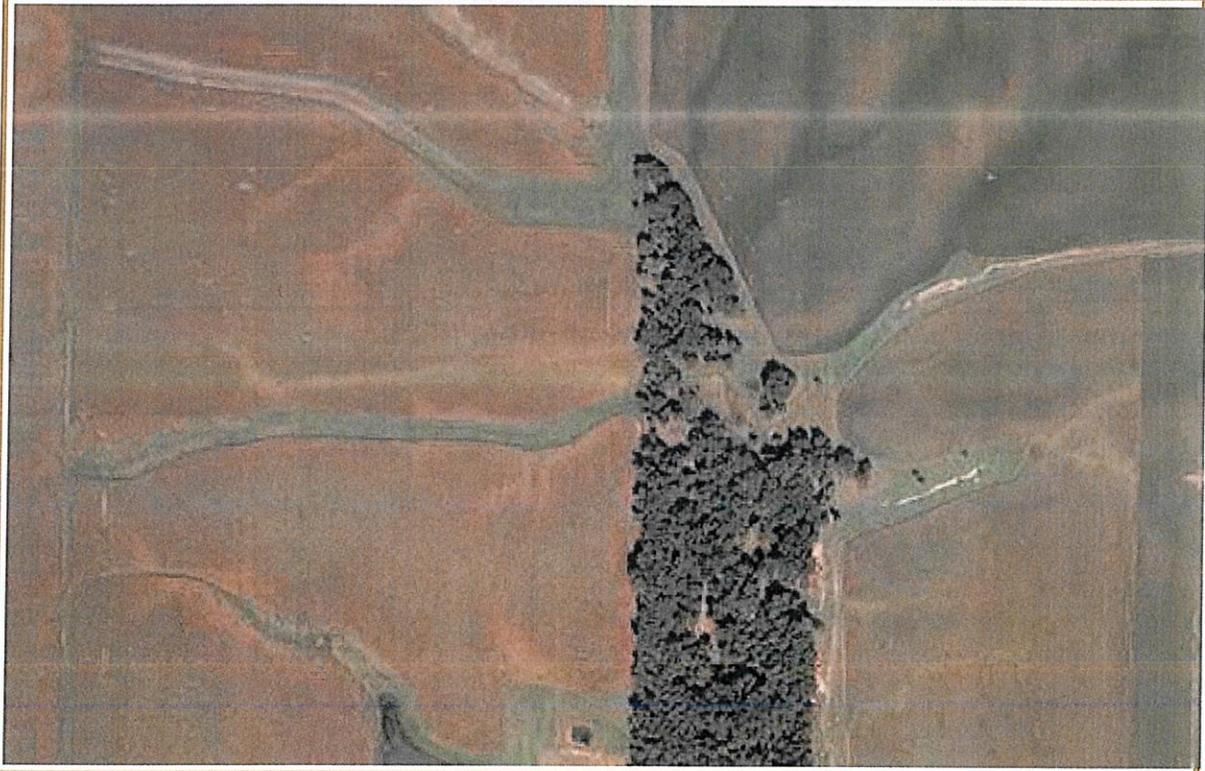
Grassed Waterways

Grassed waterways in Iowa (top, oblique image) and in Missouri (bottom, vertical photo). Both images courtesy of USDA, NRCS.

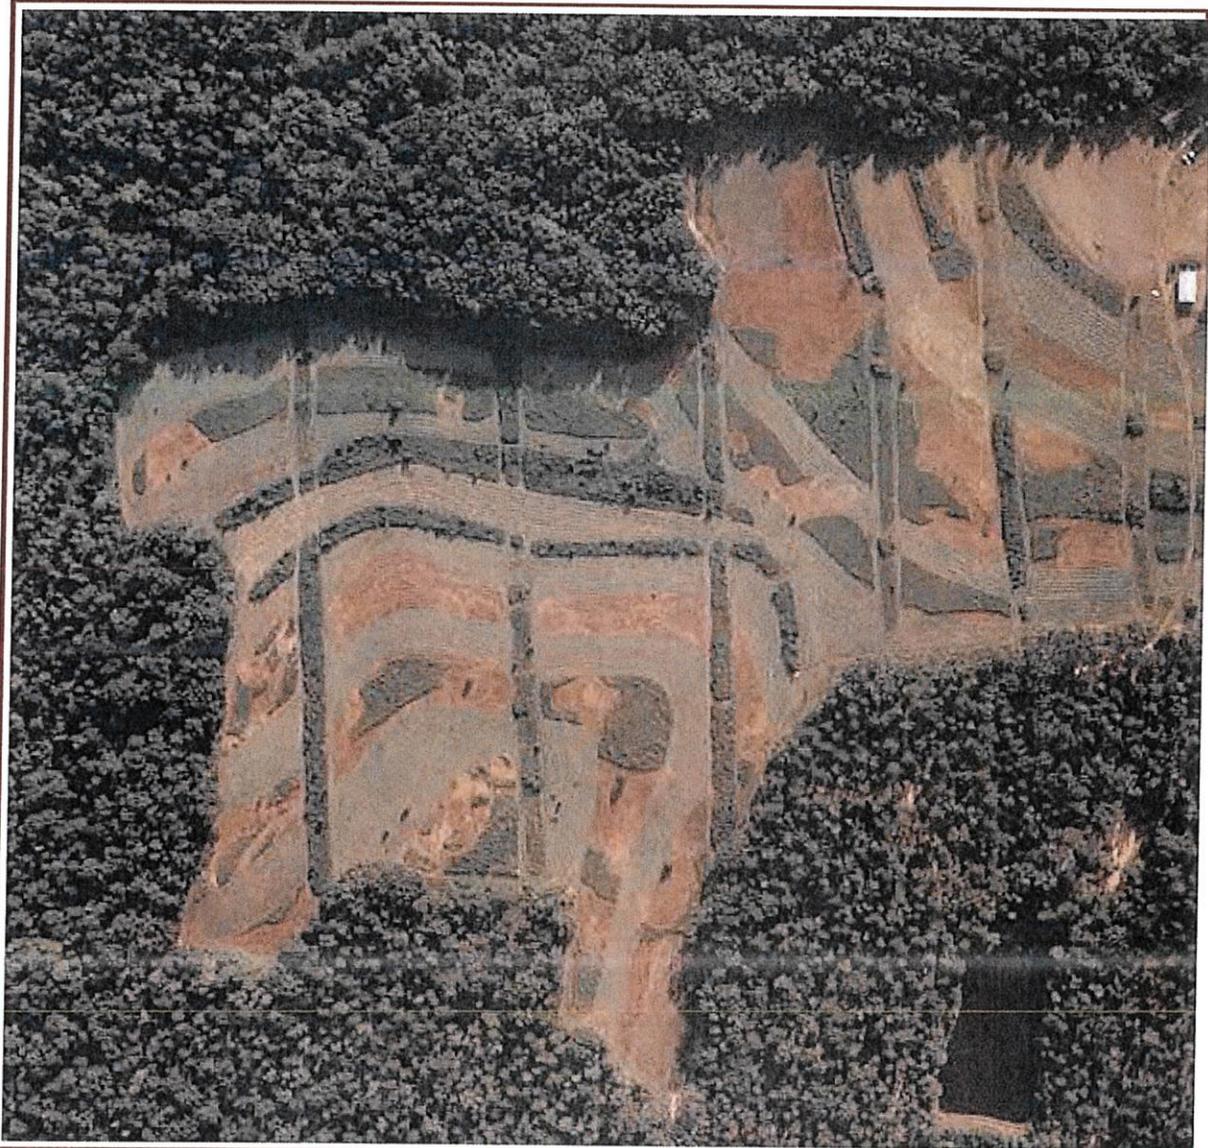
Herbaceous Wind Barriers

Herbaceous wind barriers in Richmond County, North Carolina. In this case, there are a series of contour buffer strips that curve across the field following the contours of the land. The straight, east-west-trending herbaceous wind barriers are superimposed on the buffer strips. Image courtesy of USDA, NRCS.

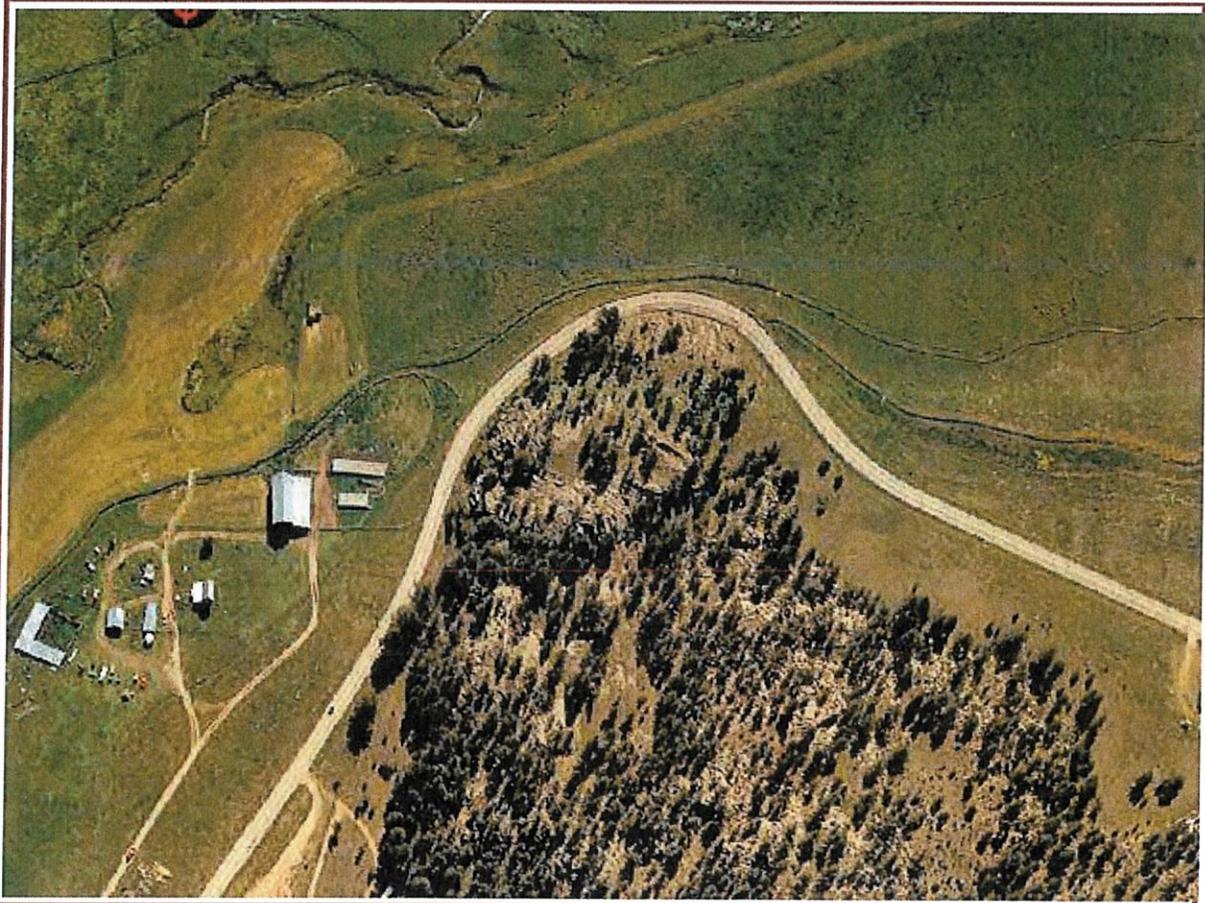
Hillside Ditch

Hillside ditch in Teller County, Colorado. Image courtesy of USDSA, NRCS.

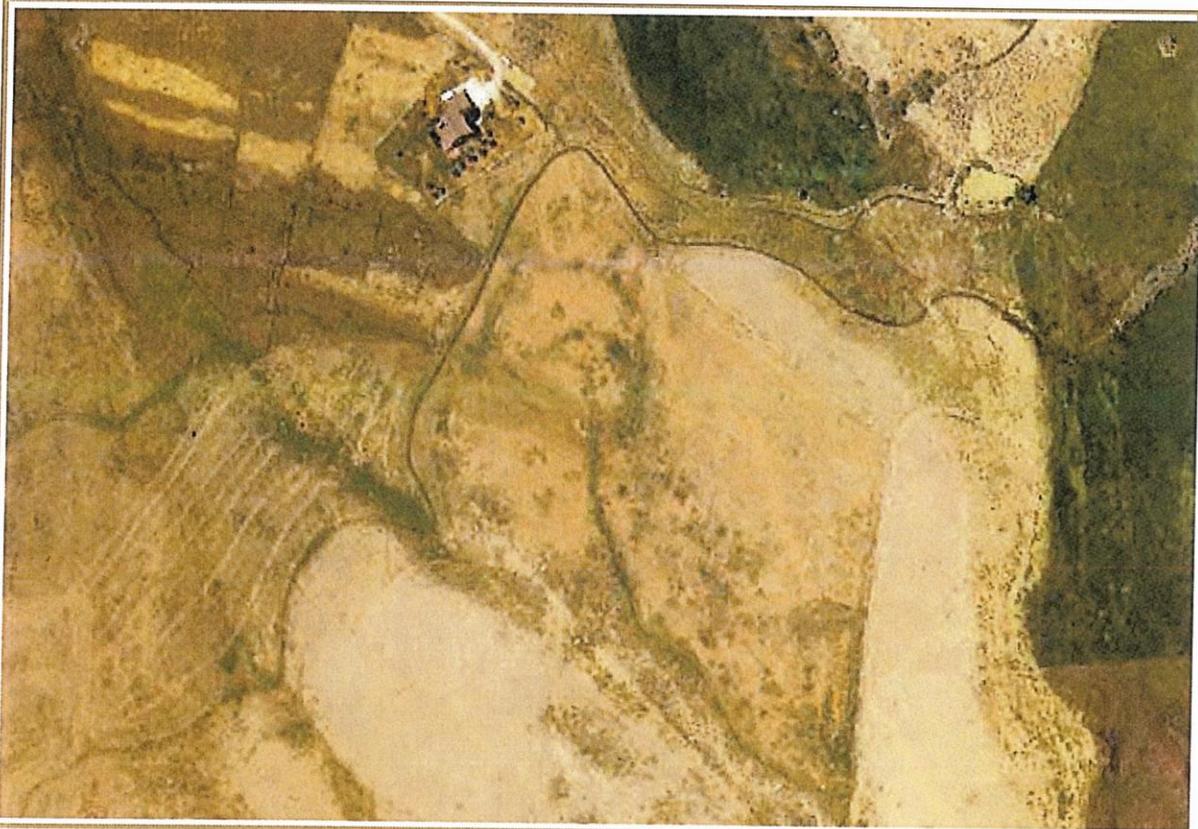
Hillside Ditch

Hillside ditch in Elko County, Nevada. Note how the ditch "hugs" the contour, forming "V's" as it crosses the concentrated flow lines (especially evident in the lower left of the image). Image courtesy of USDSA, NRCS.

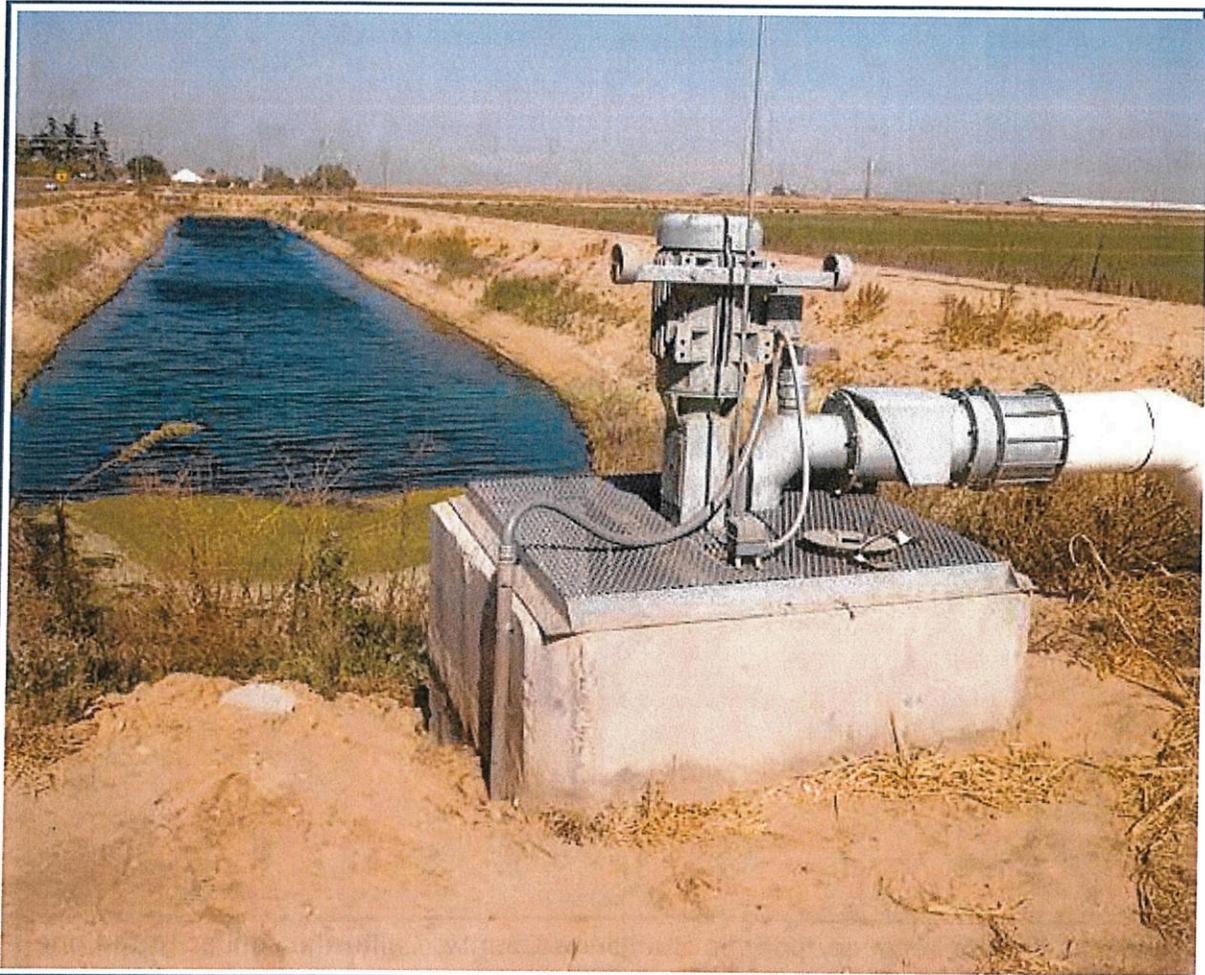
Tailwater Recovery

An irrigation tailwater recovery system in California. Note the recovery pond, the pond-outlet sump and the redistribution pump and piping. Image courtesy of USDA, NRCS.
