Conservation Practices

There are 167 conservation practices listed in the National Handbook of Conservation Practices. The table below summarizes some of the most common practices that can be interpreted from large-scale aerial imagery.

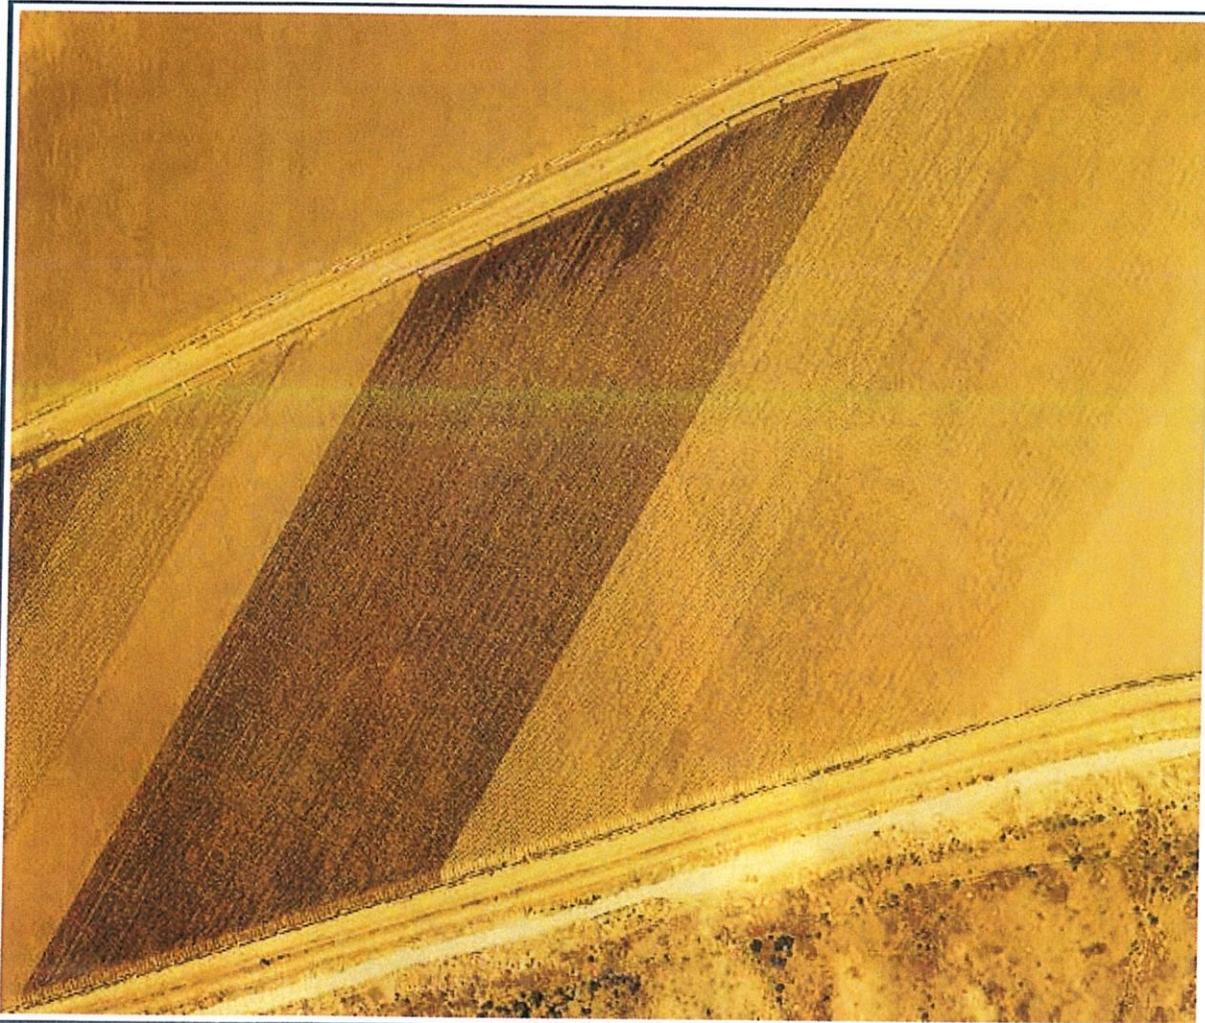
Irrigation Tailwater Recovery

An irrigation tailwater recovery system in Maricopa County, AZ. This image captured the dark field as it was being gravity irrigated. Note the series of evenly-spaced flood gates along the supply channel at the top edge of the field. The tailwater is leaving the field along its bottom edge (note the closely-spaced discharge runs that empty into the return ditch). A pump facility is located in the lower-right of the image on the N-S extension of the return-flow ditch. The returned water is piped (underground) back into the supply channel for re-use. Image courtesy of USDA, NCRS.

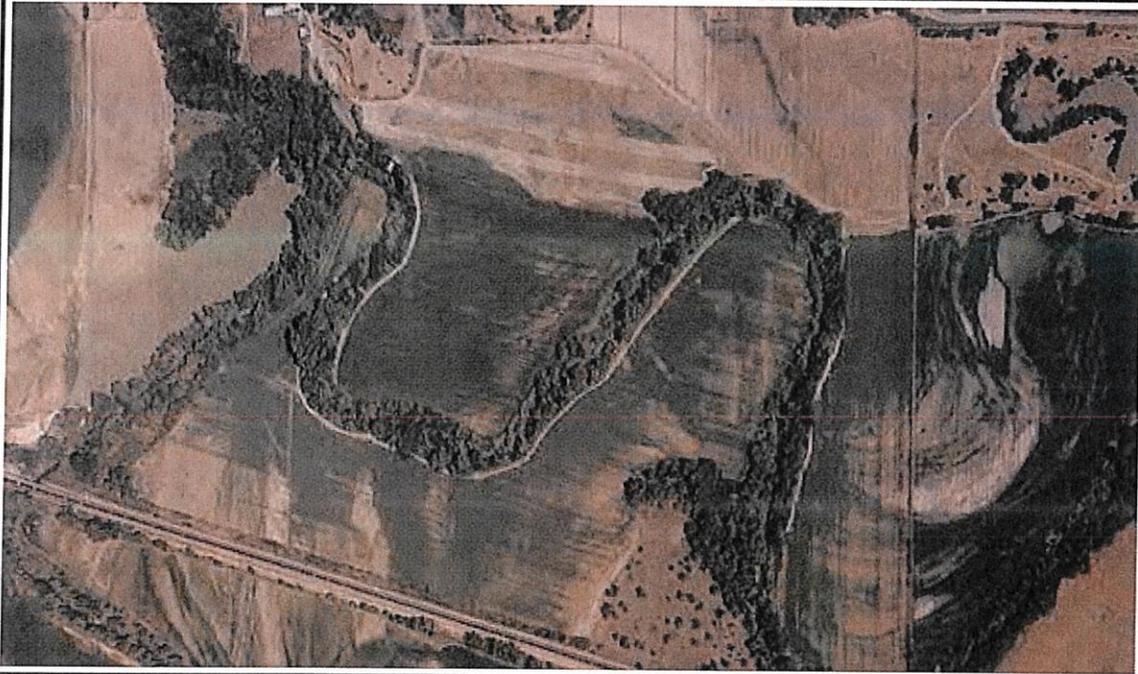
Riparian Forest Buffer

Riparian forest buffer in central, Nebraska. Image courtesy of USDA, NRCS.

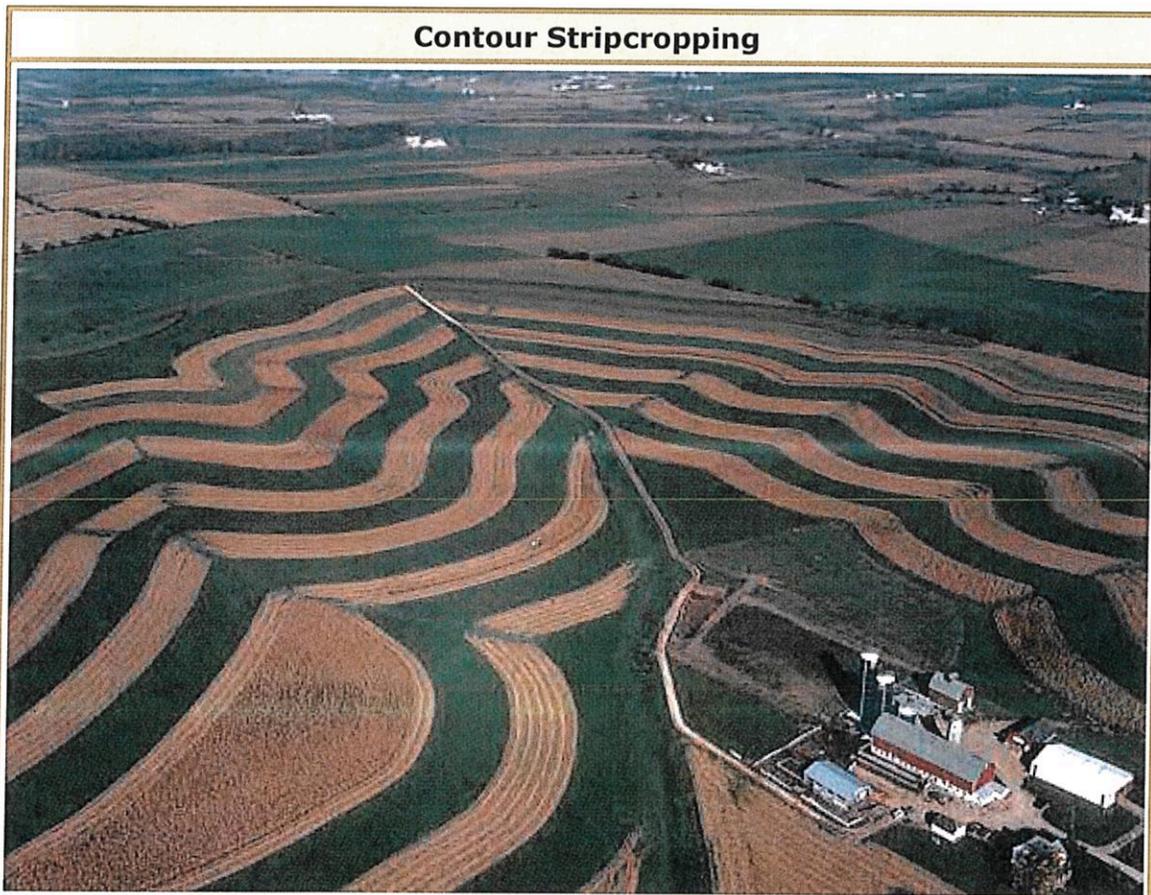
Contour stripcropping corn (tan) and alfalfa (green) in central Wisconsin. Note the use of grassed waterways to control water erosion in the numerous concentrated flow lines in this field. Image courtesy of USDA, NRCS.

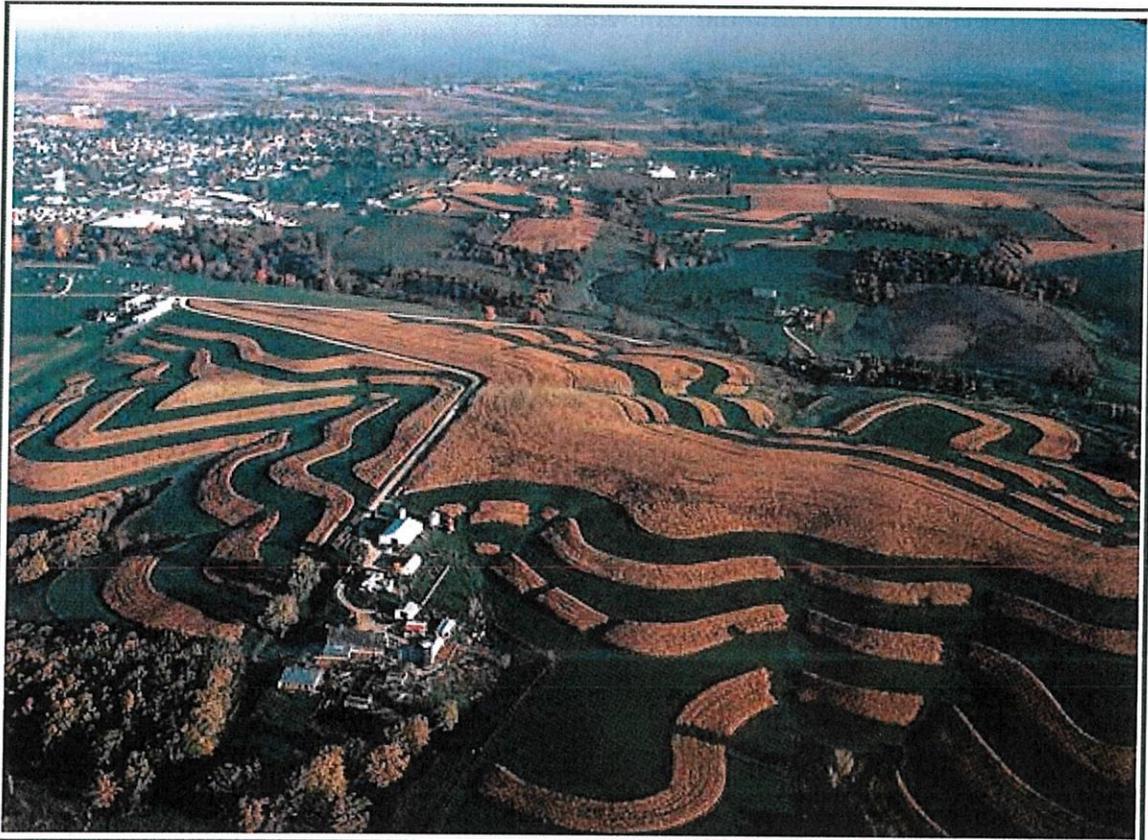
Contour Stripcropping

Contour stripcropping of corn (brown) and alfalfa (green) in Iowa. The use of grassed waterways to control water erosion in the numerous concentrated flow lines in this field is masked to some degree by the overall greenness of the alfalfa. Image courtesy of USDA, NRCS.

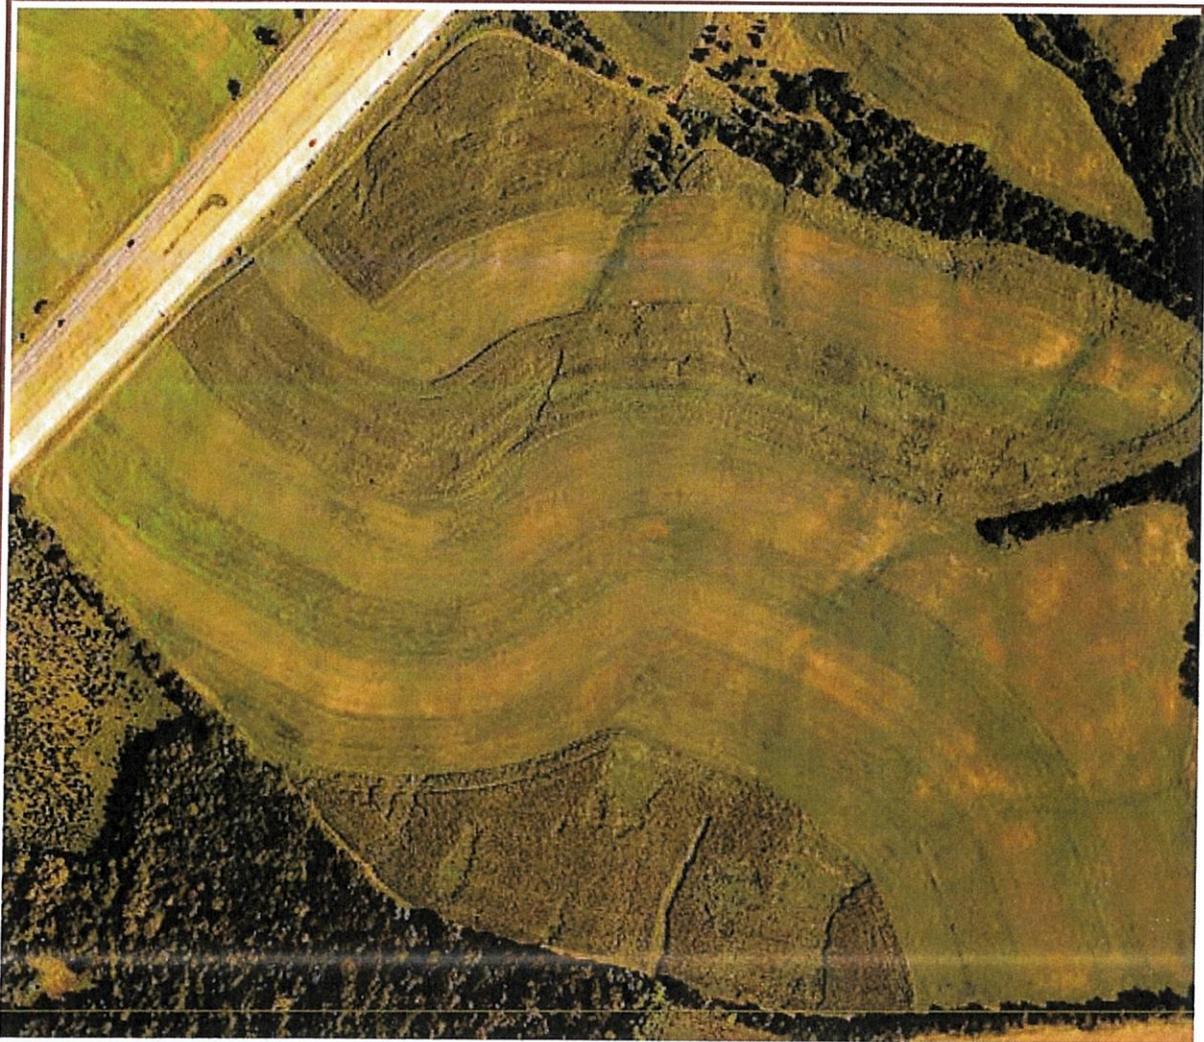
Contour Stripcropping

Contour stripcropping in Adams County, Pennsylvania. Image courtesy of USDA, NRCS.

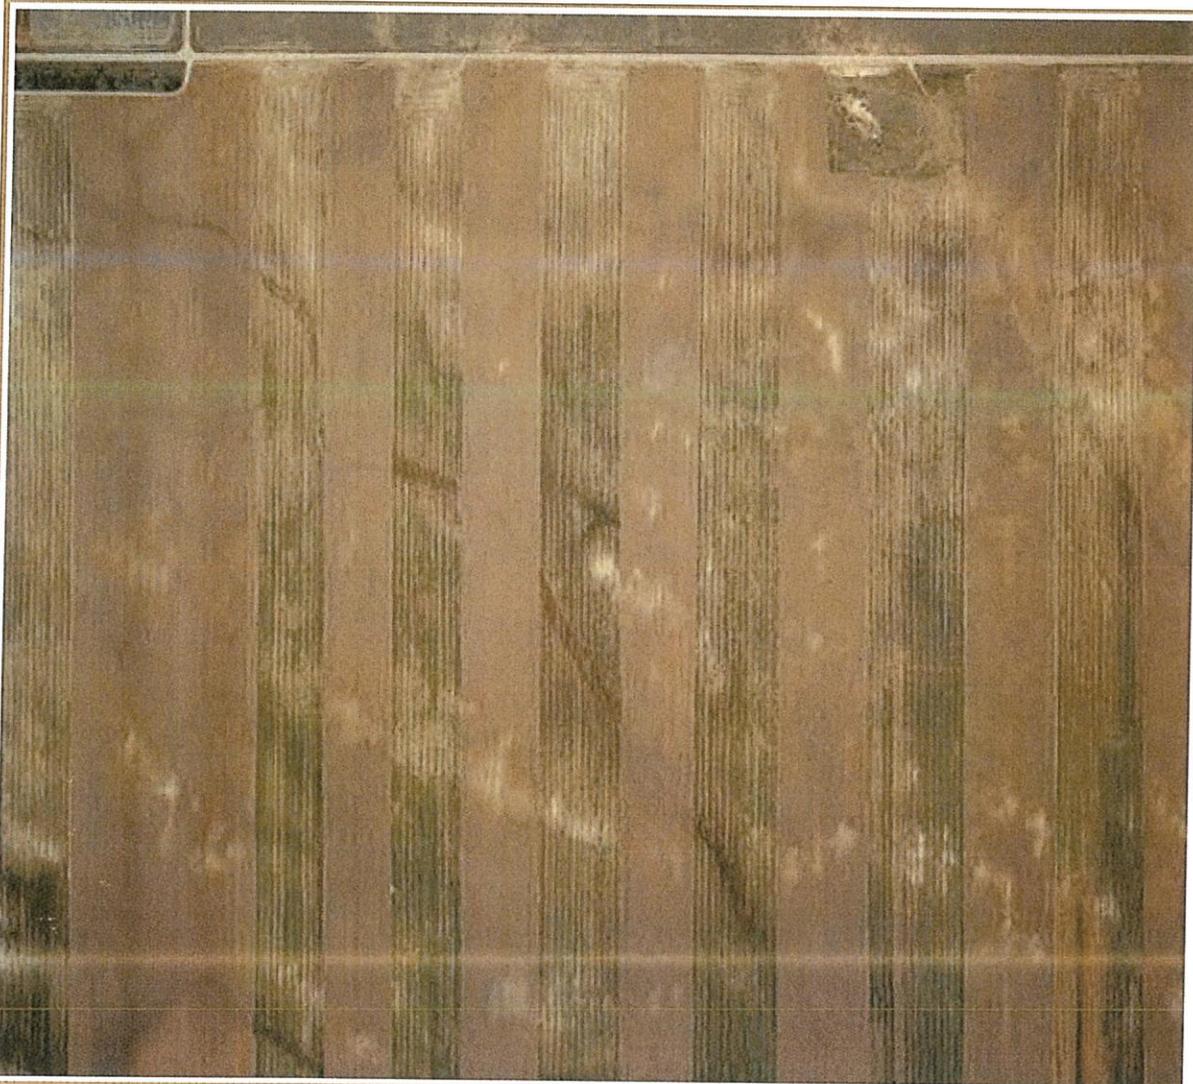
Cross-wind Stripcropping

Cross-wind stripcropping in Banner County, Nebraska. By inspecting the form of the concentrated flow line crossing this field diagonally from upper left to bottom center, you can deduce that, in general, the land slopes down to the lower right. Hence, the orientation of the bands of close-grown crop in this field appear to have been arranged across the prevailing wind-erosion direction, NOT across the general slope (differentiating it from field stripcropping) and NOT on the contour (differentiating it from contour stripcropping). Image courtesy of USDA, NRCS.

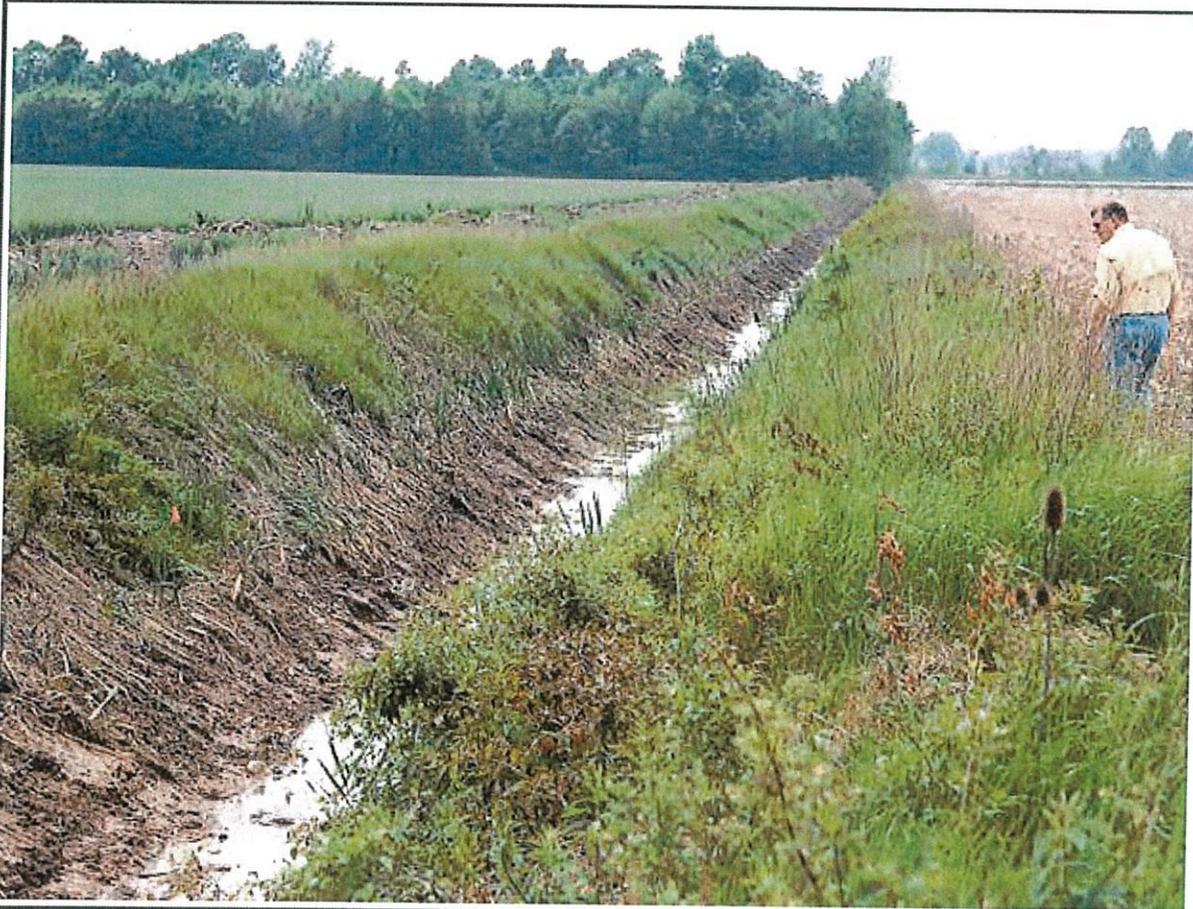
Drainage Ditch

Drainage ditch in Saginaw County, Michigan. Photo courtesy of Randy Schaetzl, MSU.

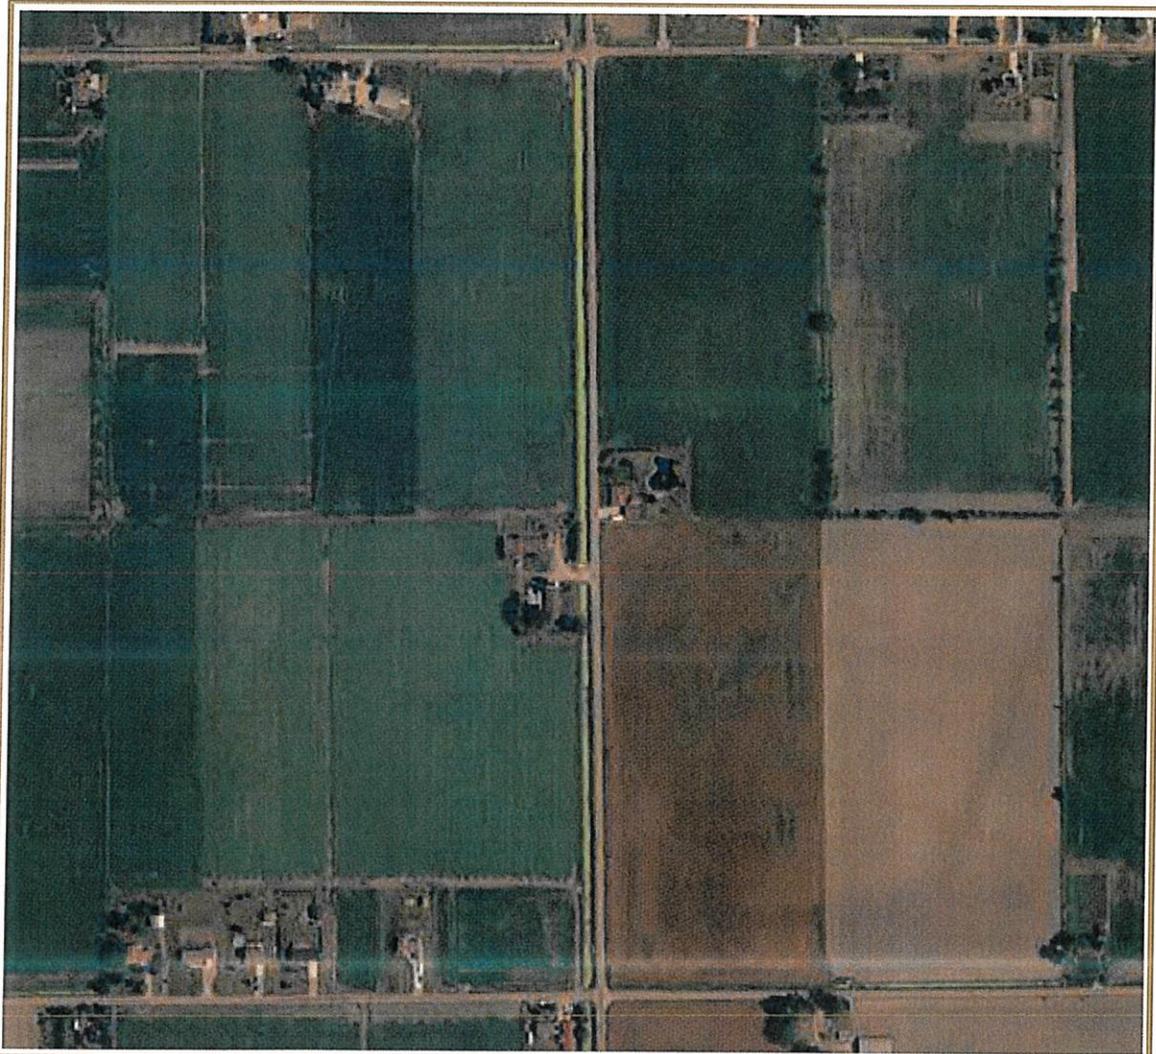
Drainage Ditches

Drainage ditches in Bay County, Michigan. In this image, the water in the ditches is covered with Duckweed, a floating aquatic plant, that makes the ditches appear a light green color. Image courtesy of USDA, NAIP.

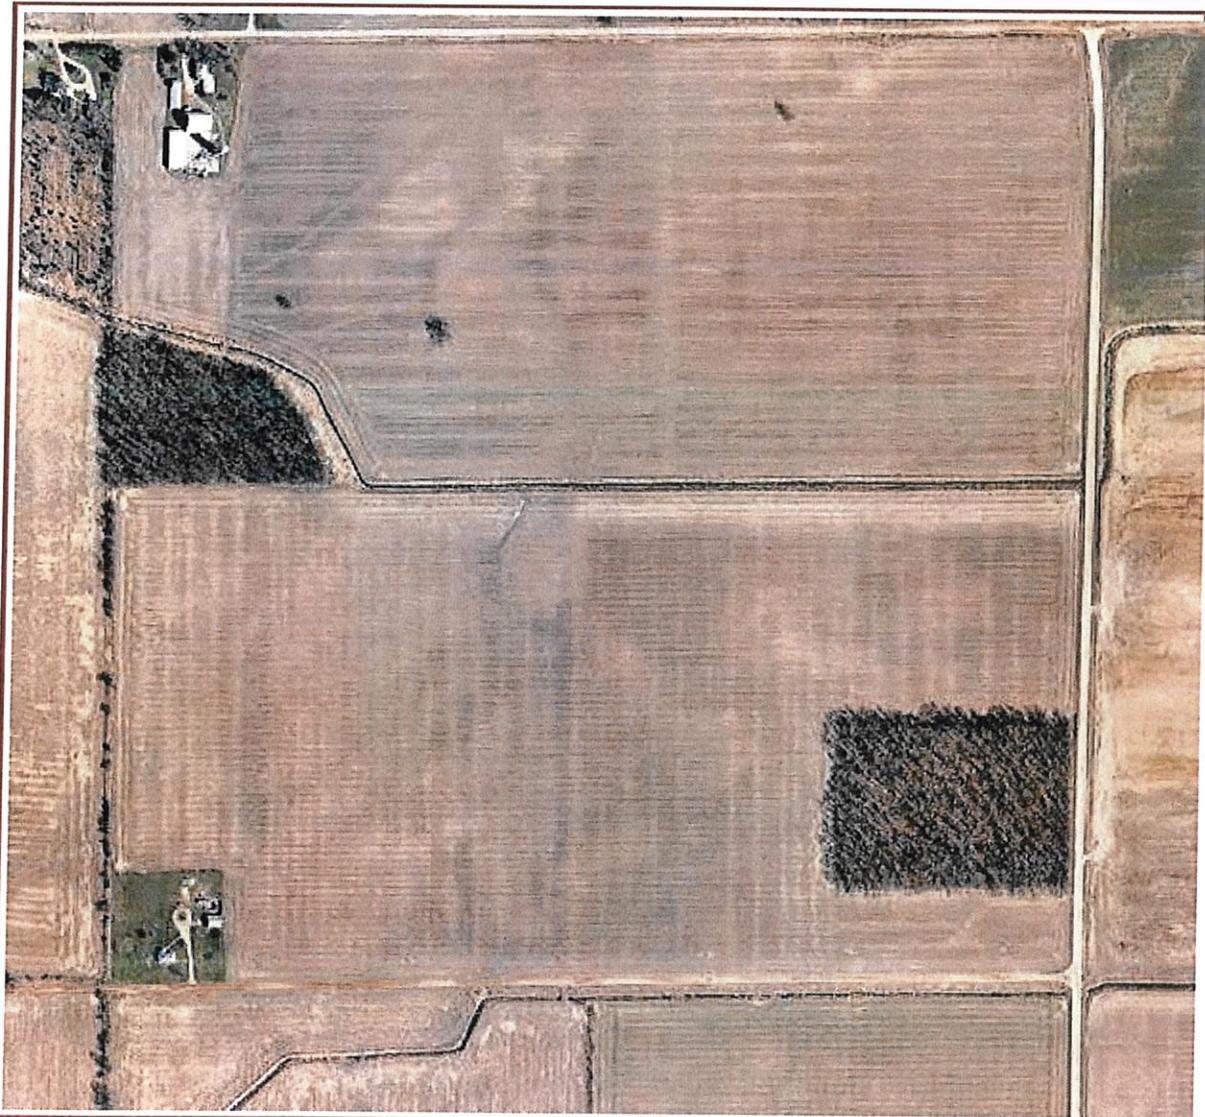
Drainage ditches (arrows) in Clinton County, Michigan. In this leaf-off, spring image, the pattern of the tile drains underlying several of the fields is obvious. The drain tiles discharge to the ditches. Image courtesy of Clinton County, Michigan.

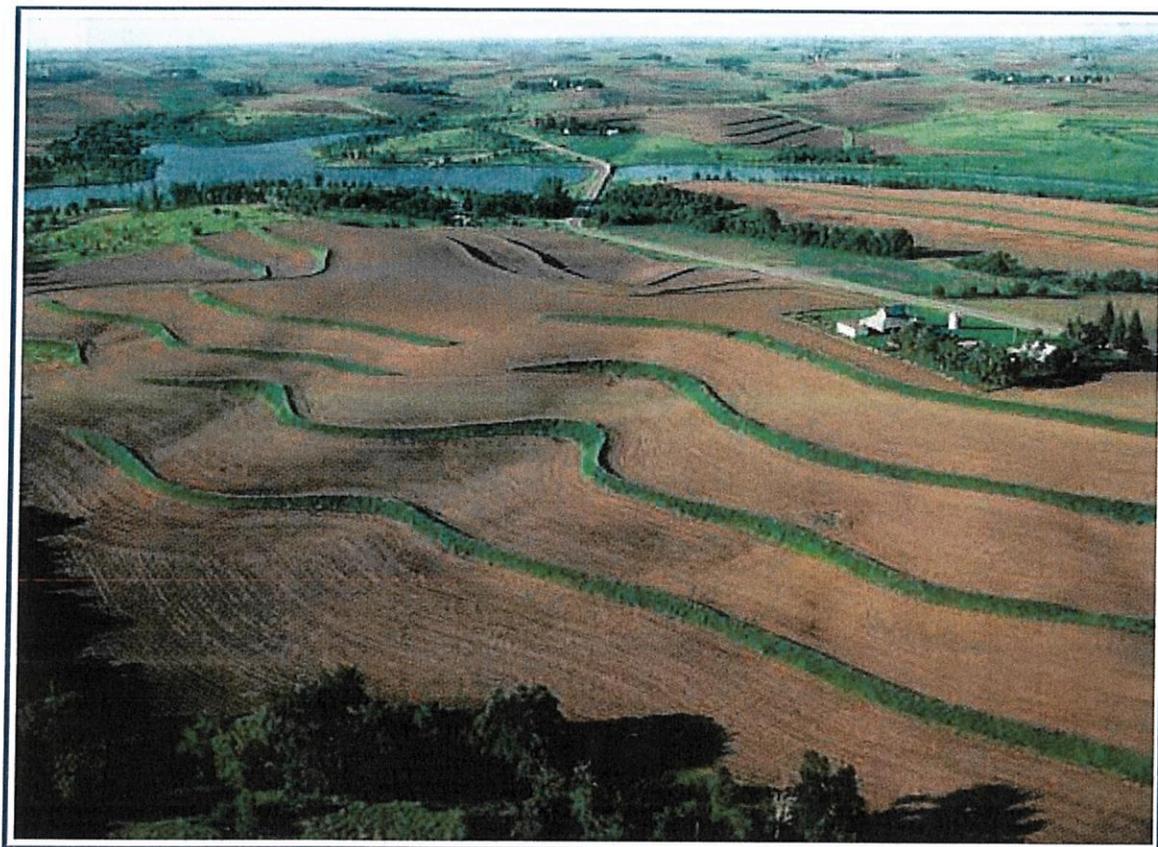
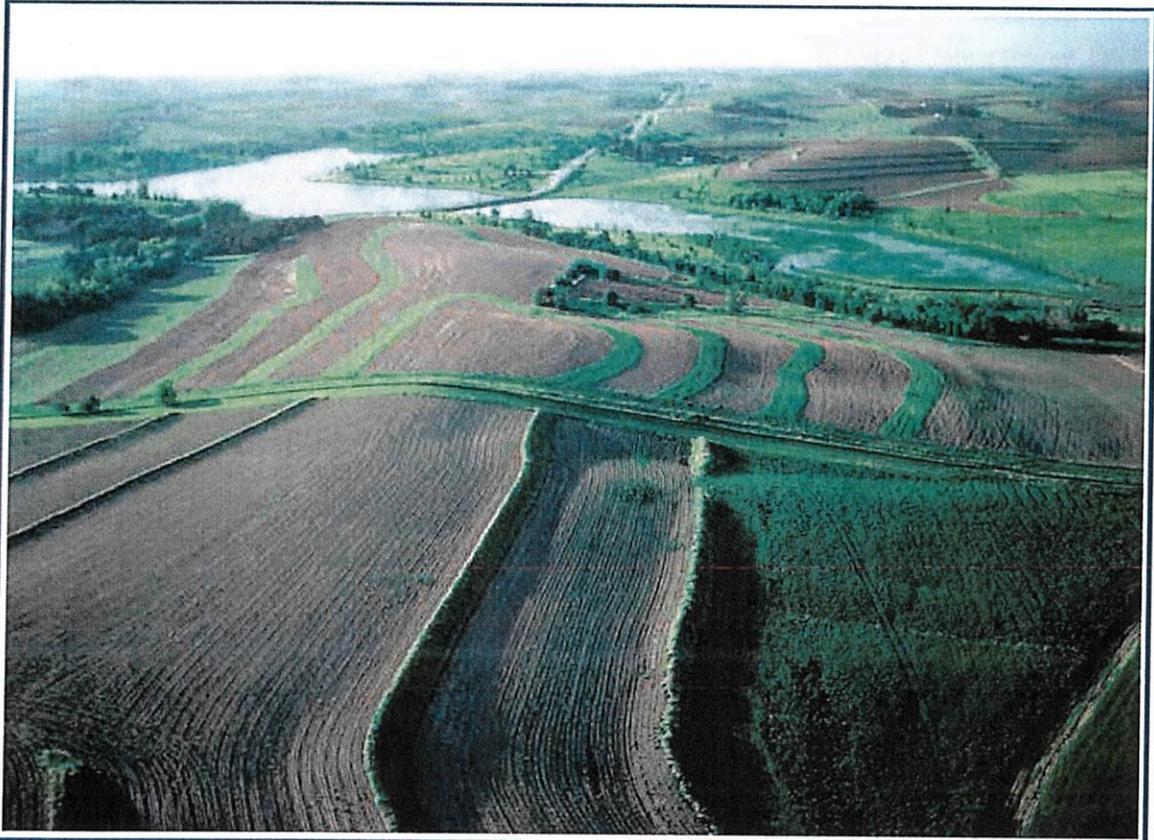
Terraces in Shelby County, Iowa. Images courtesy of USDA, NRCS.

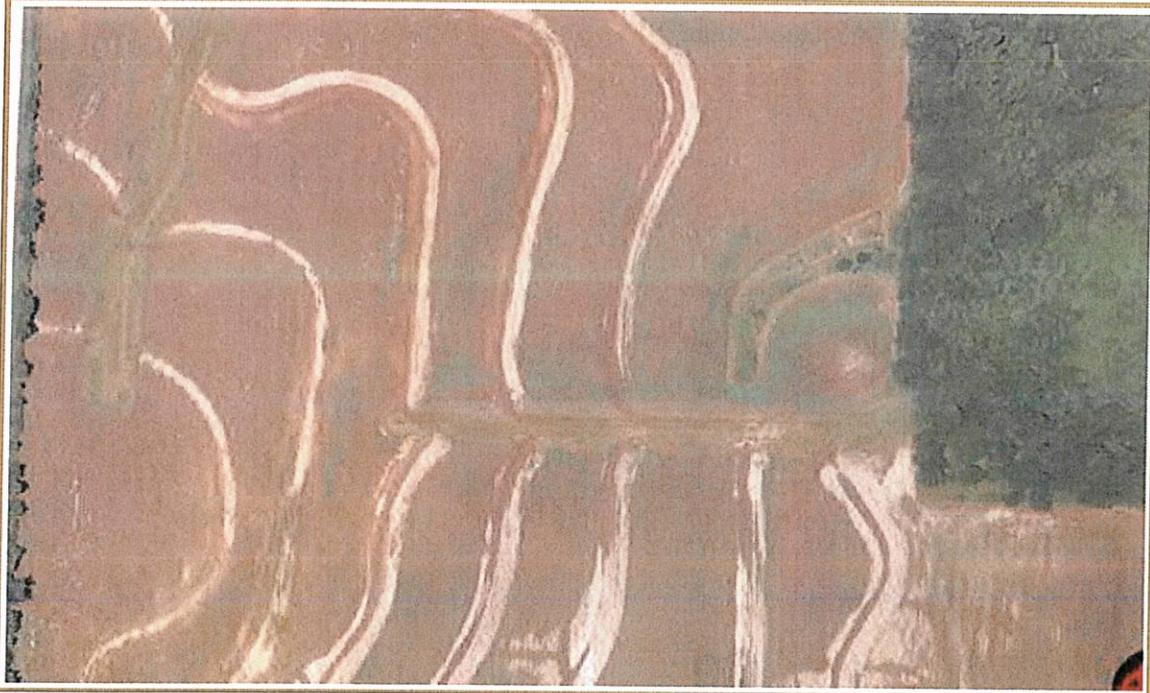
Terraces in Allen County, Kansas. Image courtesy of USDA, NRCS.

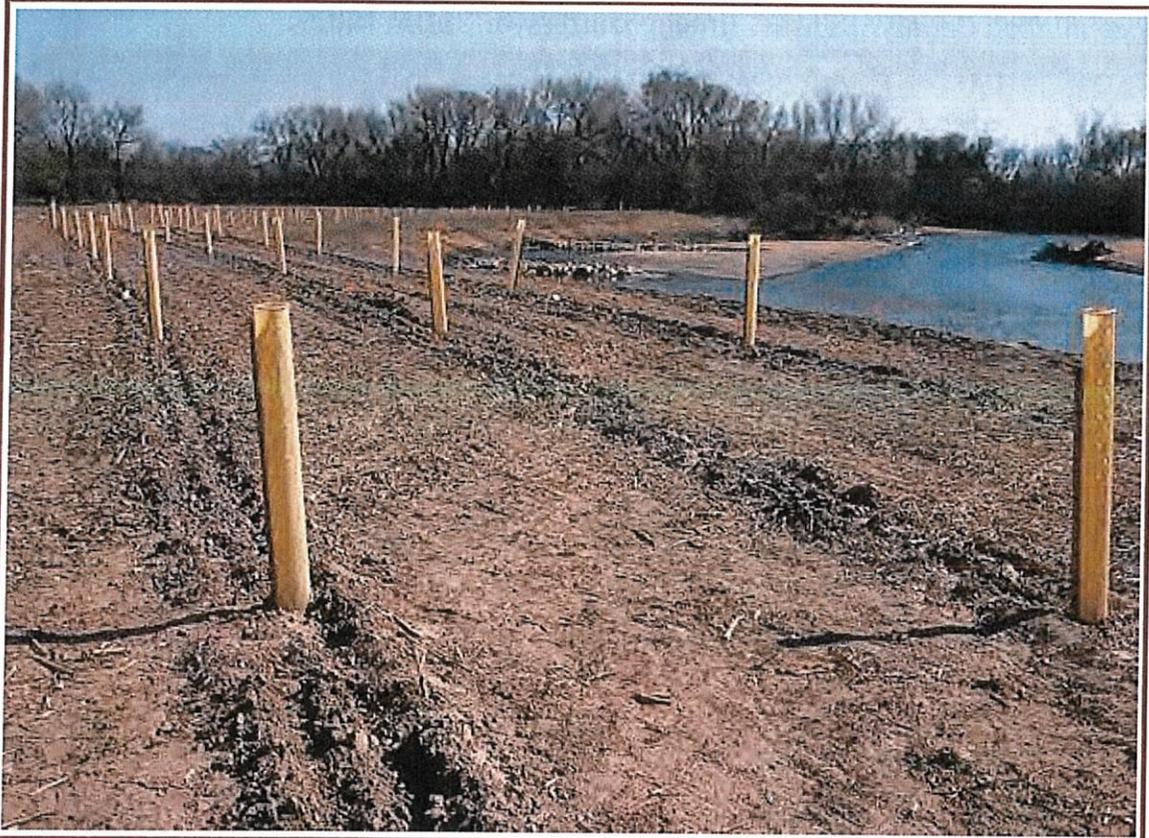
Tree Planting

Tree planting within a riparian area in Kansas. Note the shelter tubes used to protect the seedlings from winter-kill and deer-browse. Image courtesy of USDA, NRCS.

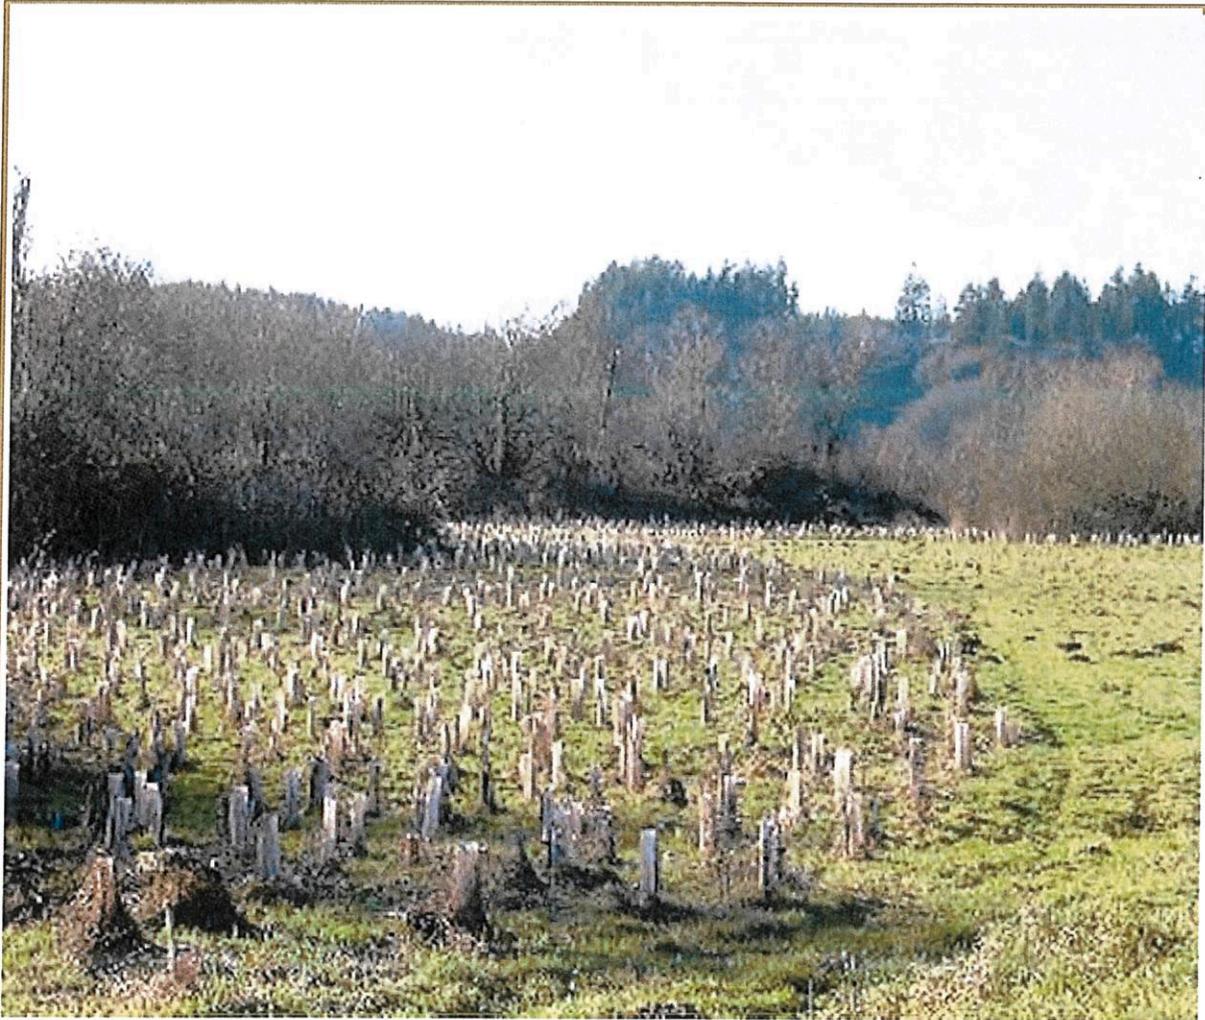
Riparian Zone Restoration

Riparian zone restoration using trees planted in shelter tubes. Image courtesy of USFWS.

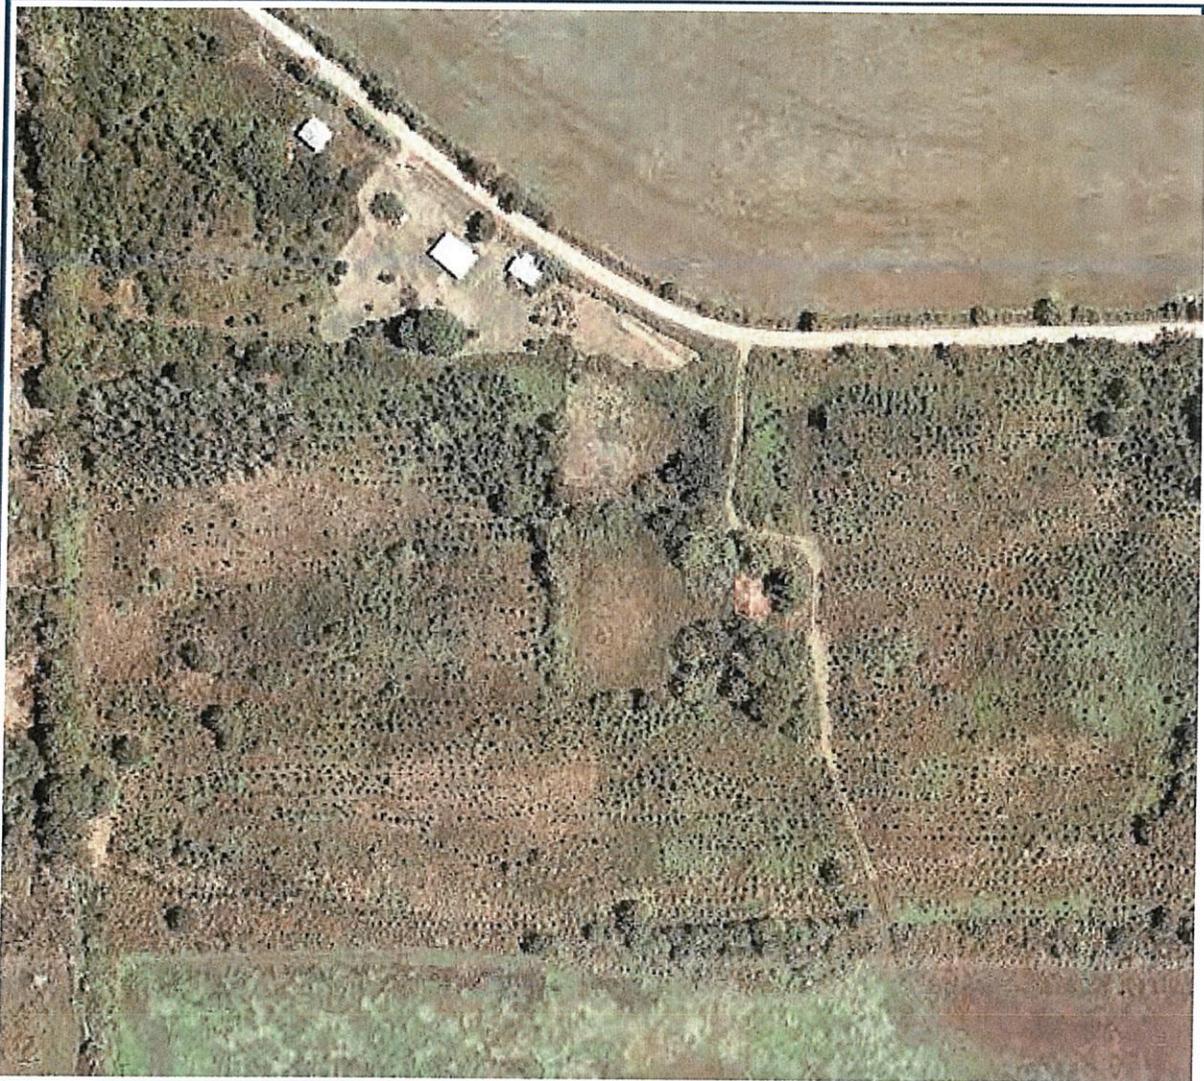
Tree Establishment

Tree establishment in Chicot County, Arkansas. Image courtesy of USDA, NRCS.

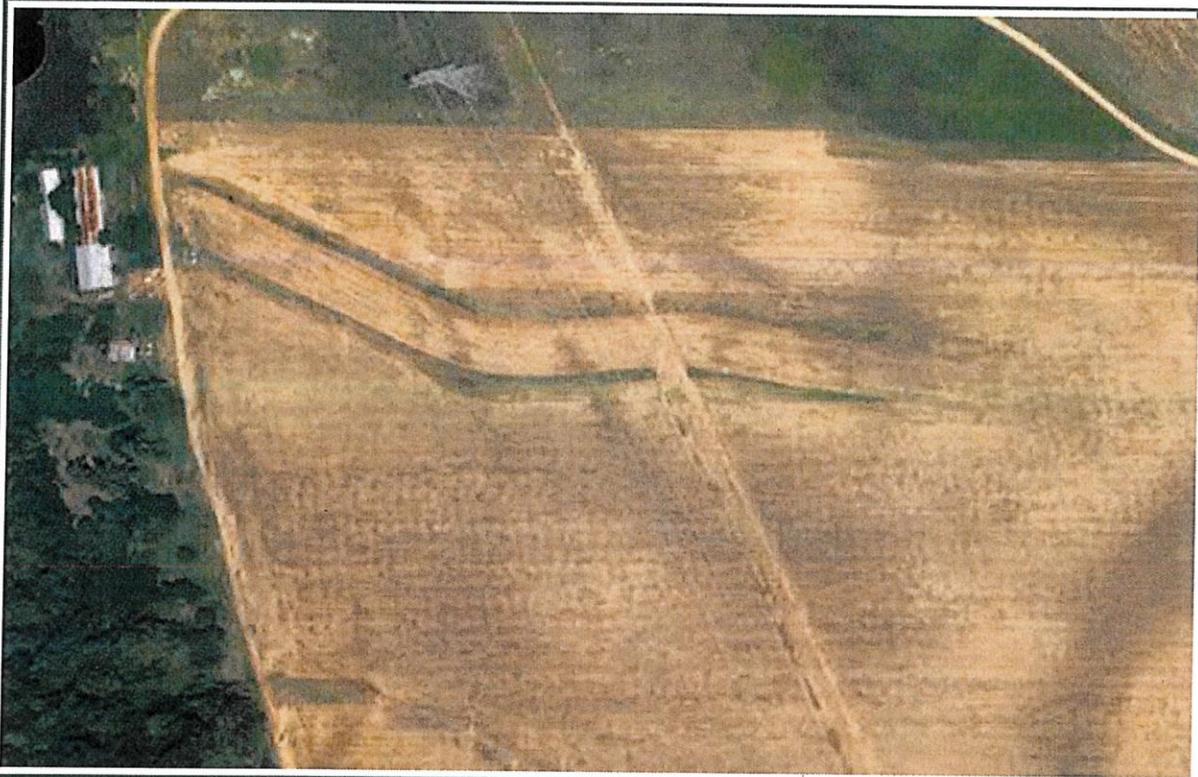
Vegetative Barrier

Vegetative barrier in Autauga County, Alabama. Image courtesy of USDA, NRCS.

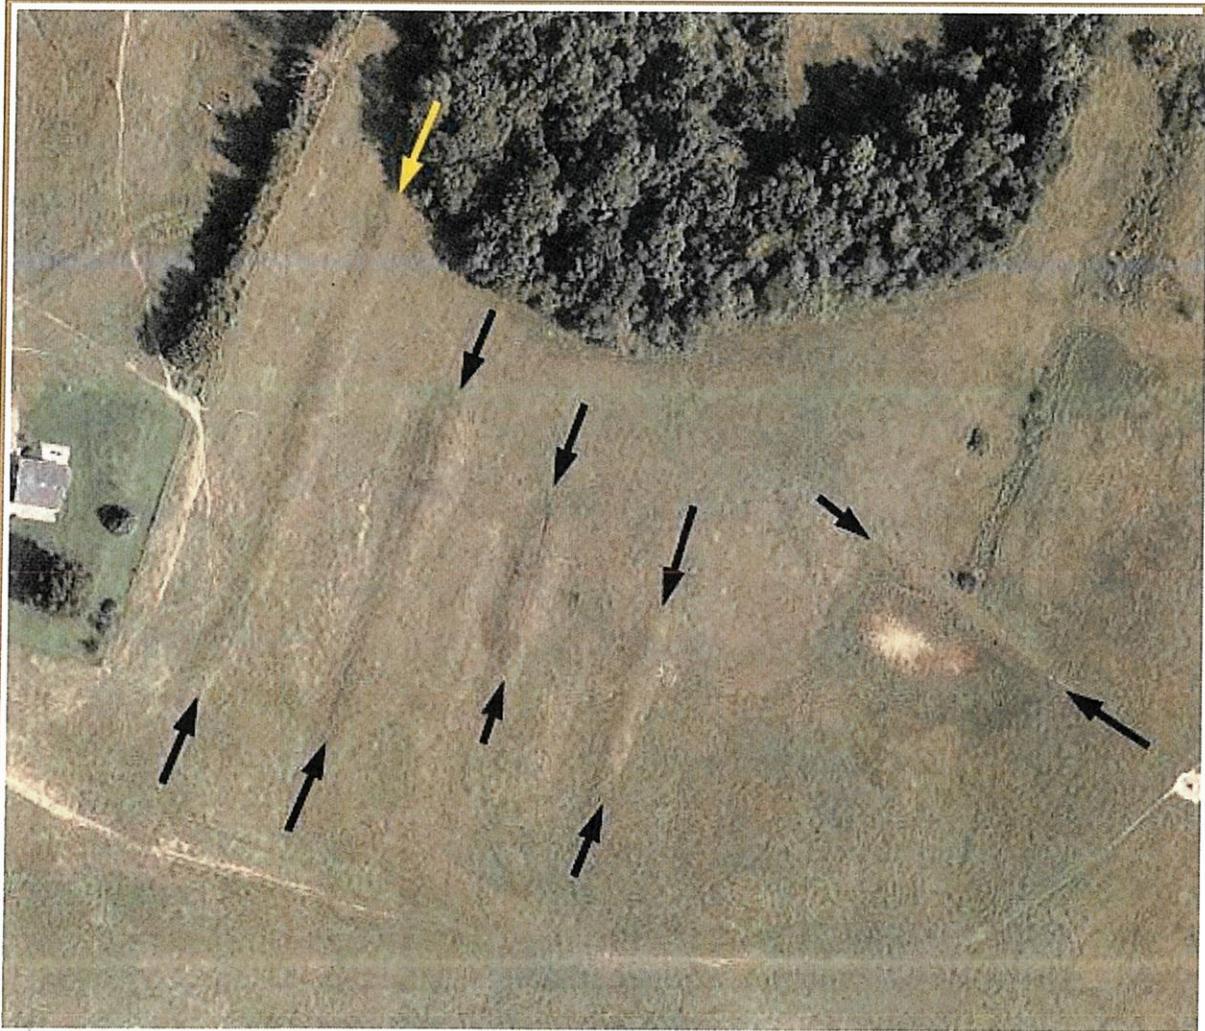
Water-sediment control structures (arrows) in Lauderdale County, Tennessee. Note the minor watercourse that is "interrupted" by these structures. The upper (i.e. left) four structures appear to create very narrow basins, but the lower (i.e. right-most) structure clearly impounds a sizable detention basin. Image courtesy of USDA, NRCS.

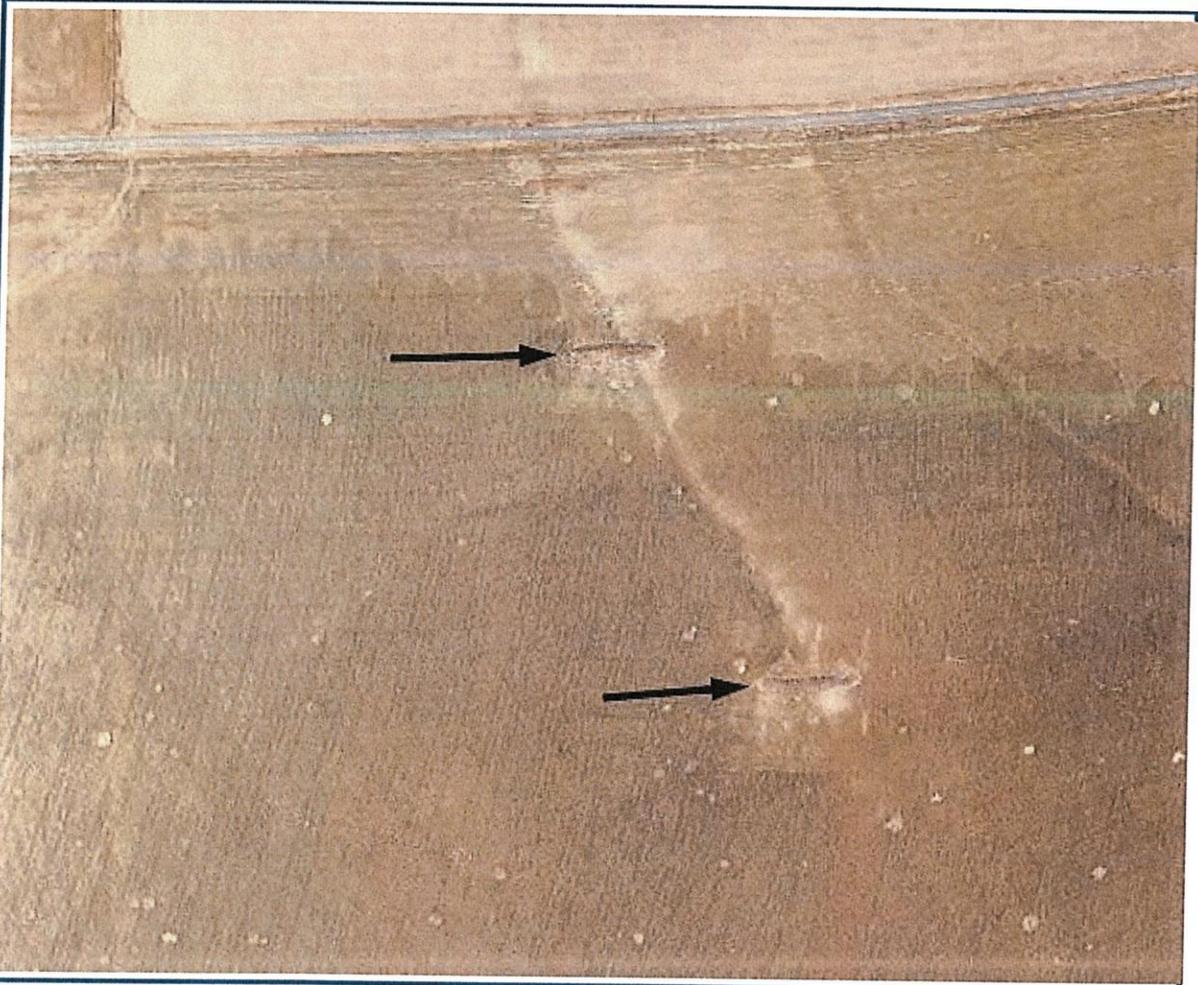
Water-sediment Control Structures

Water-sediment control structures (arrows) in Gilliam County, Oregon. Note the minor watercourse that is "interrupted" by these structures (flow is toward the top of this image). The width of the lighter soil areas immediately up-gradient from the structures indicates how effective they are in creating a sediment trap and water detention basin. Image courtesy of USDA, NRCS.

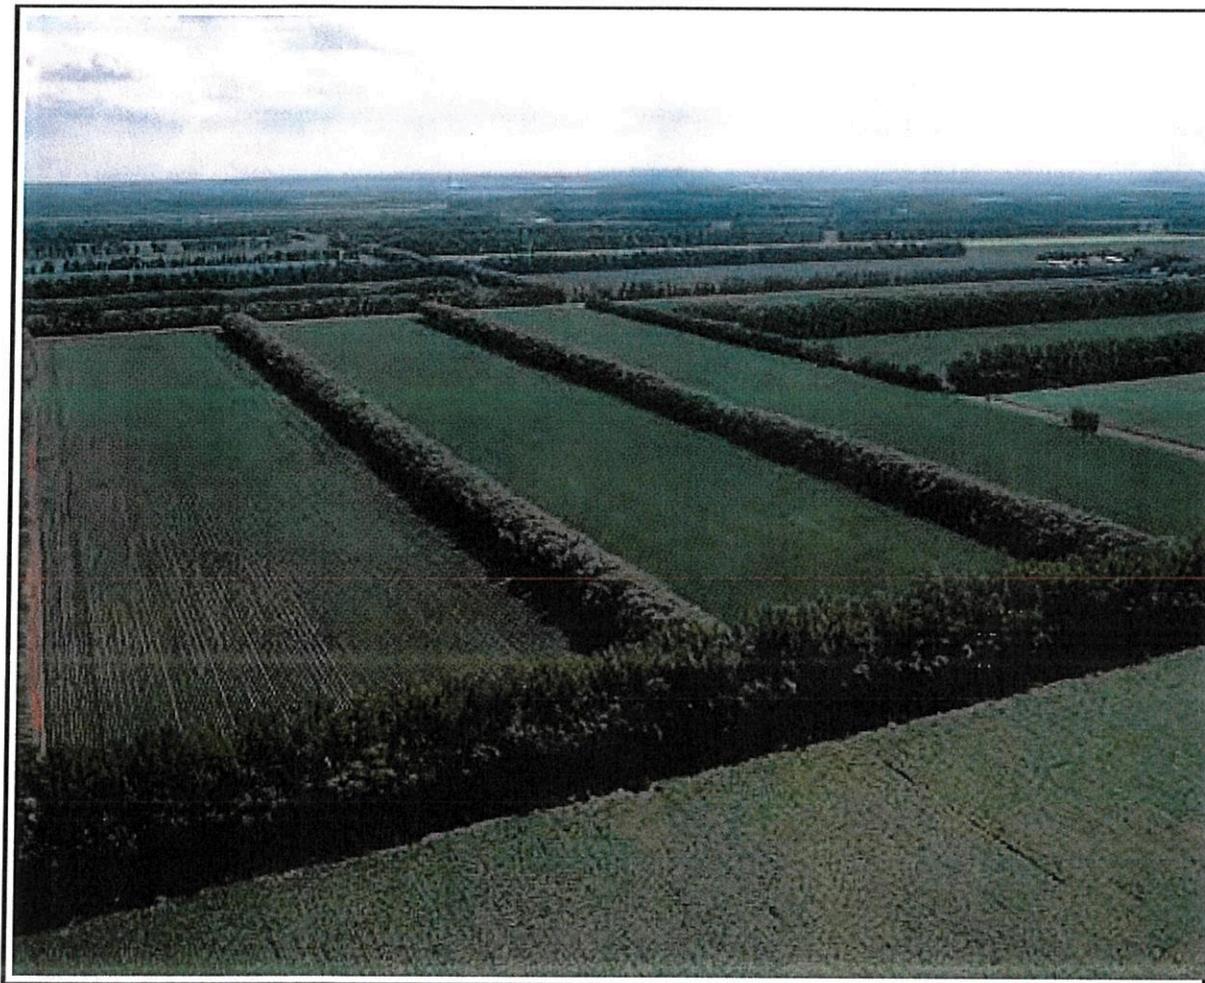
Windbreaks in North Dakota. Images courtesy of USDA, NRCS.
