Conservation Practices

There are 167 conservation practices listed in the National Handbook of Conservation Practices. The table below summarizes some of the most common practices that can be interpreted from large-scale aerial imagery.

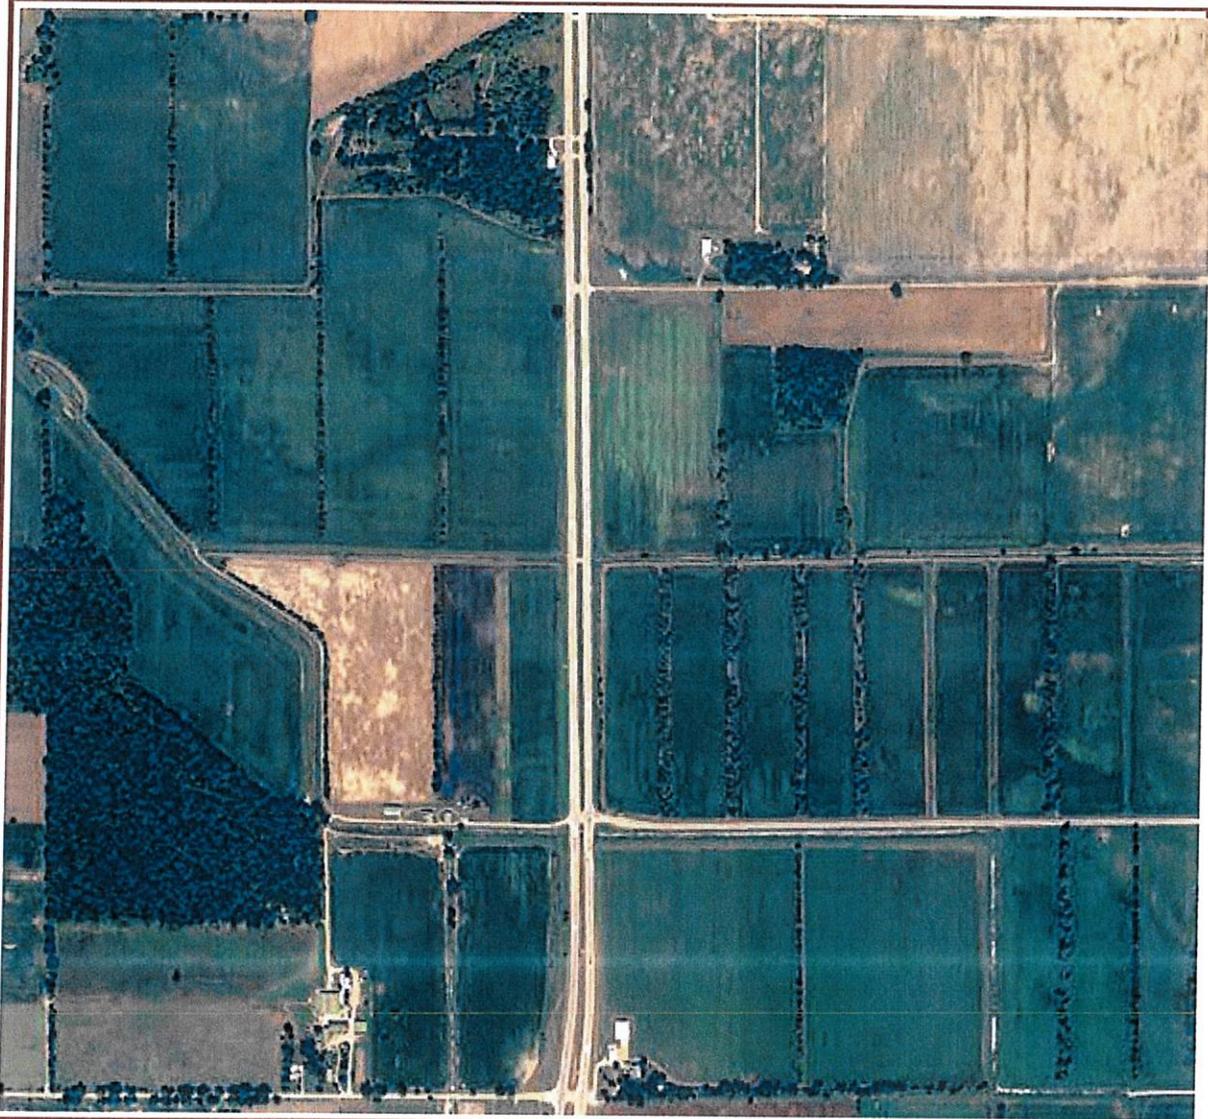
Windbreaks on organic soils in Clinton County, Michigan . Note the north-south-only orientation of the windbreaks in this area of predominantly westerly winds. Image courtesy of USDA, NAIP.

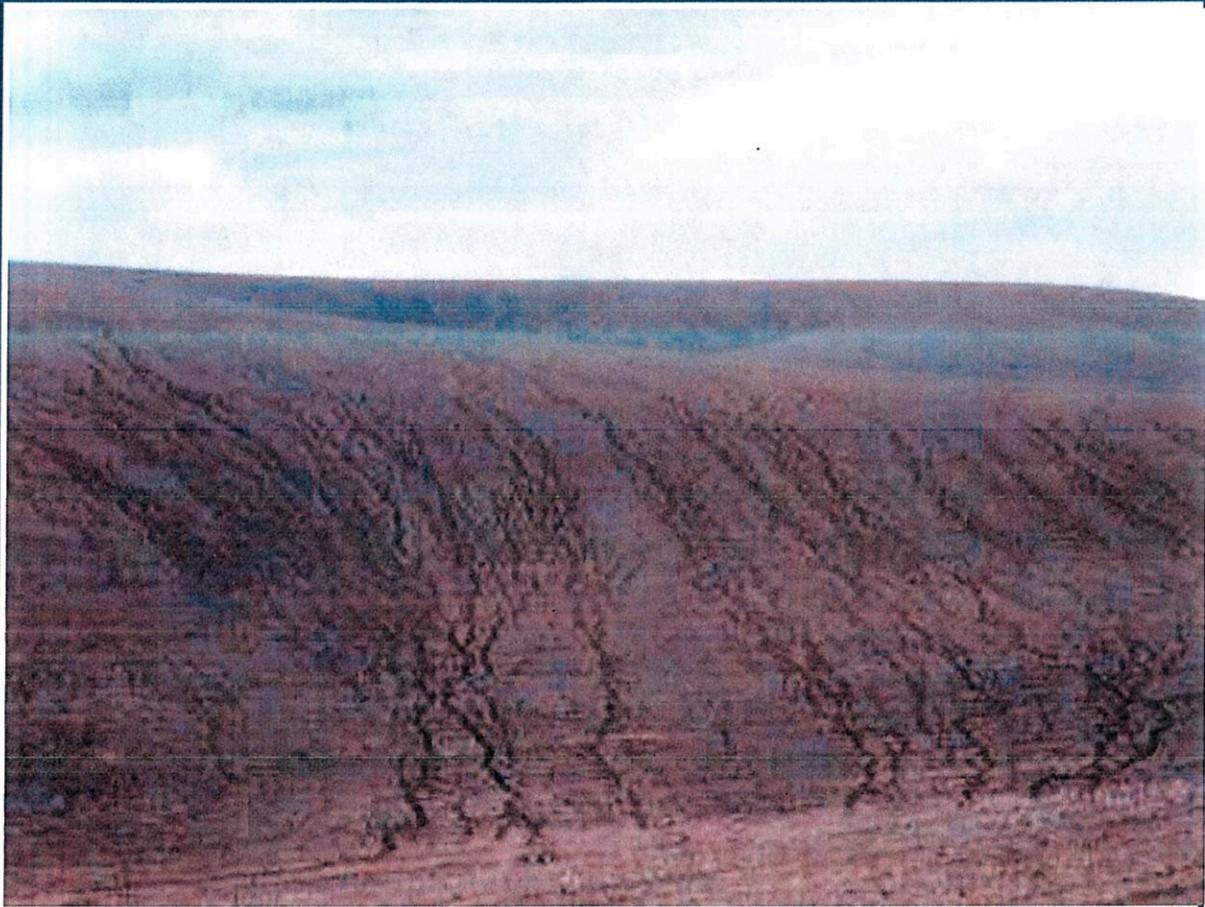
Rills are **small, shallow (generally less than 2 inches deep), intermittent channels** that are eroded into the soil surface by runoff from most rainfall events. Rills are usually parallel to one another and are aligned directly down the steepest local slope. Image courtesy of the Agricultural Experiment Station, Oregon State University.

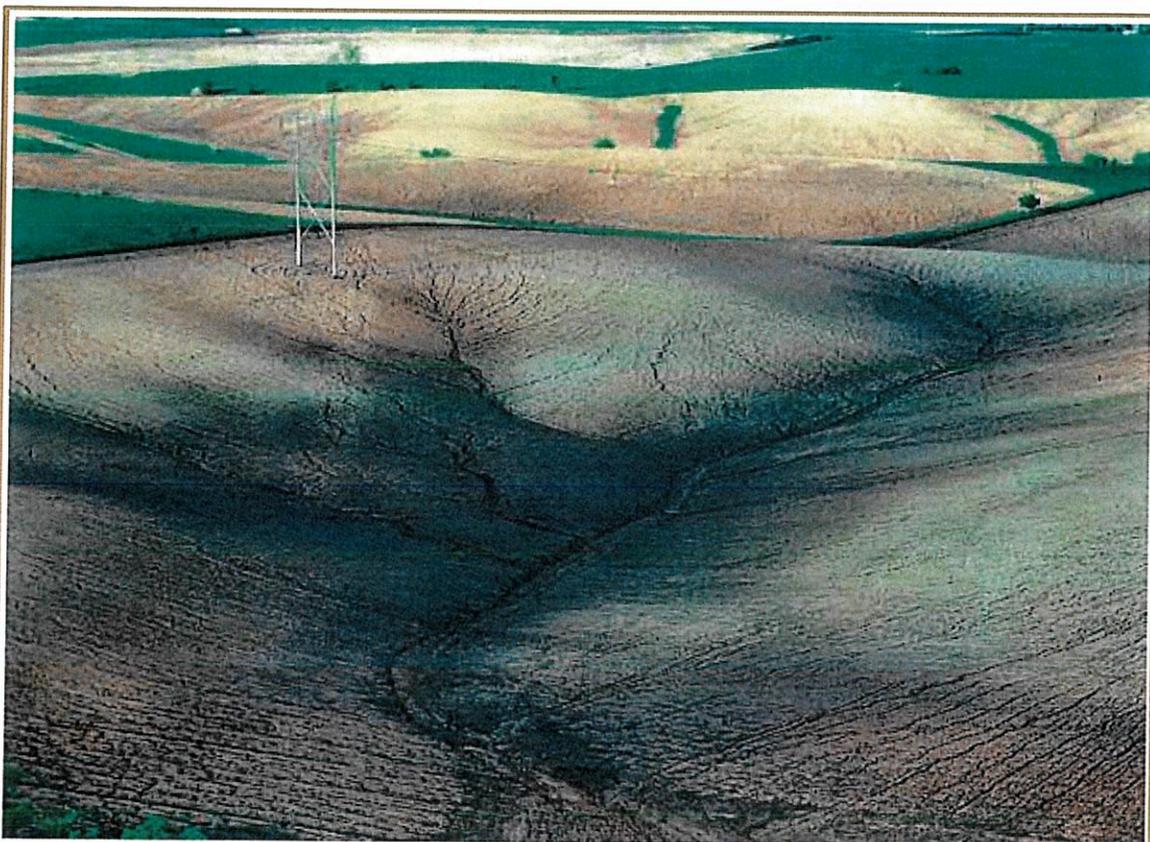
Rills

The smaller, narrower and shallower concentrated flow lines in this image are rills. The larger, wider and deeper drainage lines are intermittent gullies. All of these erosional channels can be leveled by conventional tillage. Image courtesy of USDA, NRCS.

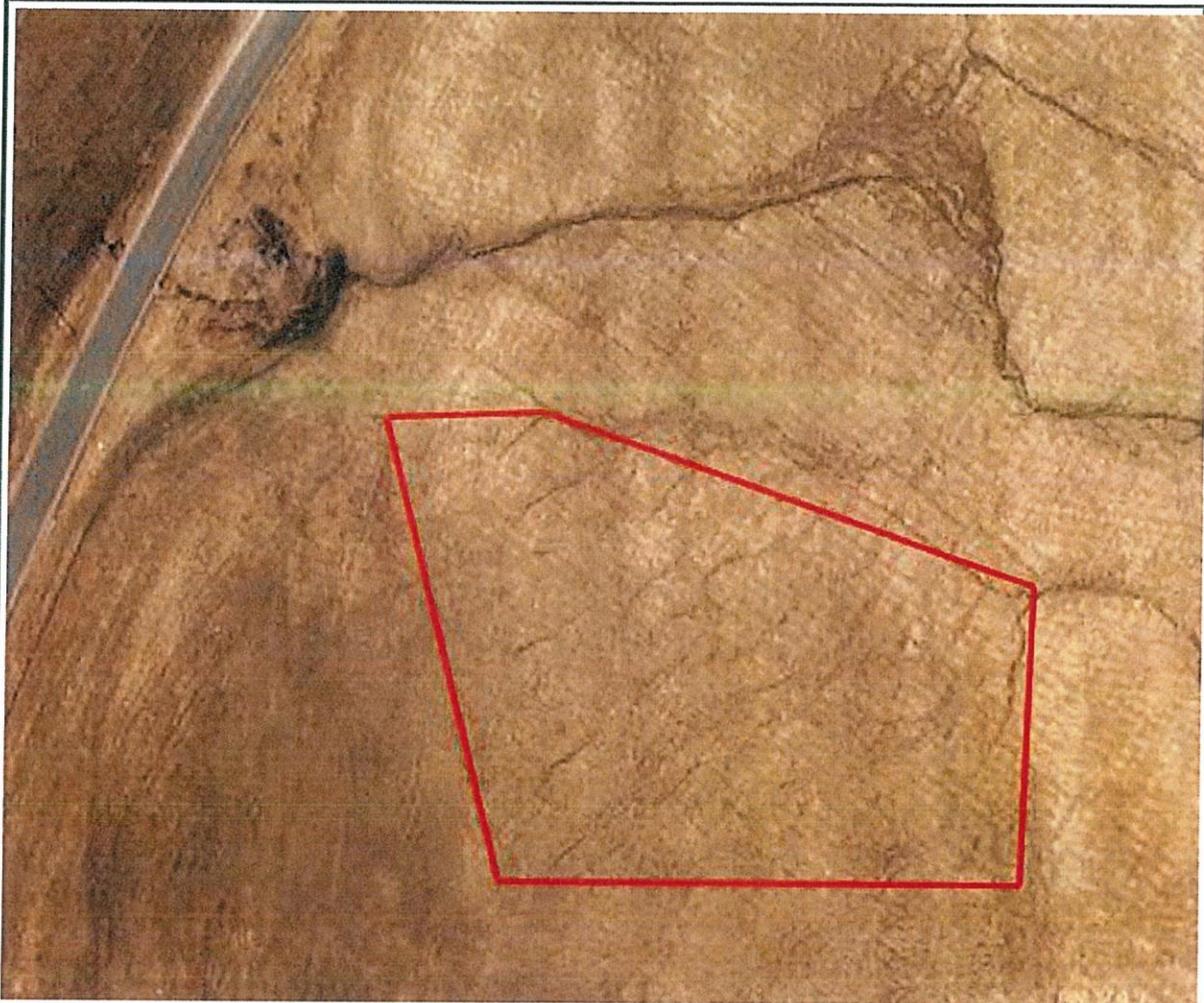
The parallel nature of the erosional features within the red polygon in this field in Tolland County, Connecticut suggests that they are **Rills** - small, shallow (generally less than 2 inches deep), intermittent channels that are eroded into the soil surface by runoff from most rainfall events. The three larger concentrated flow lines in this image are good examples of ephemeral gullies. Image courtesy of USDA, NRCS.

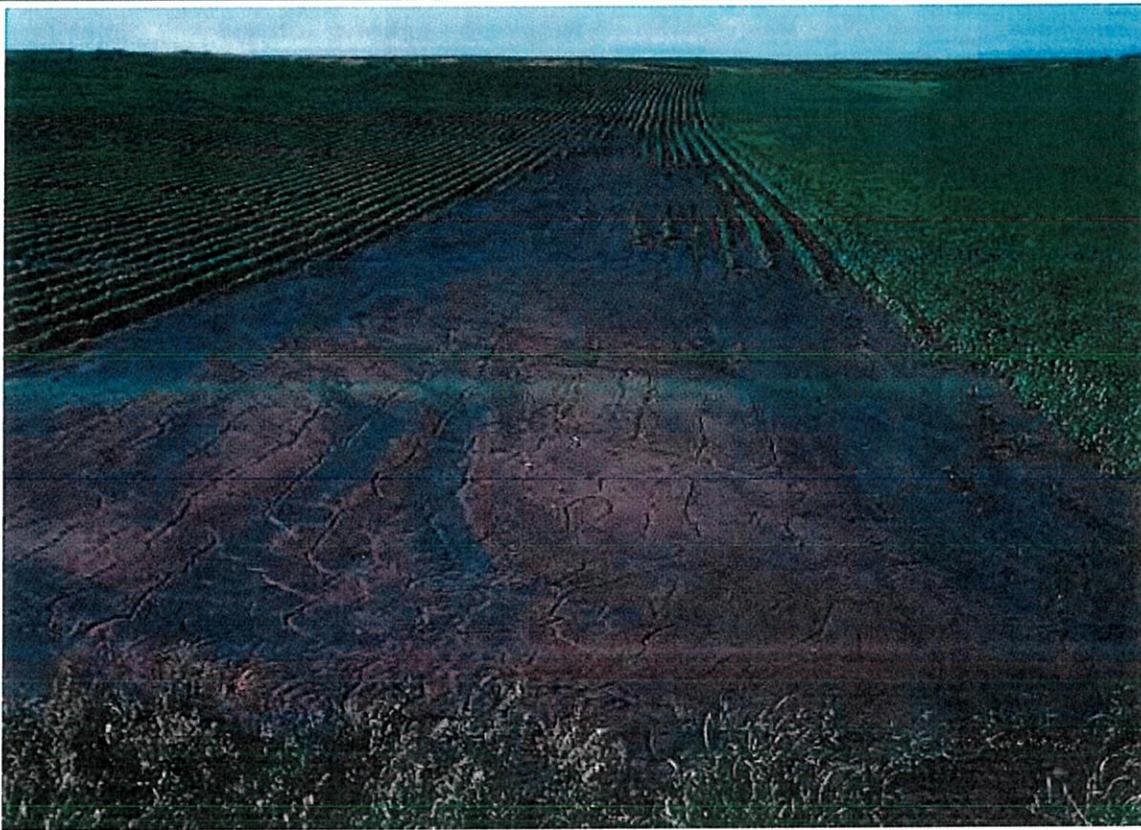
The SHEET EROSION resource concern is often evidenced by the PHYSICAL FEATURE of **Deposition at toe slopes** (see slope name graphic, below). This is well illustrated in this image from Caldwell County, Missouri [arrows]. Both images courtesy of USDA, NRCS.

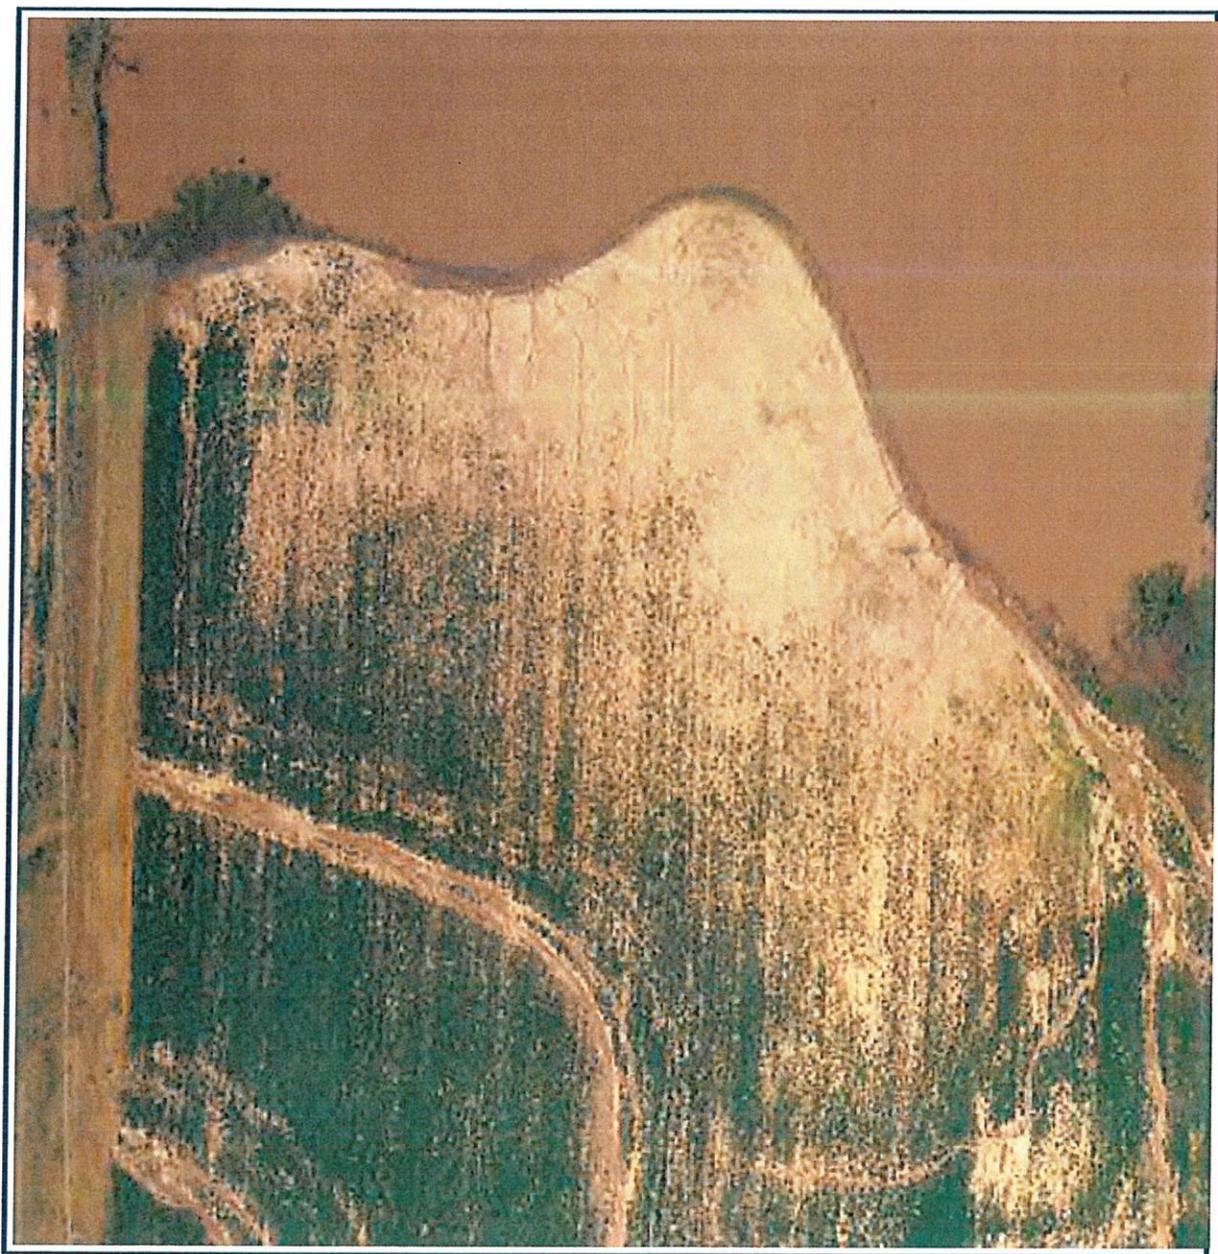
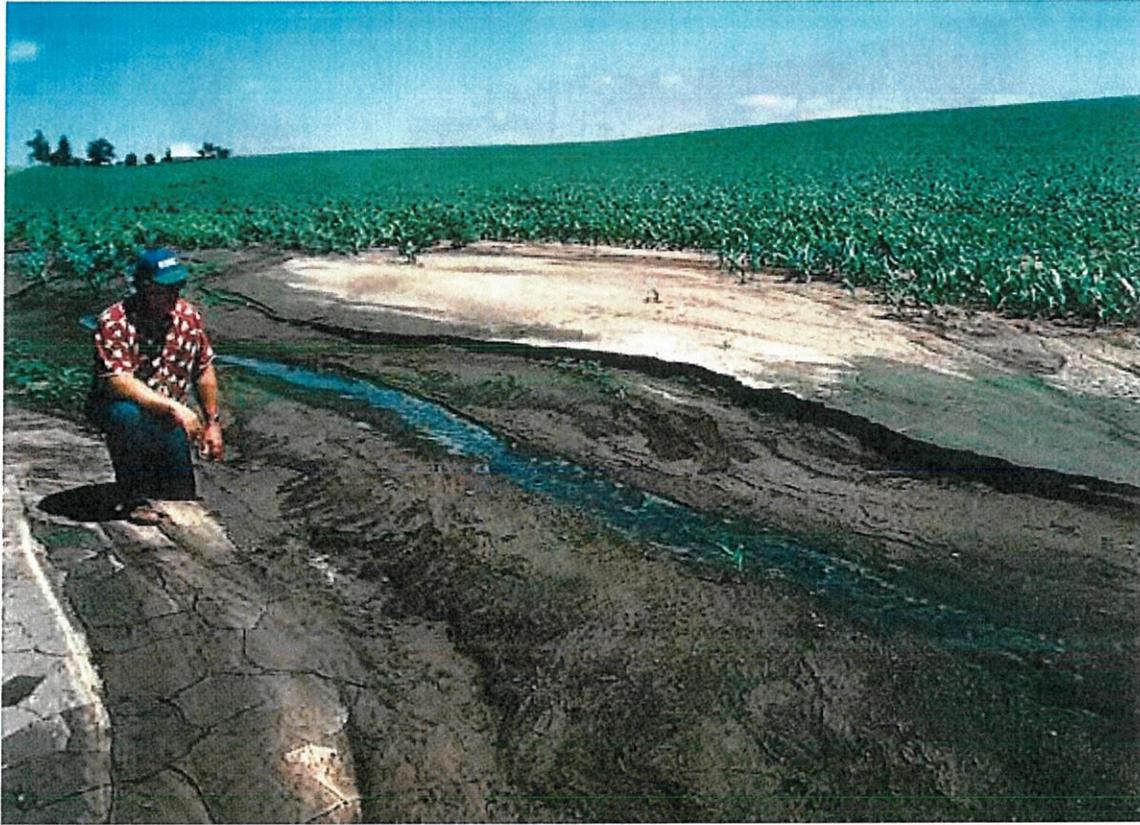
Sheet Erosion

The SHEET EROSION resource concern is often evidenced by the PHYSICAL FEATURE of **Deposition at toe slopes**. This image from Caldwell County, Missouri also exhibits the resource concerns of Concentrated Flow (ephemeral gullies) and Water Contaminants, Turbidity. Image courtesy of USDA, NRCS.

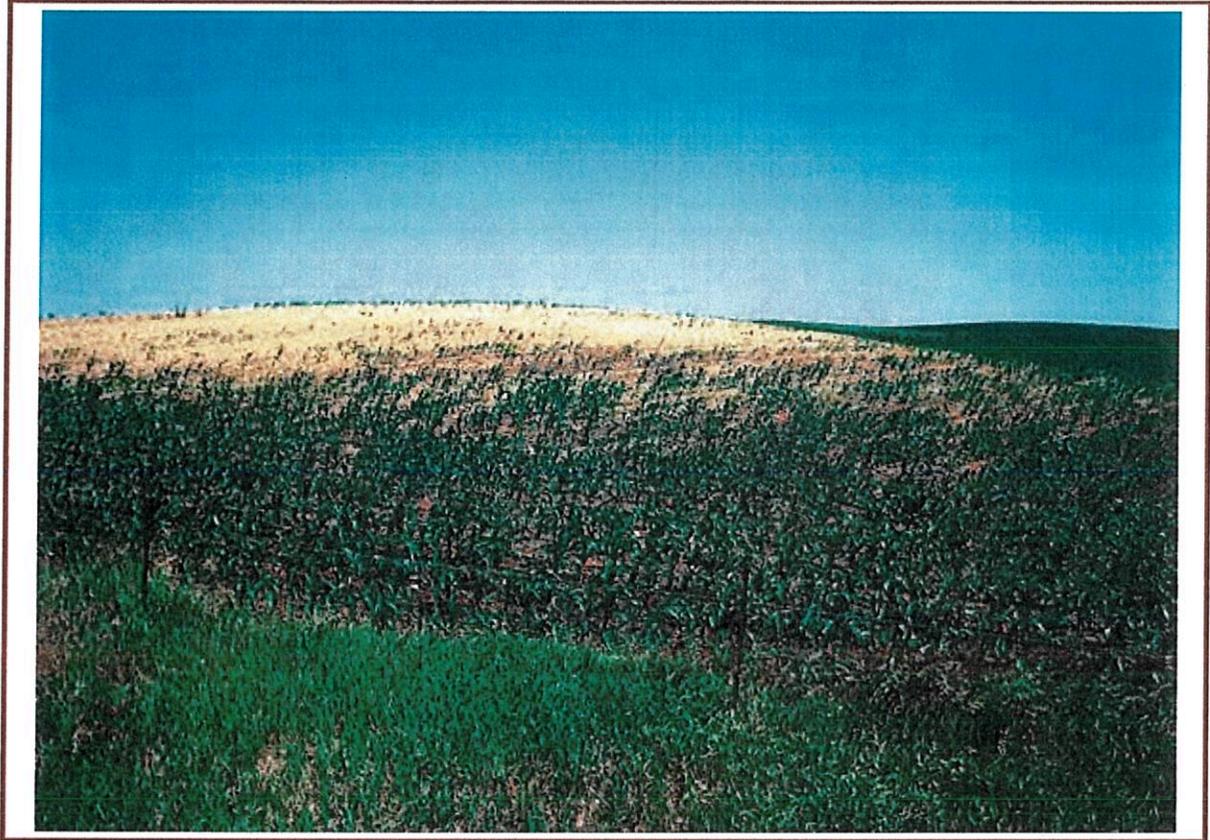
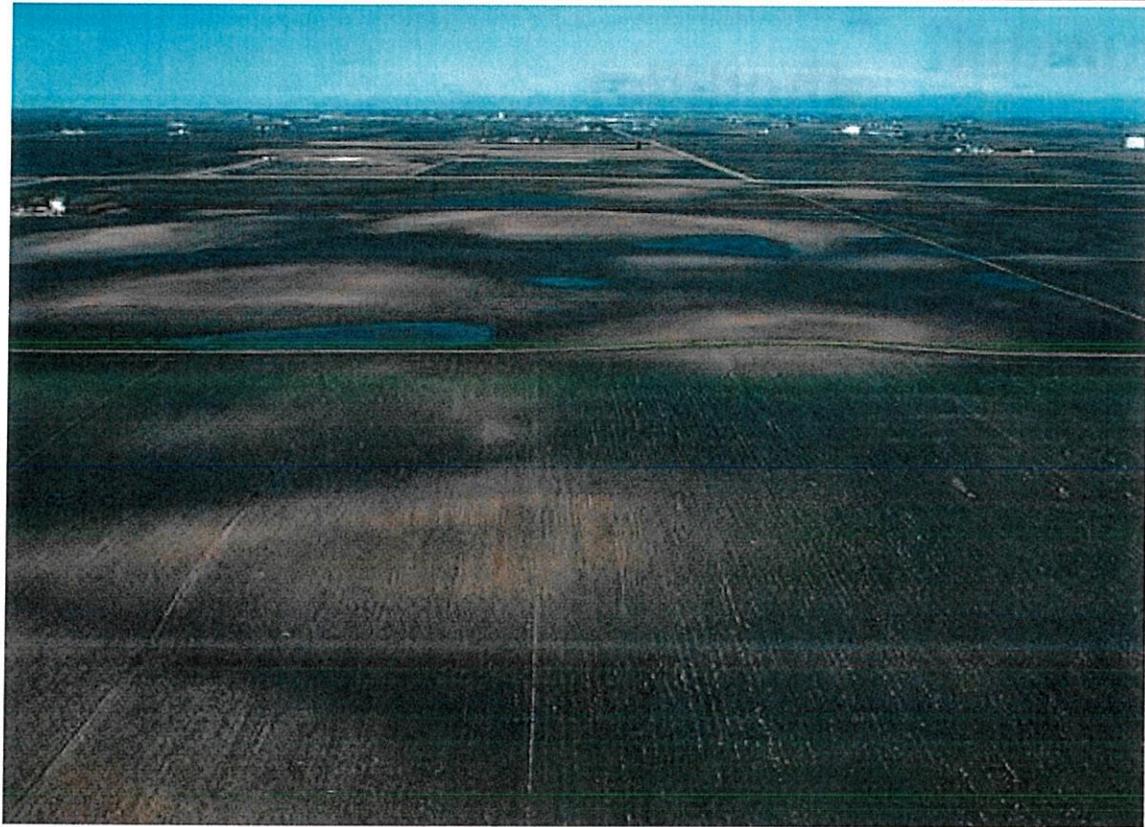
Wind Erosion

Soil erosion by water is a slope process focused on the shoulder and backslope areas (see slope names, below). Summit erosion is most often associated with WIND EROSION both because of the gentle gradients of the summits and their generally better drainage (dry soils are more prone to wind erosion than moist soils, which are usually associated with the footslope and toeslope positions). These two images (a ground-level view and a low-altitude, aerial oblique view) show the classic landscape pattern of wind erosion problems. Both images courtesy of USDA, NRCS.

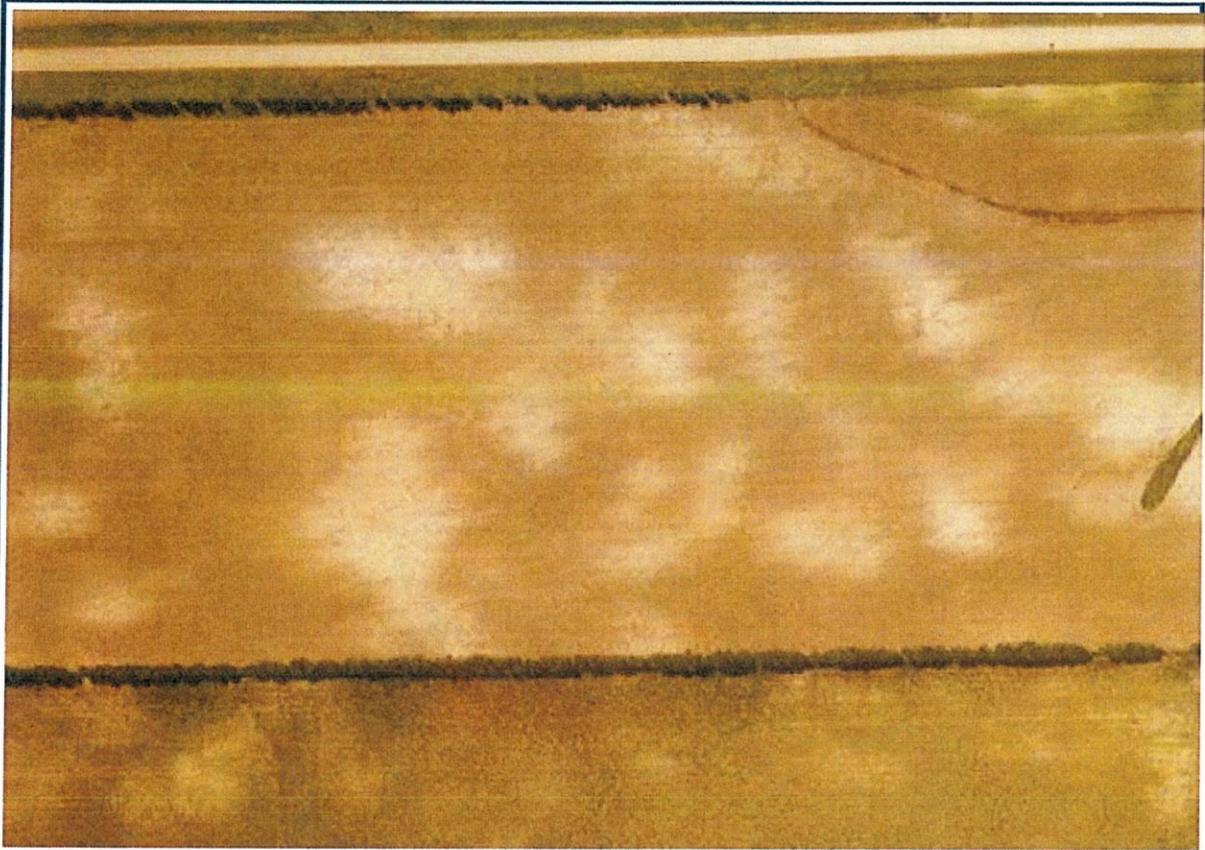
Wind Erosion

This image from Big Stone County, Minnesota exhibits the patchy pattern typical of summit wind erosion. Image courtesy of USDA, NRCS.

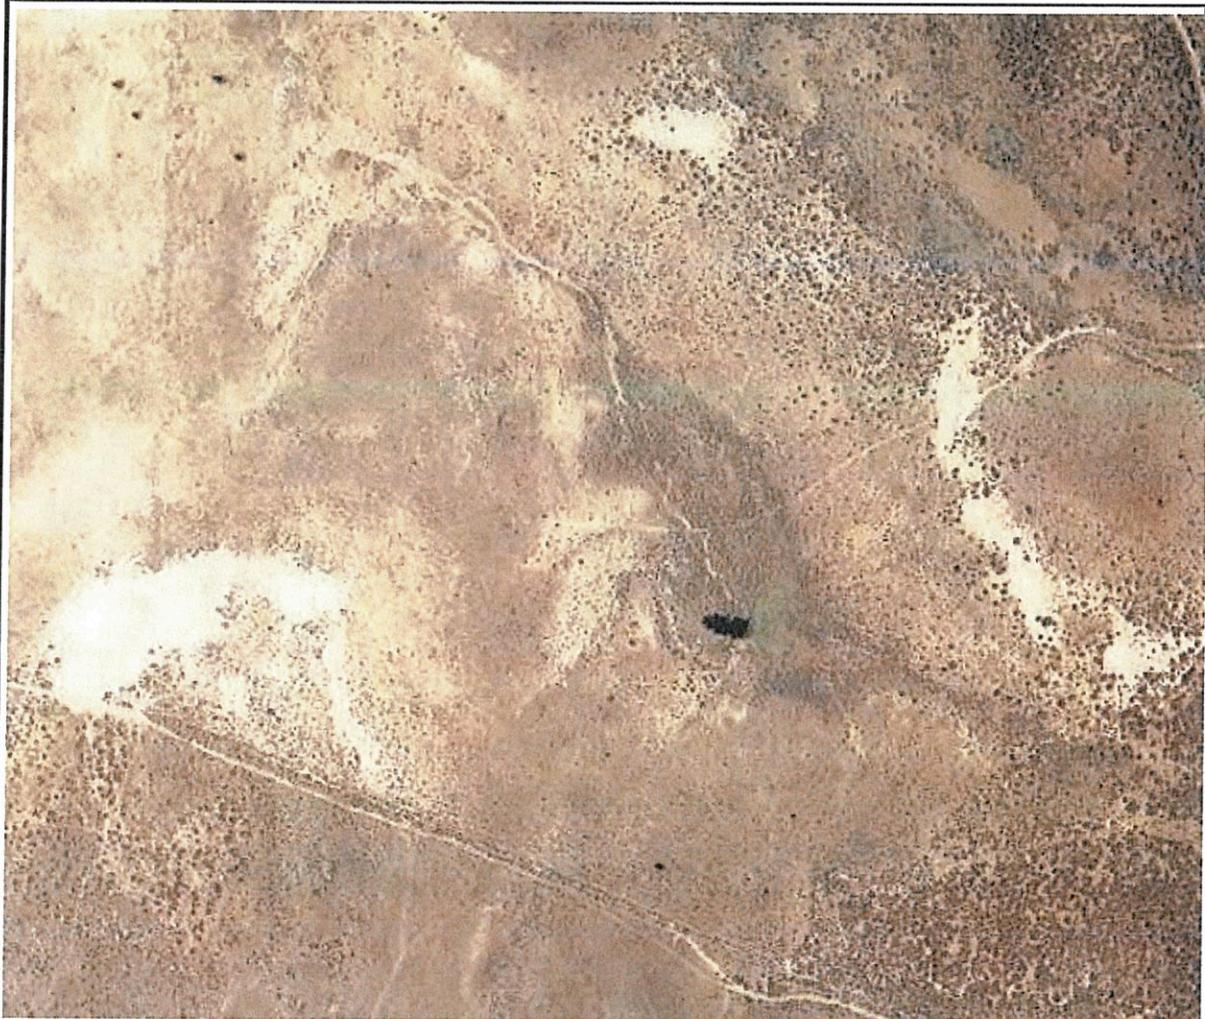
This image from Okanogan County, Washington exhibits the physical feature: **Blowouts** (wind erosion focused on an area lacking vegetation) as an indication of the **Wind Erosion** resource concern. Image courtesy of USDA, NRCS.

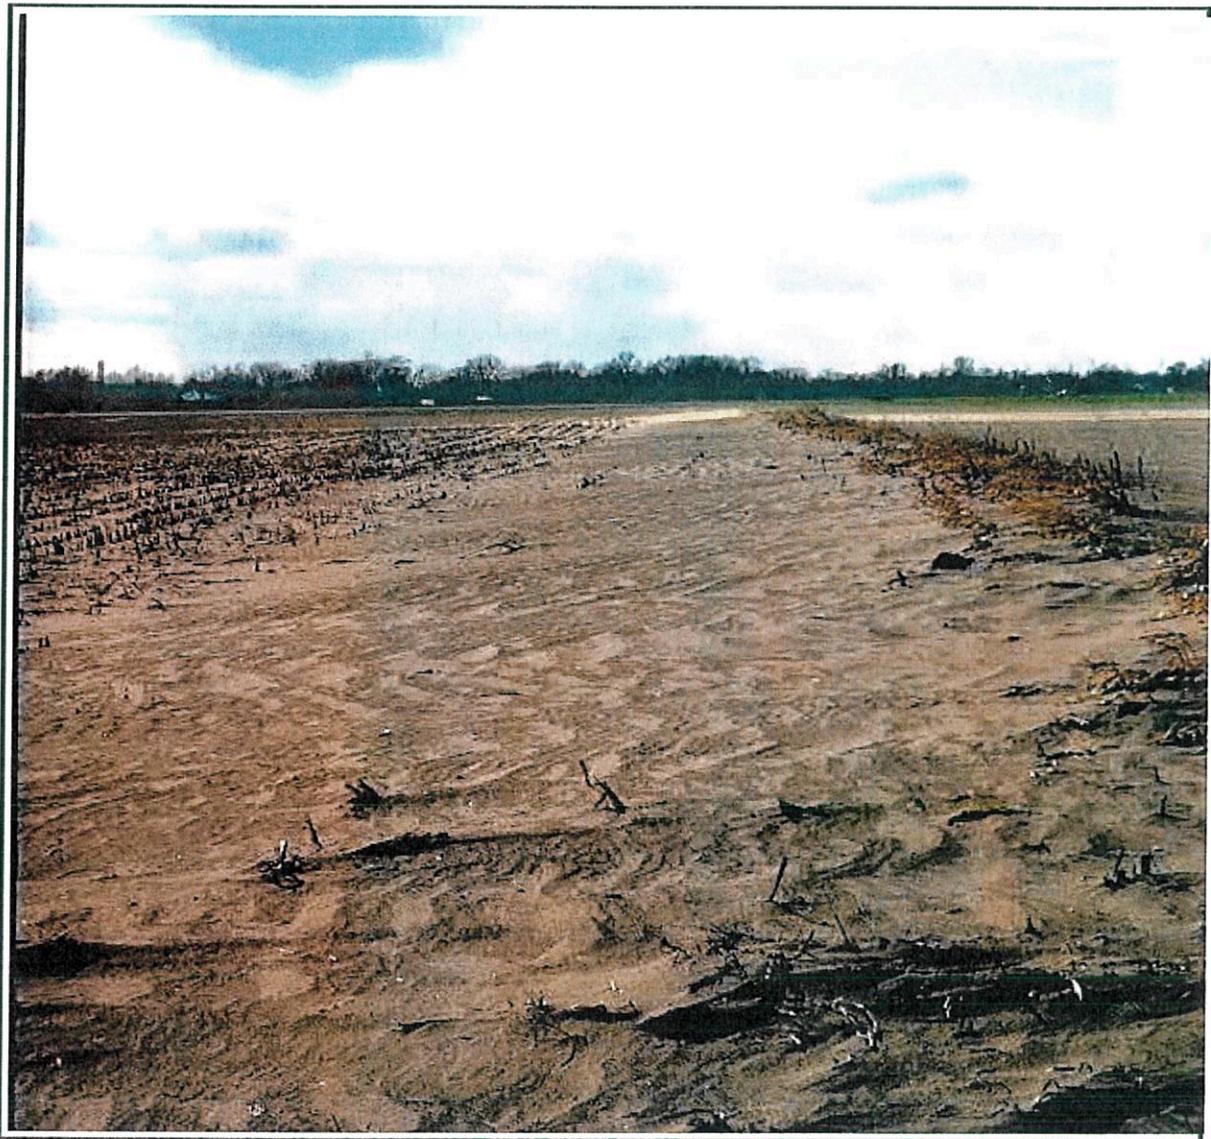
> **Leeward deposition** is a physical feature indicating a **wind erosion** resource concern. Leeward (i.e., downwind) deposits occur at (1) abrupt slopes (where the wind blows over the top of the slope facet and the slower velocity in the negative space allows the eolian material to "rain out" of the air column); and (2) along abrupt cover changes where open or sparse-covered soil adjoins a denser cover (the roughness of the denser cover slows the wind velocity in the boundary layer, allowing the eolian material to "rain out" of the air column). Aerial image from Adams County, Colorado. All three images courtesy of USDA, NRCS.

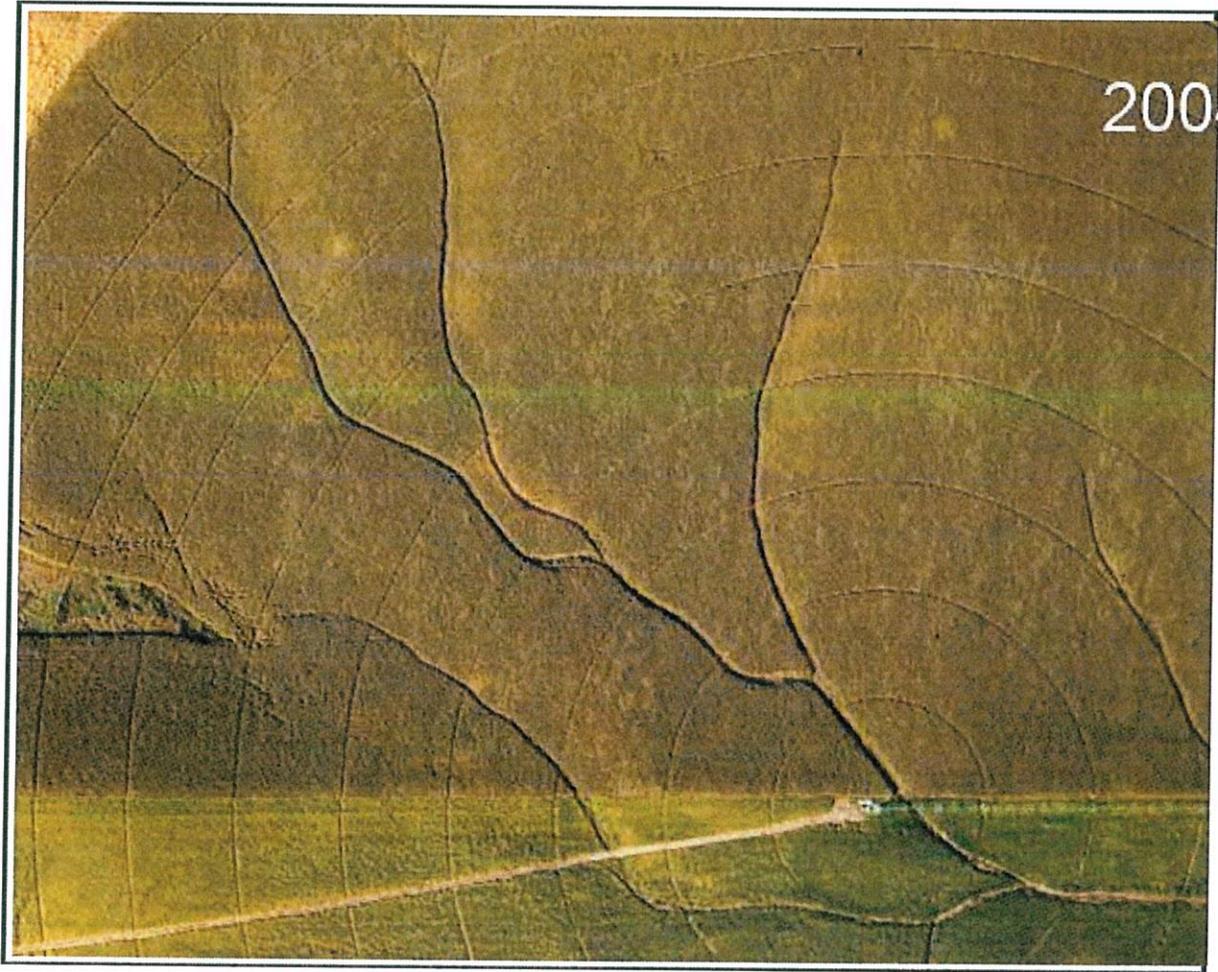
Ephemeral Gullies

The ephemeral nature of the gullies shown in this image from Antelope County, Nebraska can be easily confirmed by inspecting the multi-temporal image set. In the 2004 image, the crop shadows make these concentrated flow lines appear very strong, suggesting maybe that they are small classic gullies. BUT, by inspecting the 2006 image (below), it is very obvious that the operator was able to plow and plant directly across these concentrated flow lines - a key attribute of ephemeral gullies. The 2004 image is a good example of the physical feature: **Lack of crop growth in drains** an indicator of the resource concern: **Concentrated flow**. Images courtesy of USDA, NRCS.

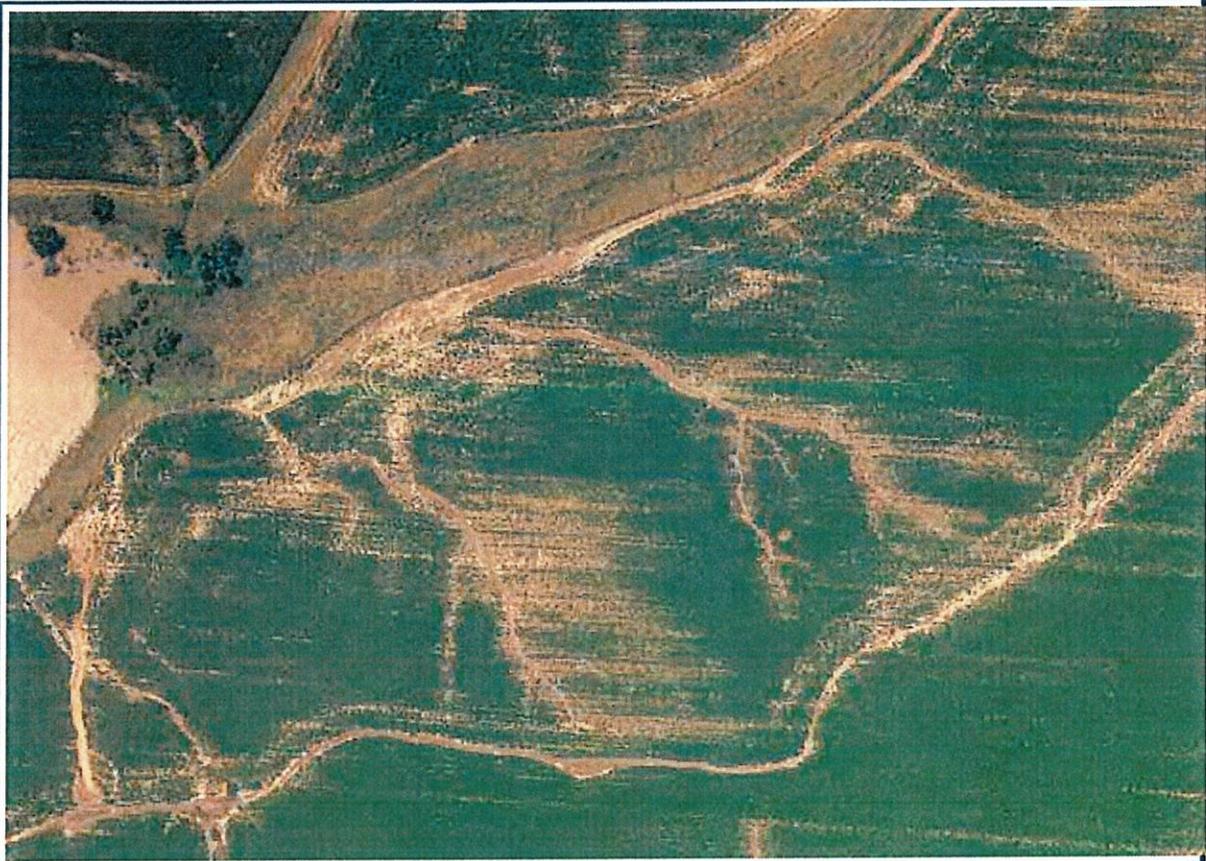
Ephemeral Gullies

This image from Cass County, Missouri is a good example of the physical feature: **Deposition in exposed drains**, an indicator of the resource concern: **Concentrated flow**. The physical feature: **Lack of crop growth in drains** also applies to some of the drainage lines. Images courtesy of USDA, NRCS.

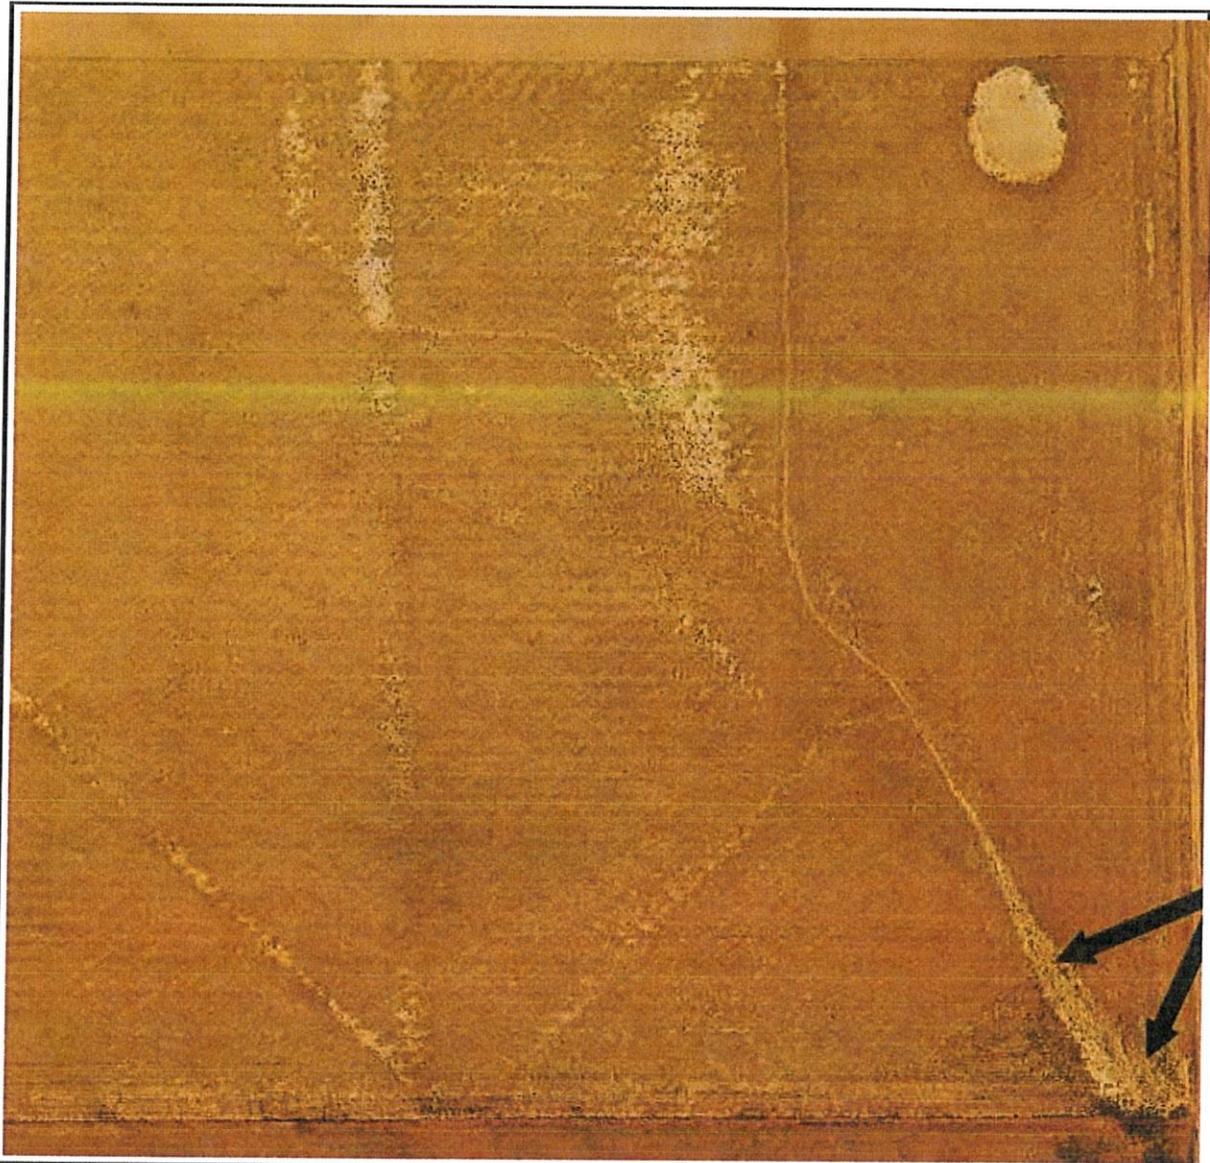
This image from Lincoln County, Colorado is a good example of the physical feature: **Deposition in exposed drains** (arrows), an indicator of the resource concern: **Concentrated flow**. The physical feature: **Lack of crop growth in drains** also applies to some of the drainage lines. Images courtesy of USDA, NRCS.

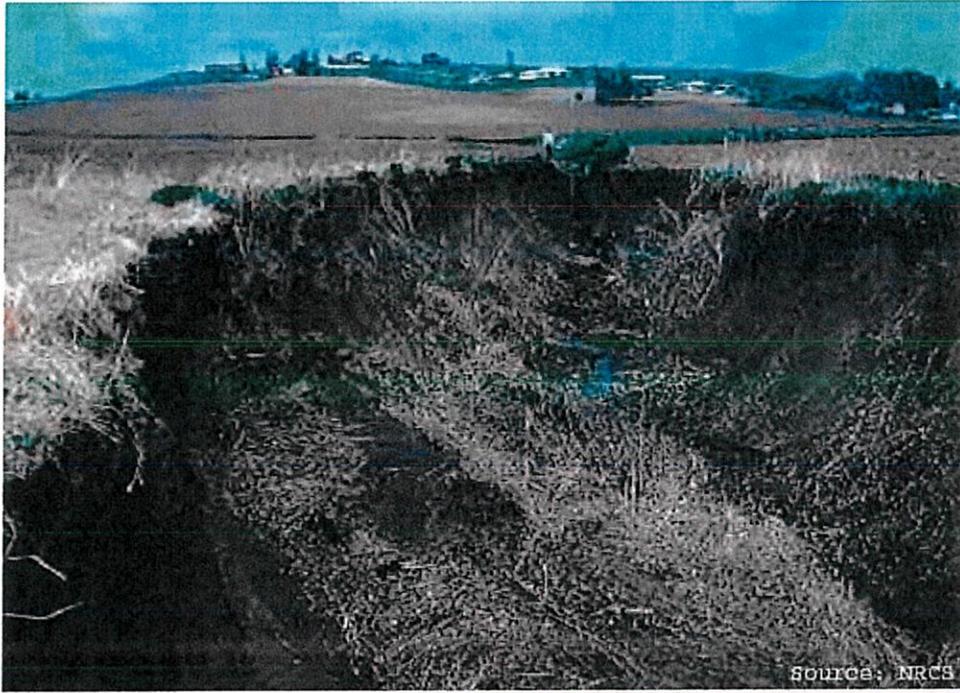
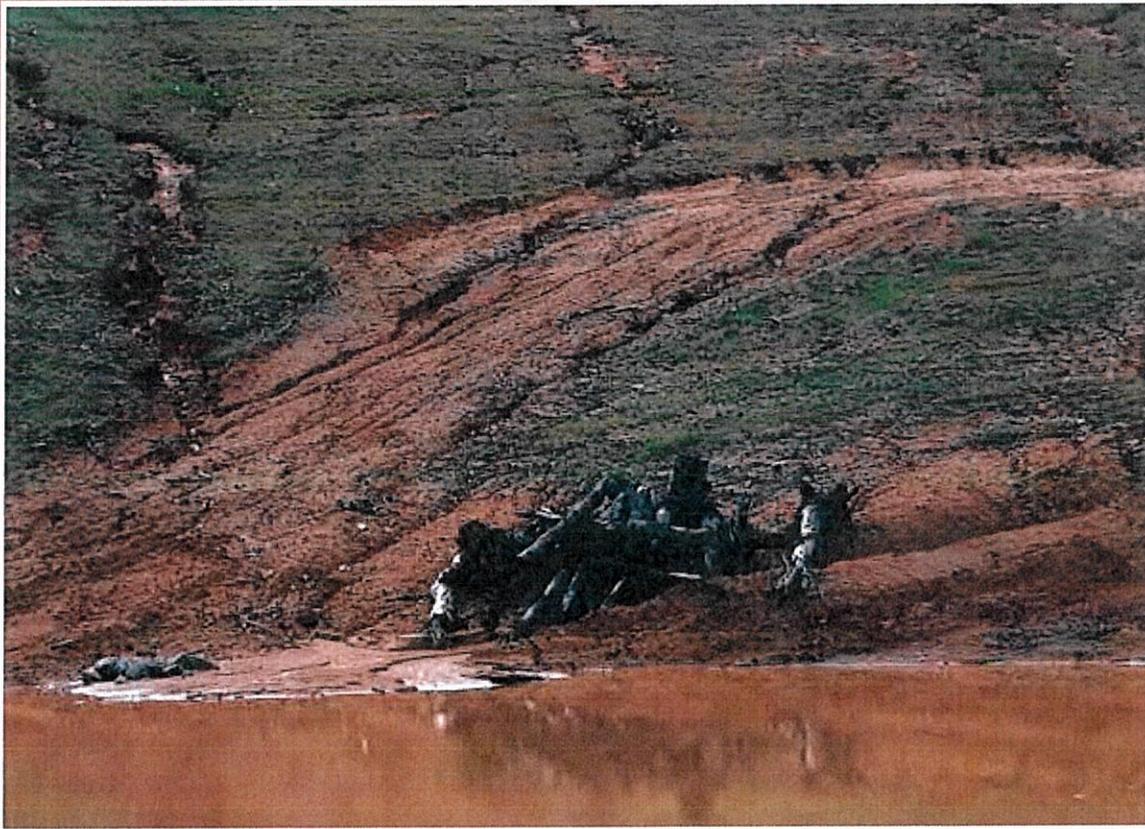
Classic Gullies

Classic gullies are deep, well-defined channels created by concentrated, but intermittent, runoff flow both during and immediately following rain events. **Classic gullies are often deeper than 1.5 feet and cannot be leveled by normal tillage operations.**
