Conservation Practices

There are 167 conservation practices listed in the National Handbook of Conservation Practices. The table below summarizes some of the most common practices that can be interpreted from large-scale aerial imagery.

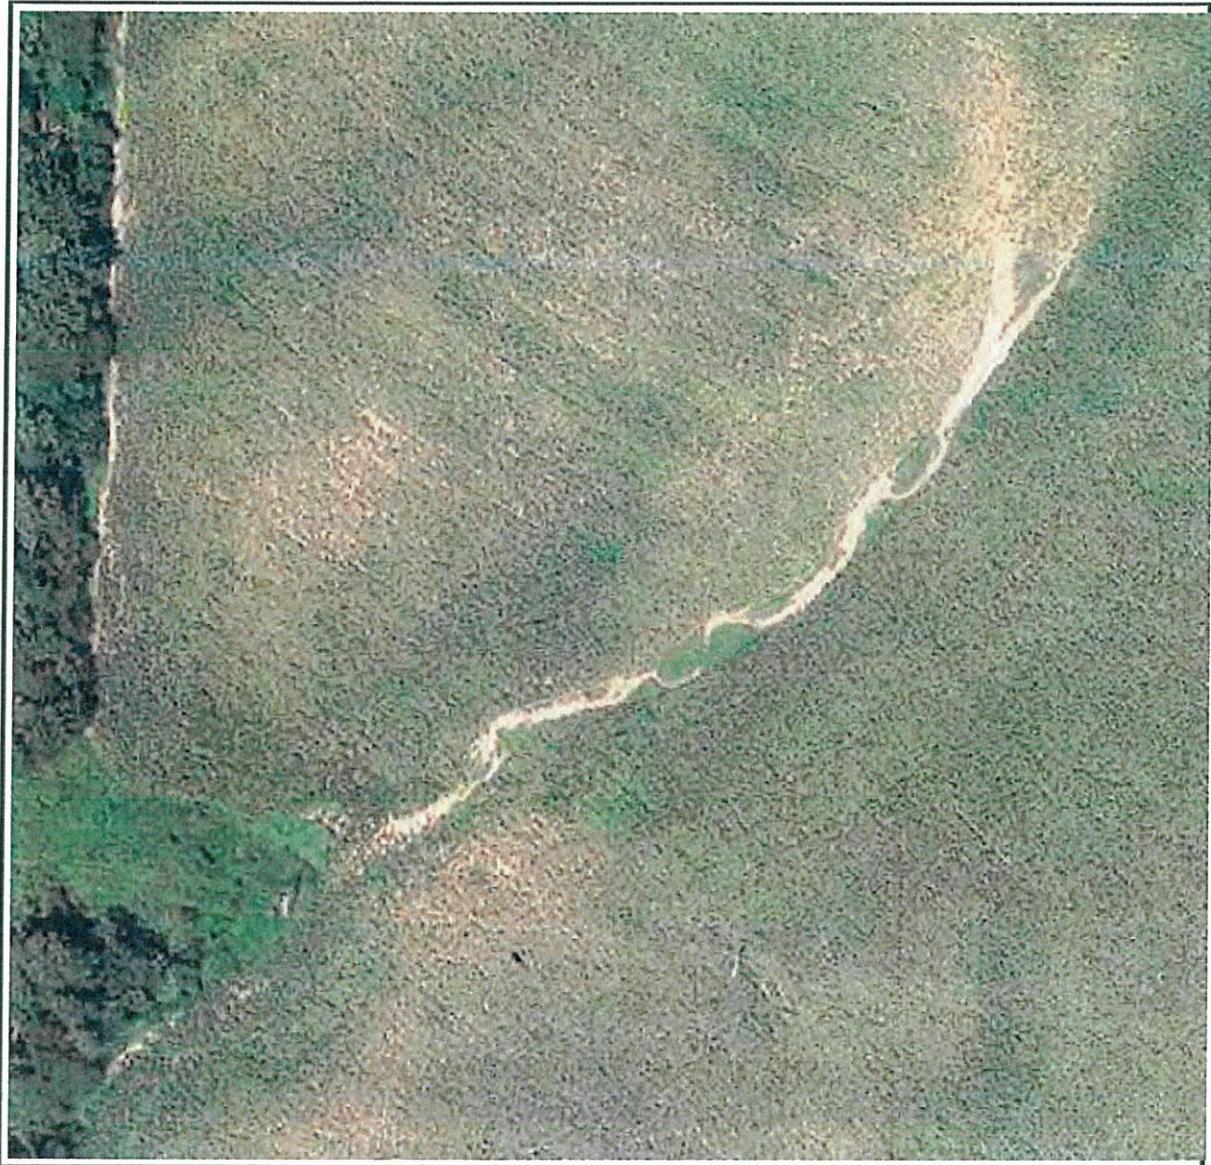
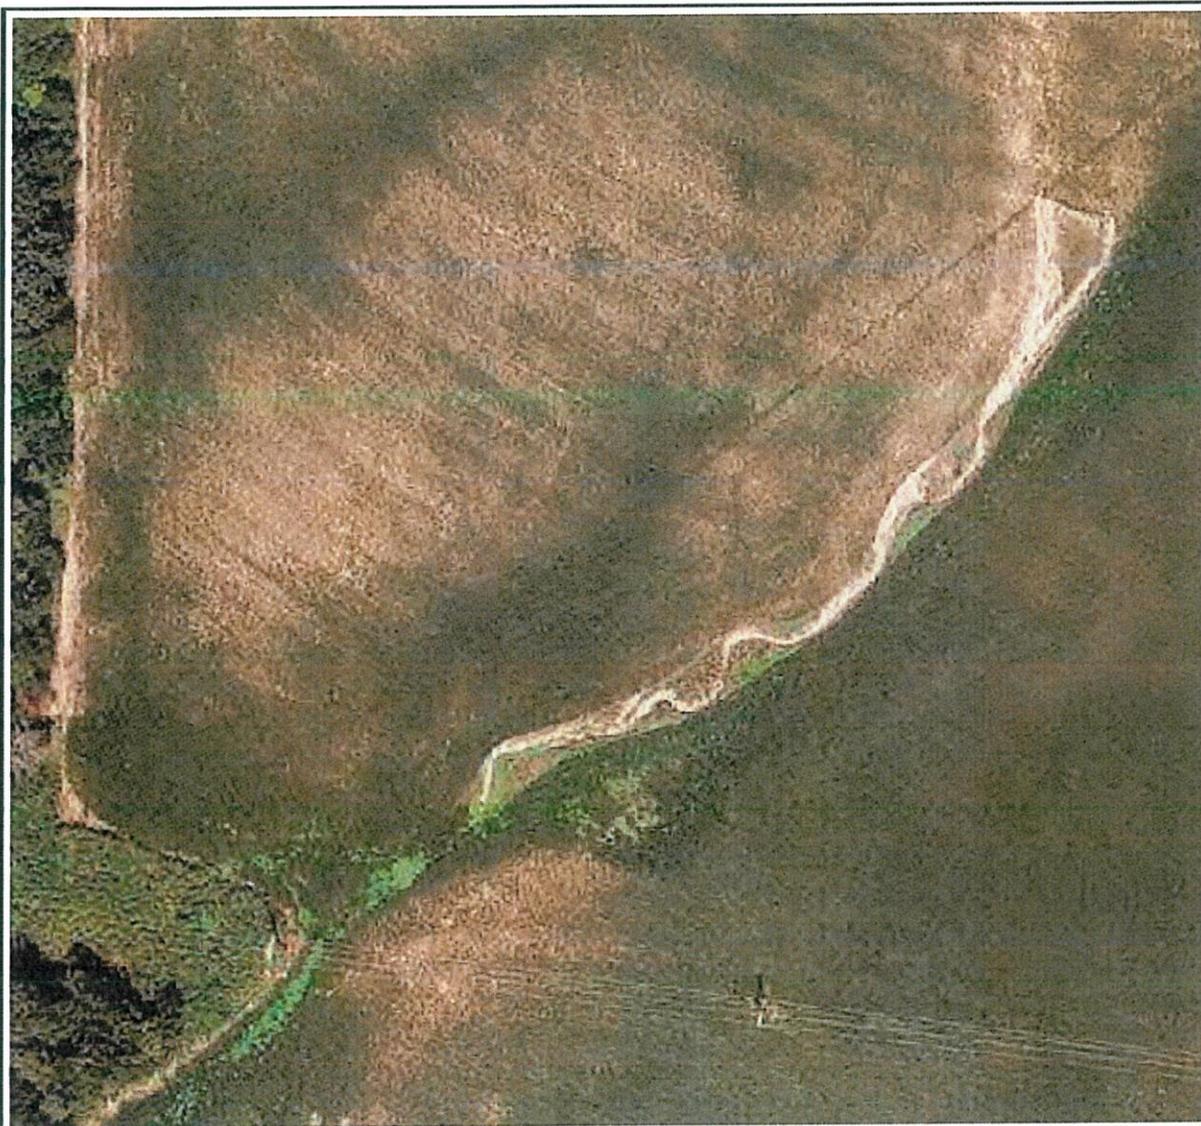
Concentrated flow lines may produce either ephemeral gullies or classic gullies. The difference is in their depth (and width, to some extent). The use of the multi-temporal image set available for most segments allows the interpreter to observe whether the operator was able to plow/plant across the drainageway in subsequent years. In this example from Dekalb County, Missouri, an earlier image (top) clearly shows a drainageway, but it is not obvious whether it is a classic gully or an ephemeral gully. In the image from two years later (bottom), it is clear that farming operations have "gone around" (rather than over) this gully system. Such evidence supports the classification of this resource concern as a **Classic Gully**. Images courtesy of USDA, NRCS.

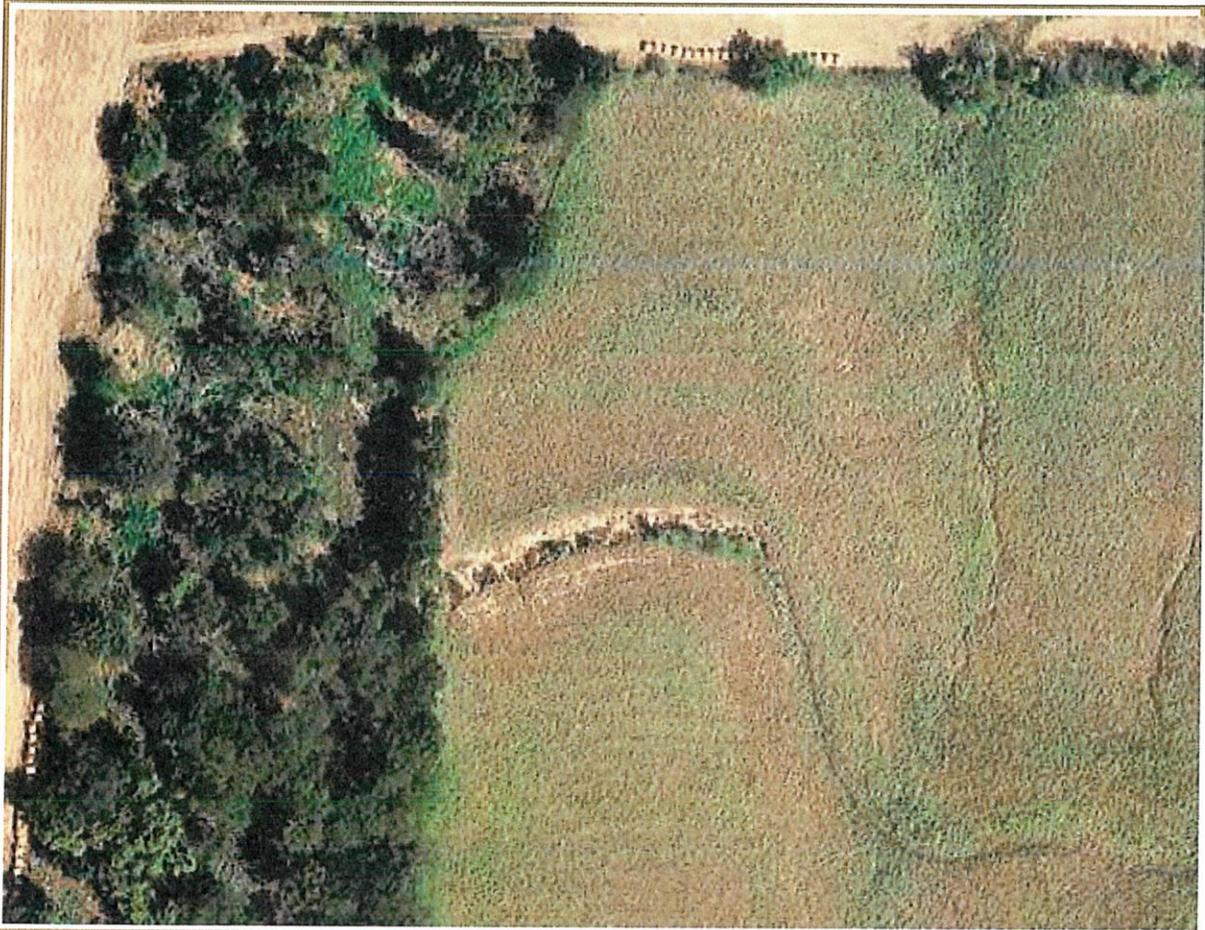
Classic Gully

>**Classic gullies** are deep, well-defined channels created by concentrated, but intermittent, runoff flow both during and immediately following rain events. **Classic gullies are often deeper than 1.5 feet and cannot be leveled by normal tillage operations.** This image from Caldwell County, Missouri illustrates one of the physical features that helps to identify a classic gully: **the lack of vegetation along its trend.** Image courtesy of USDA, NRCS.

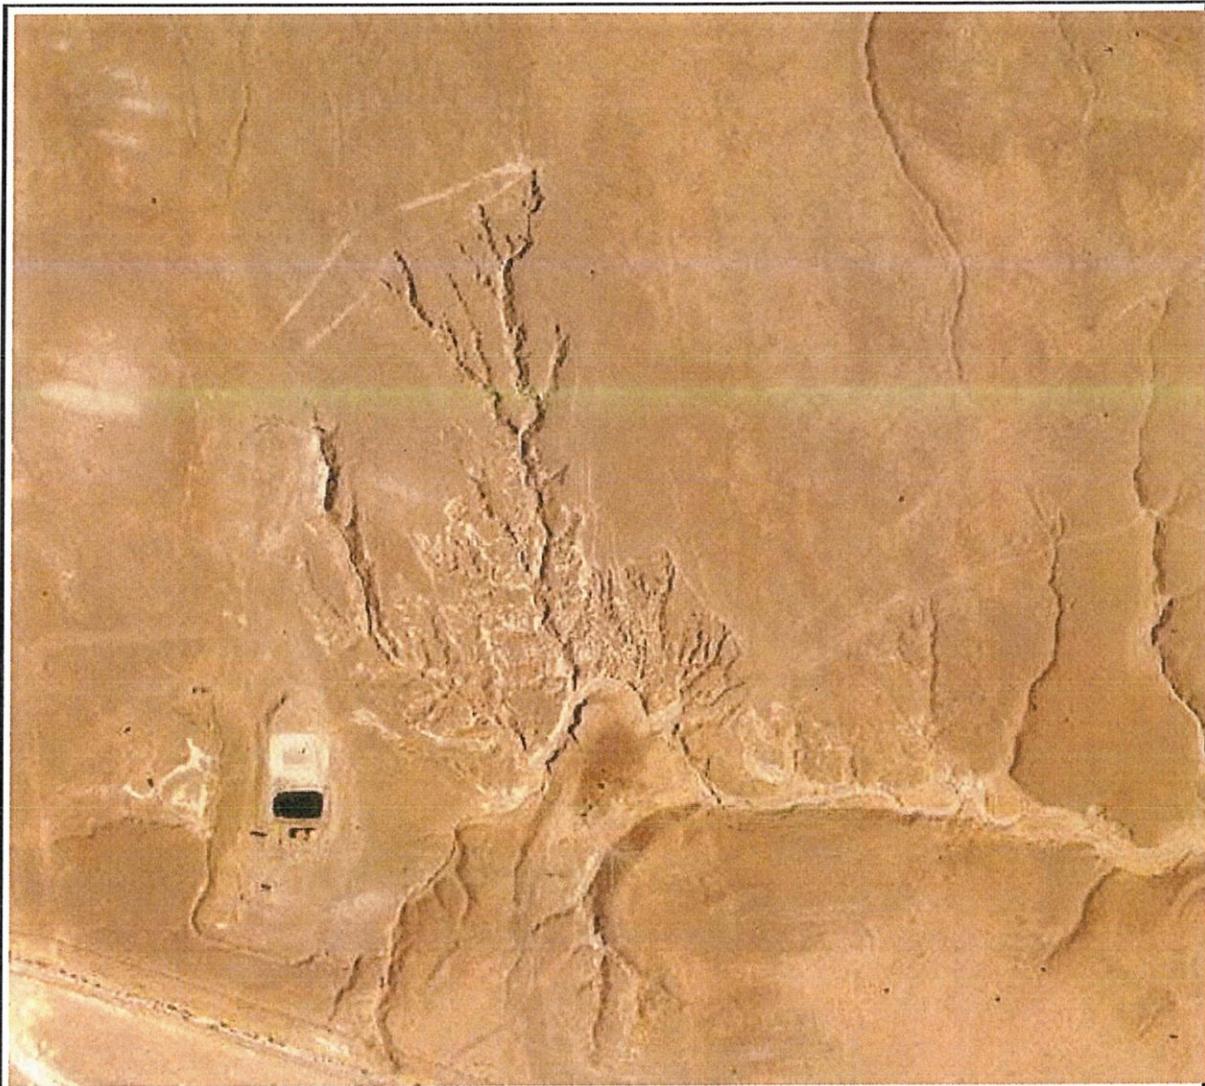
This image from San Benito County, California illustrates two other physical features that help to identify a classic gully: **Dendritic Pattern** and **Distinct, Strong Shadows** due to its depth. Classic gullies are often deeper than 1.5 feet and cannot be leveled by normal tillage operations. Image courtesy of USDA, NRCS.

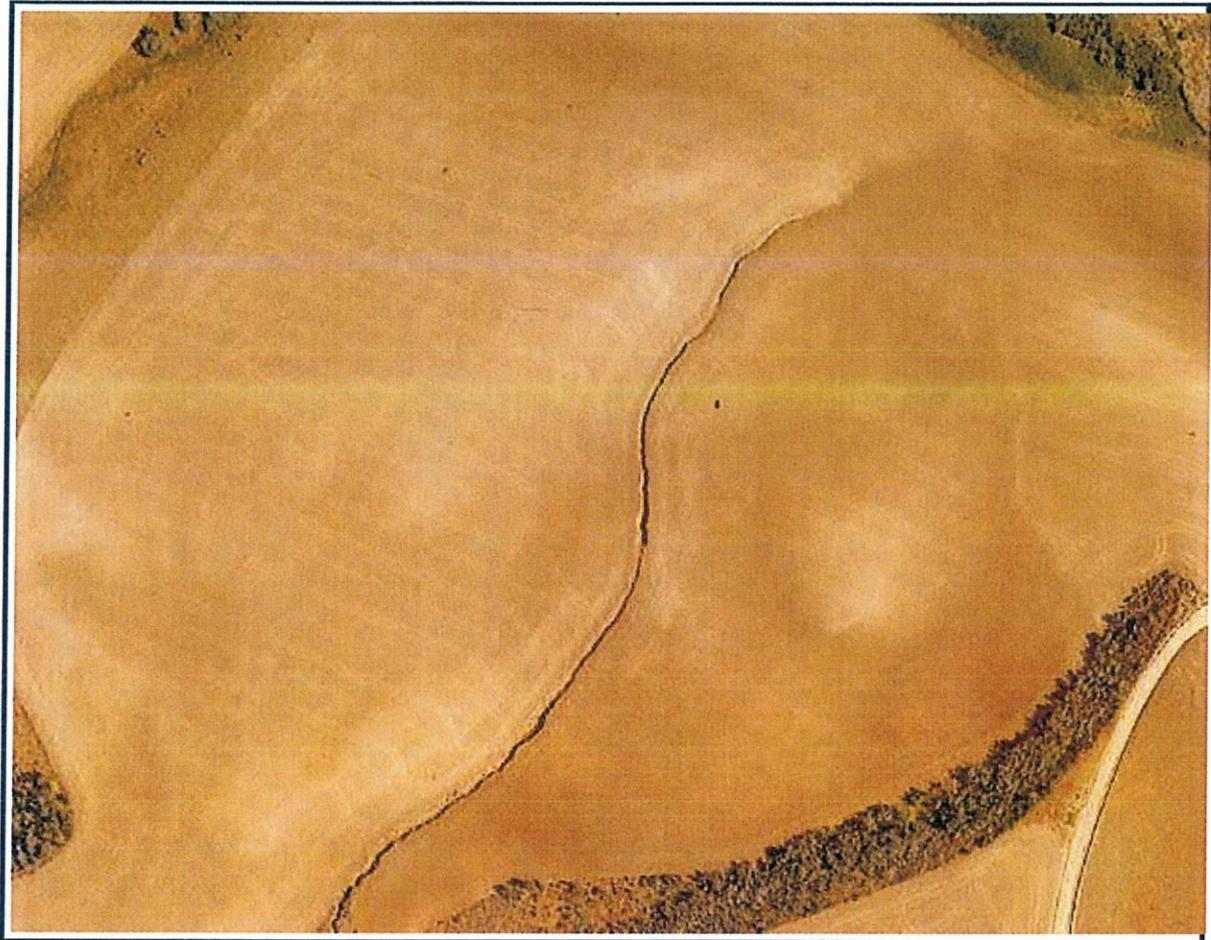
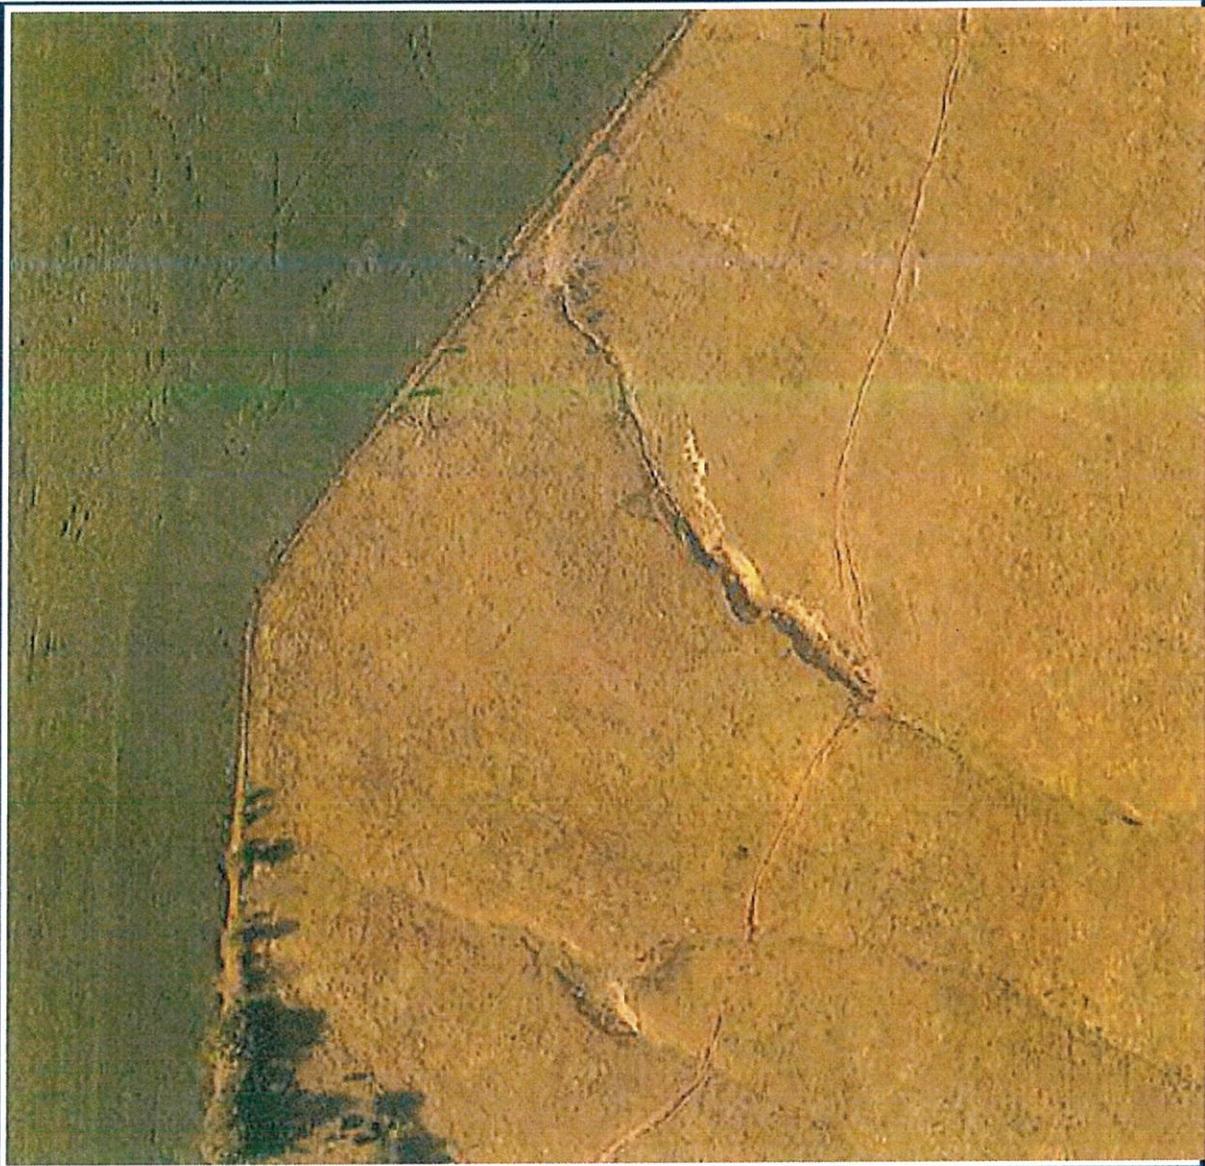
Classic Gully

These two images illustrate one of the major physical features that helps to identify a classic gully: **distinct, strong shadows** due to its depth. Classic gullies are often deeper than 1.5 feet and cannot be leveled by normal tillage operations. The top image is from Bonneville County, Idaho. The bottom image, from Shelby County, Iowa, also shows another helpful physical feature to identify a classic gully: **the lack of vegetation along its trend**. Both images courtesy of USDA, NRCS.

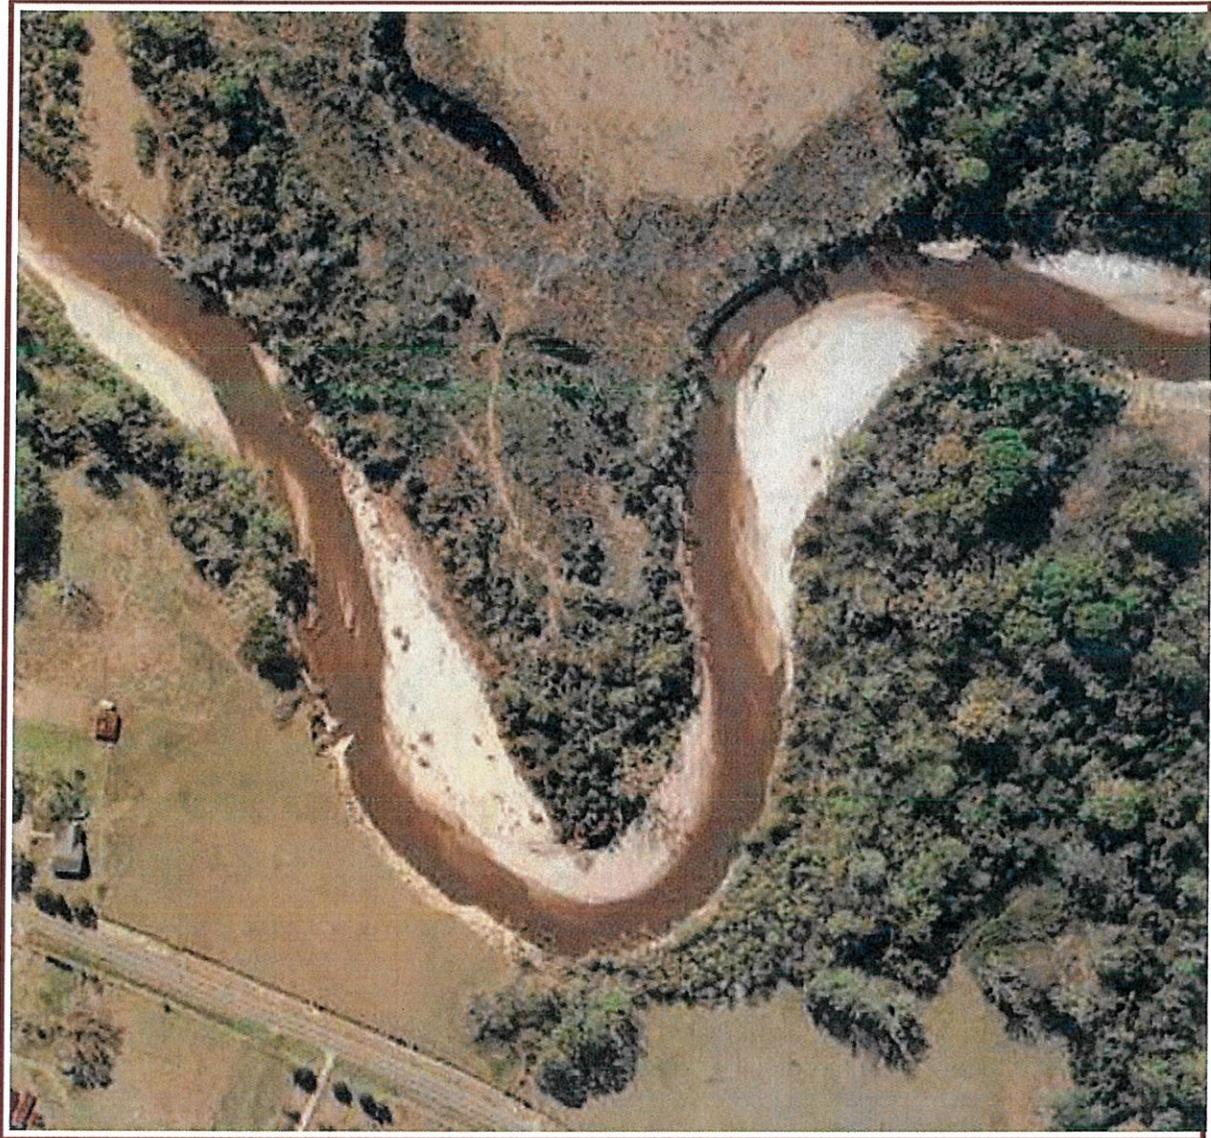
Streambank Erosion

Concerning the resource concern "Streambank Erosion," keep in mind that within meandering stream channels there is a predictable pattern of erosion **and** deposition. Due to significant differences in flow velocities and trajectories, **erosion** occurs along the **CUT BANK**, which is always on the outside bend of a meander (see annotated image below). **POINT BAR DEPOSITS** always occur along the inside bend of a meander. This image was taken during a low-flow period when the point bar deposits are exposed and the cut bank slope is obvious. During bank-full flows, the point bar will be underwater and the cut-bank slope length will be minimized. Image courtesy of USGS.

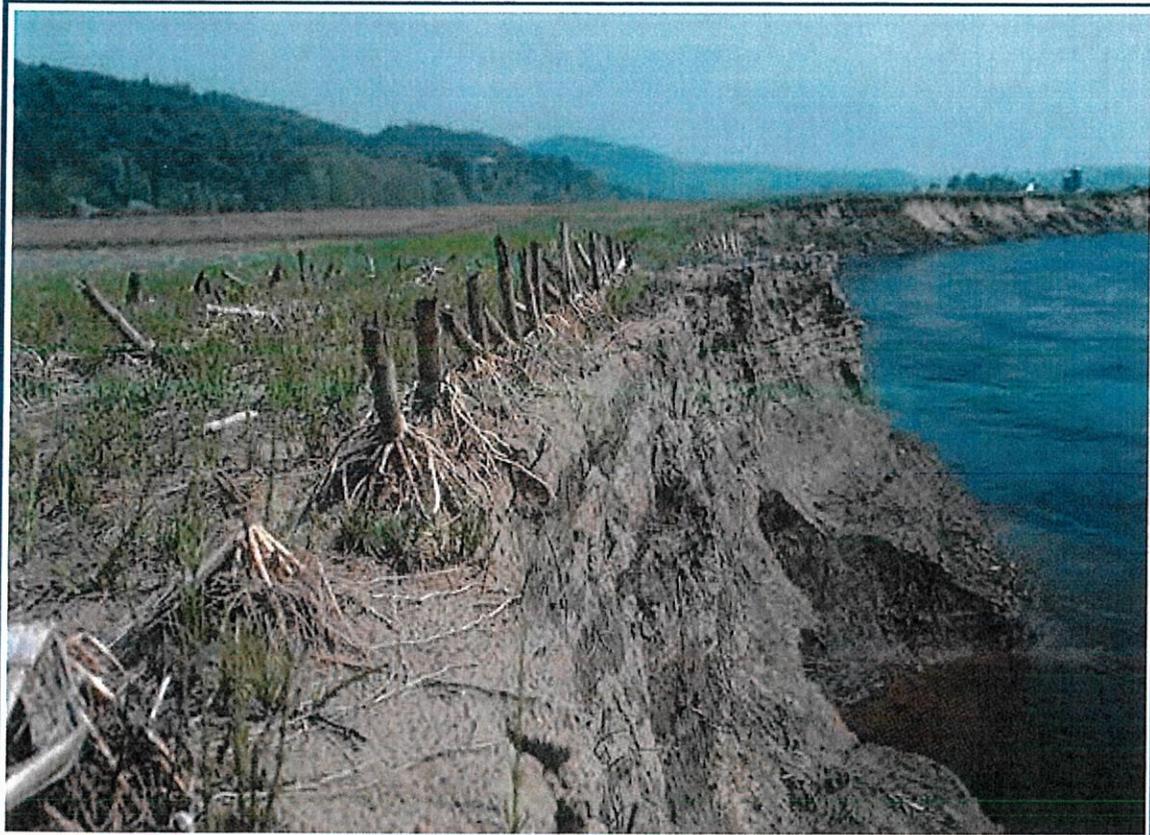
Streambank Erosion

A ground photograph along the Connecticut River illustrating the resource concern **Streambank Erosion**, as highlighted by the physical feature: **Bare Soil**. Note that the **erosion** is along the **CUT BANK**, which occurs along the outside bend of the meander. Image courtesy of USDA, NRCS.

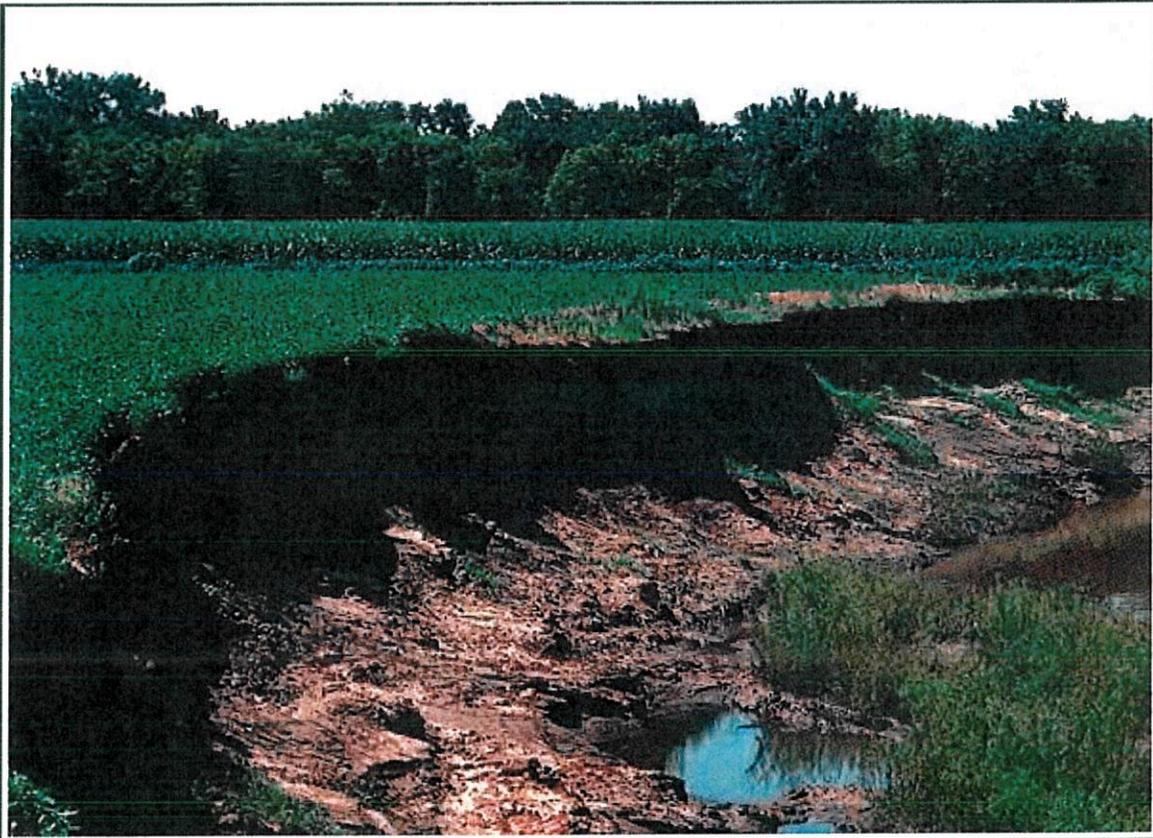
Streambank Erosion

This example of the resource concern **Streambank Erosion**, as highlighted by the **physical feature: Bare Soil**, is from Iowa. Note once again, that the **erosion** is along the **CUT BANK**, which occurs along the outside bend of the meander. Image courtesy of USDA, NRCS.

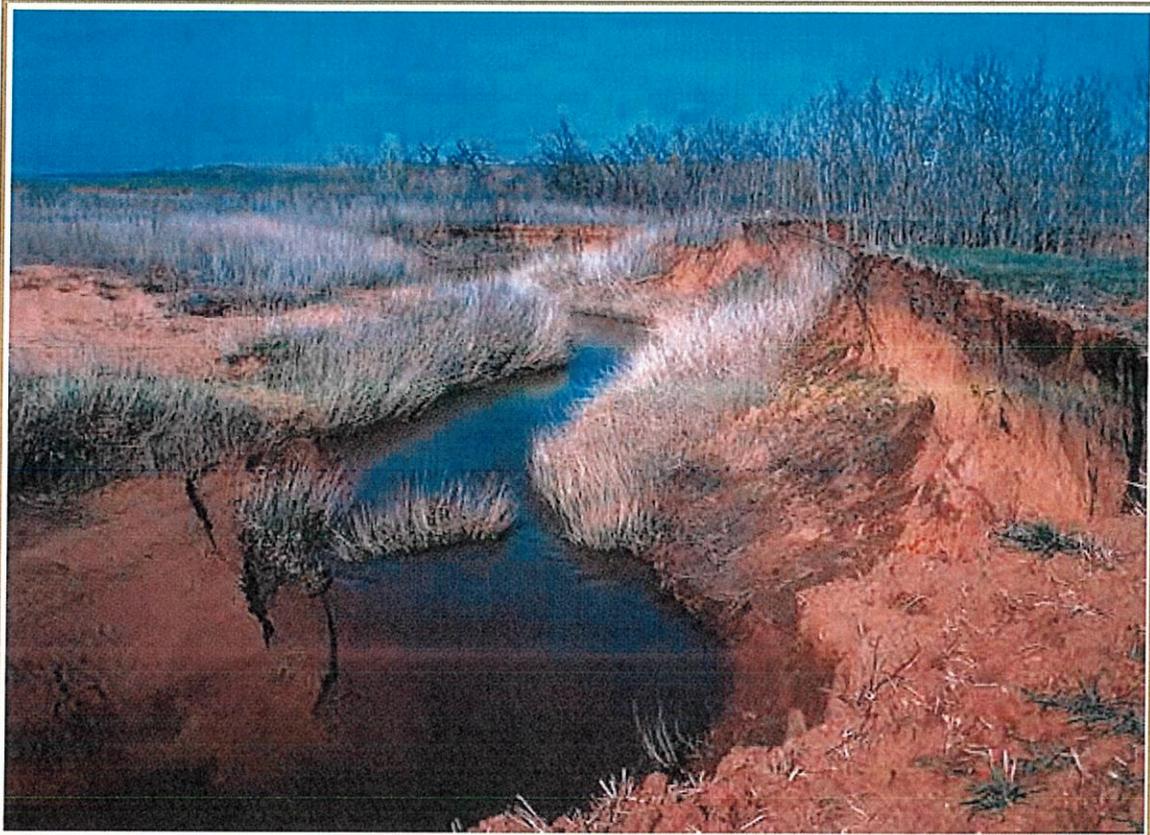
Streambank Erosion

This example of **Streambank Erosion**, as highlighted by the physical feature: **Bare Soil**, is from Oklahoma. Although more difficult to discern in this image, the **erosion** is occurring along the **CUT BANK** on the outside bend of a meander. The **Point Bar deposits** that are **NOT** indicative of streambank erosion are on the inside bend of the meander are well shown in the lower-left corner of this photograph. Image courtesy of USDA, NRCS.

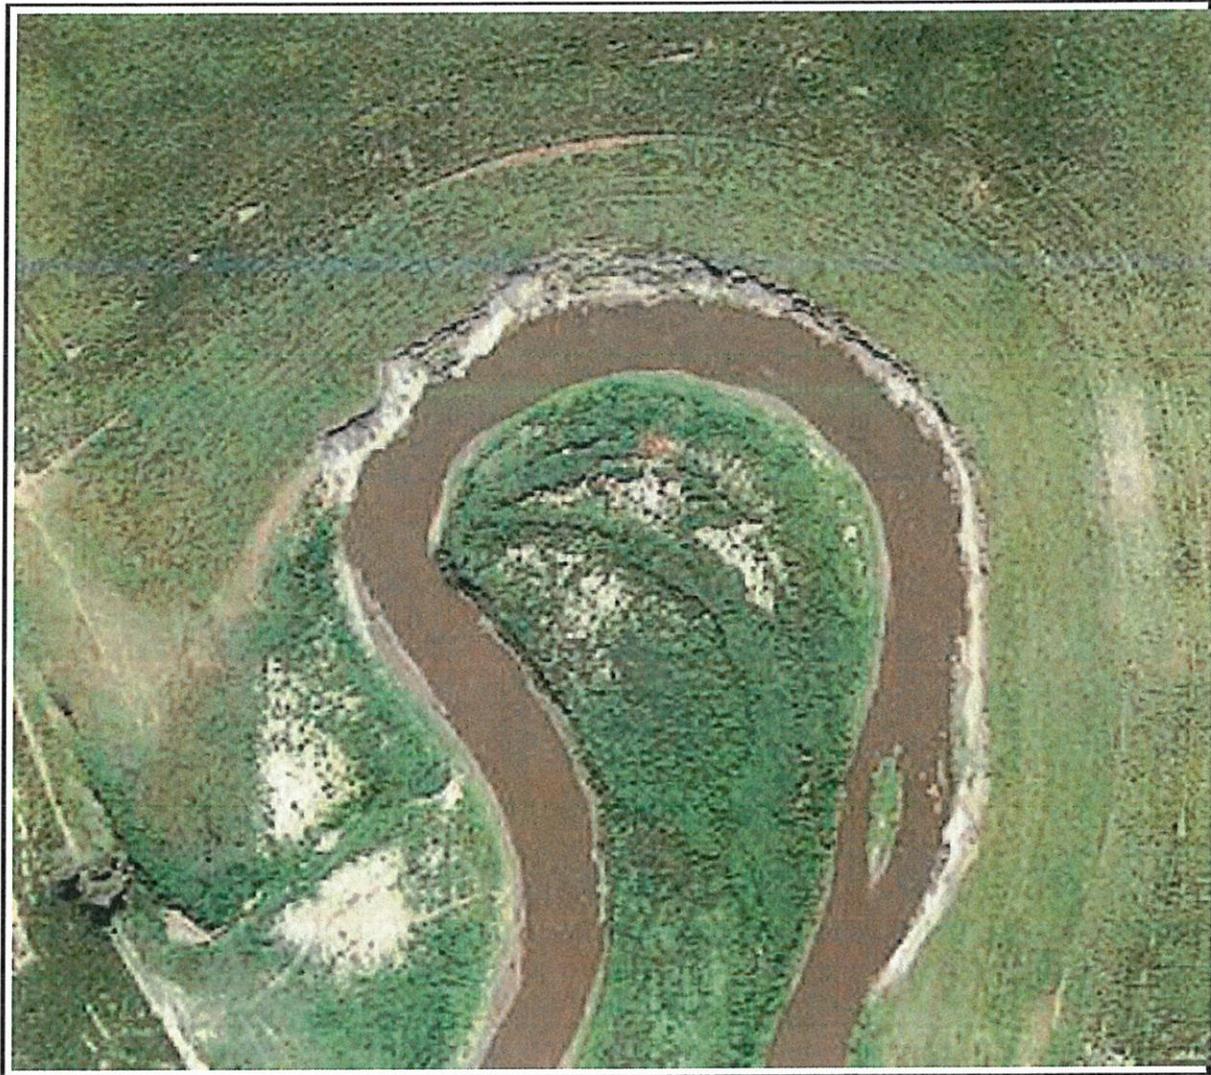
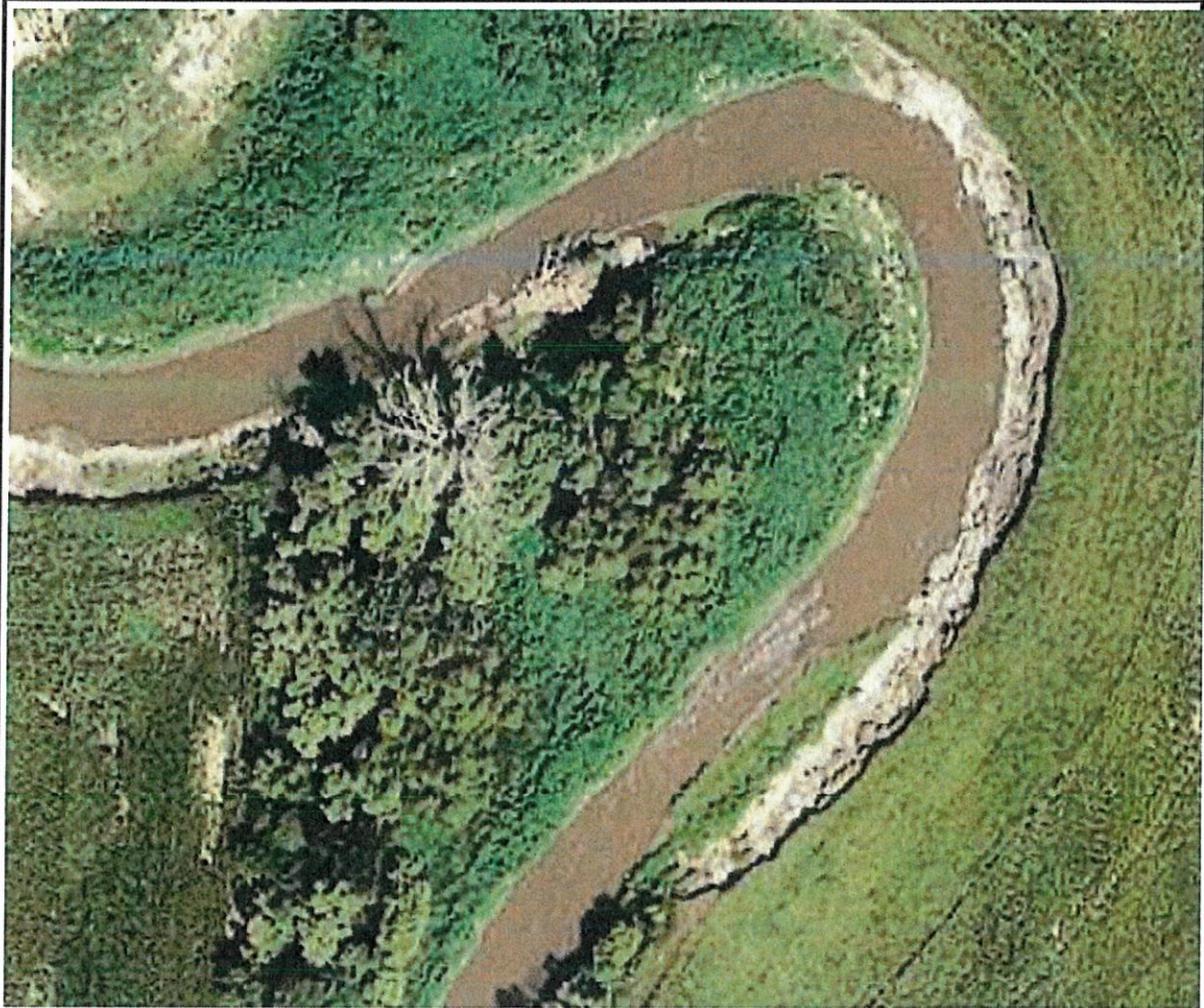
Both of these images from Shelby County, Iowa illustrate the **Streambank Erosion** resource concern, highlighted by the physical feature: **bare soil**. Note that the **streambank erosion (CUT BANK)** occurs on the outside bends of the meanders. The top image shows a very narrow, non-vegetated point bar deposit on the inside bend of the meander, while the point bar deposit in the bottom image is almost completely vegetated. Both images courtesy of USDA, NRCS.

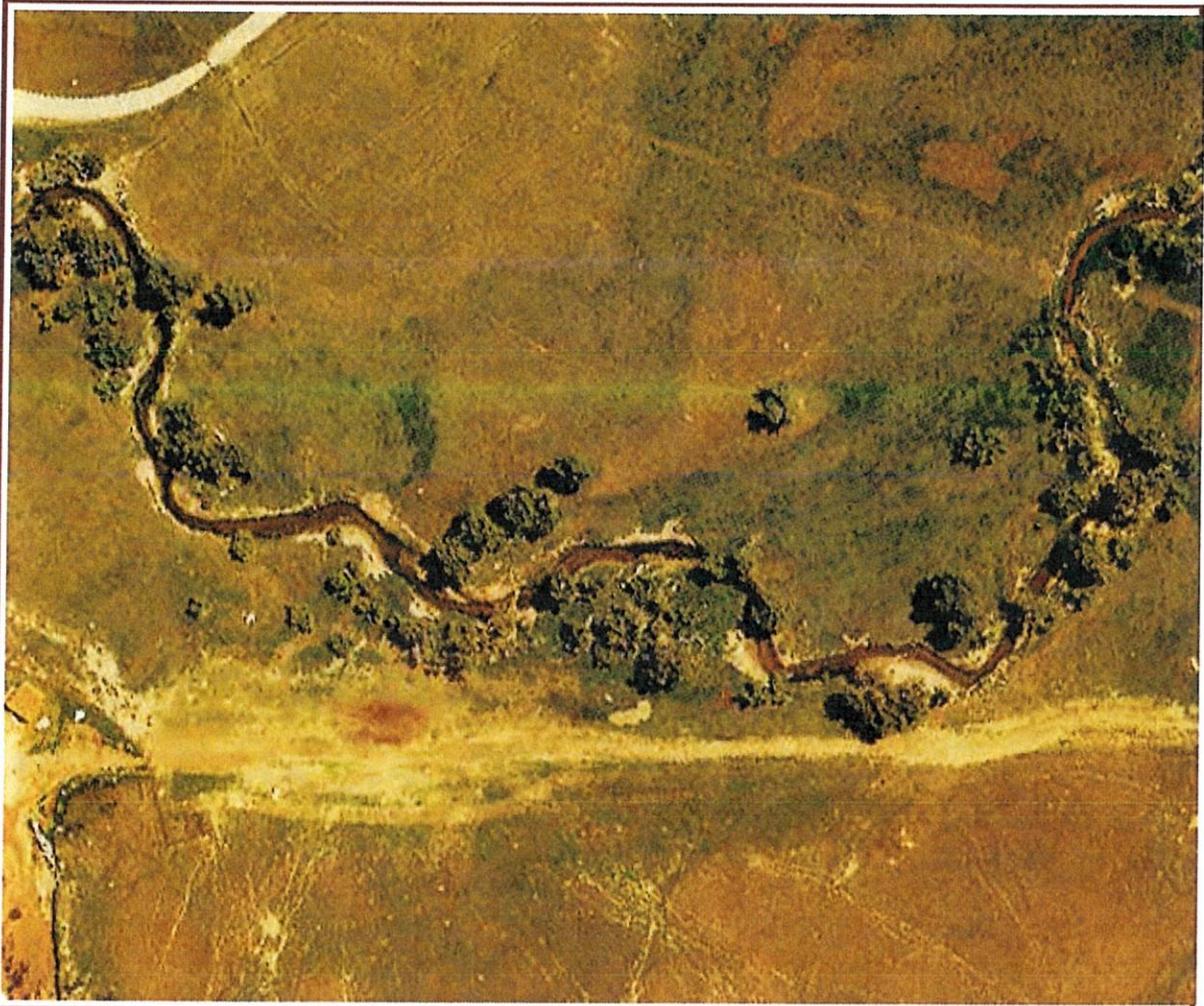
The **bare soil** physical feature is well illustrated in this image from Platte County, Wyoming. Since some of these bare soils areas are located on the outside bends of the meanders (i.e., cut banks), the resource concern **Streambank Erosion** is confirmed. Image courtesy of USDA, NRCS.

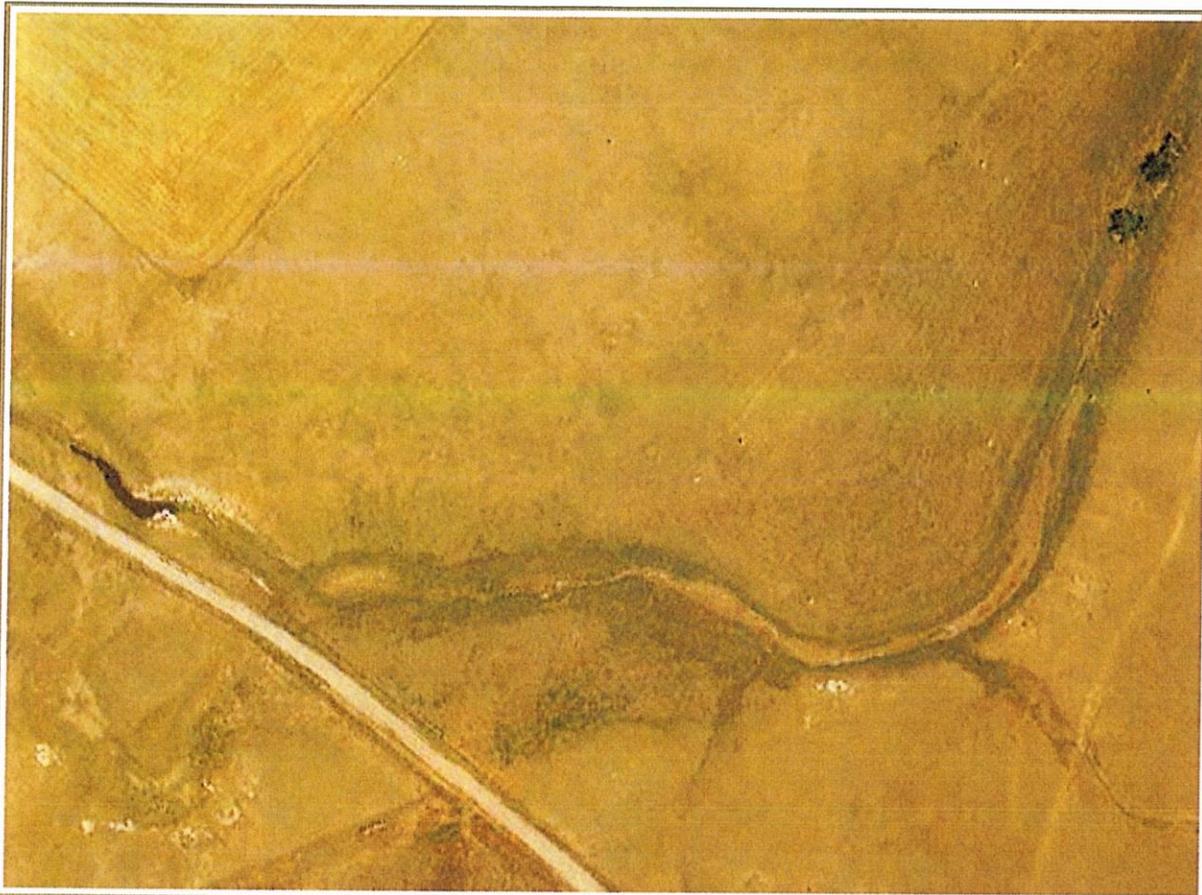
Streambank Erosion

The physical feature originally identified in this image from Lincoln County, Colorado was **Soil Material In The Waterways (documenting Streambank Erosion)**, but this is **NOT correct**. This is an intermittent stream photographed during a low-flow period when the channel contained no water. The "soil in the waterway" is actually the channel bed itself. Image courtesy of USDA, NRCS.

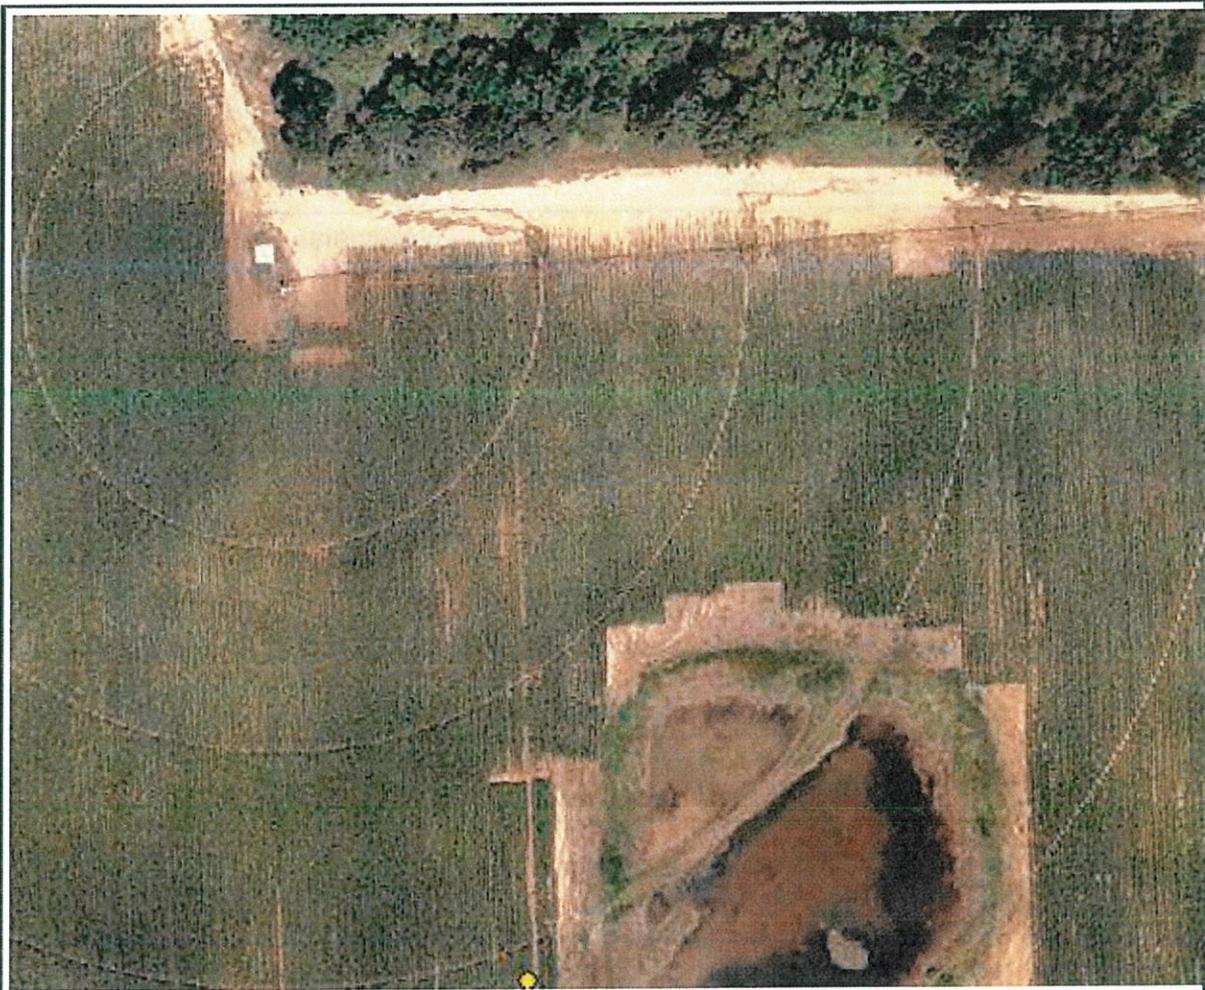
One of the best irrigation management practices is to control the frequency, duration and volume of water application in order to not induce runoff (i.e., all the irrigated water infiltrated into the root zone, where the plants could use it). This image from Kalamazoo County, Michigan exhibits the obvious physical feature of **soil deposits at the end of an irrigated (center pivot) field**. This feature is suggestive of an **Irrigation Induced Soil Erosion** problem. It may also be that this physical feature is associated with precipitation-induced runoff (**sheet and rill erosion**). Either way, this physical feature helps to identify a resource concern. Image courtesy of USDA, NRCS.

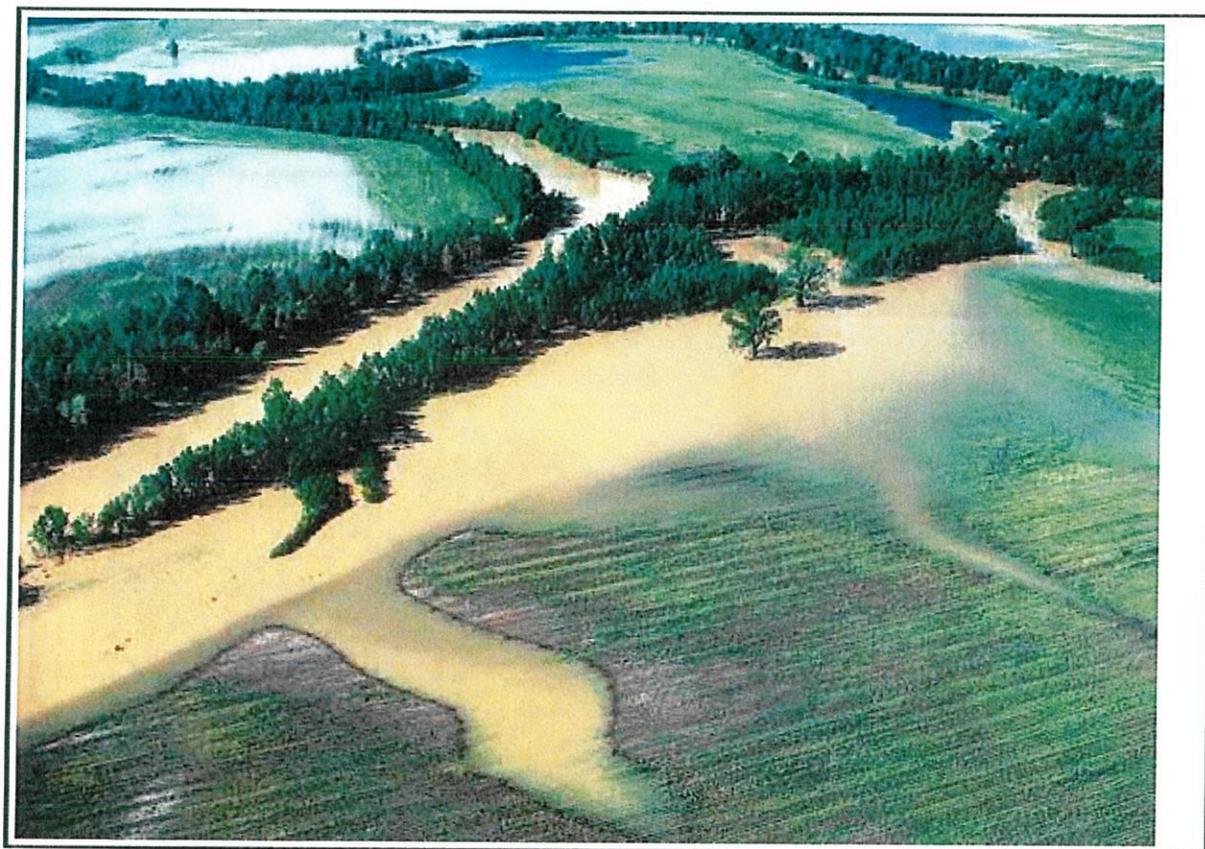
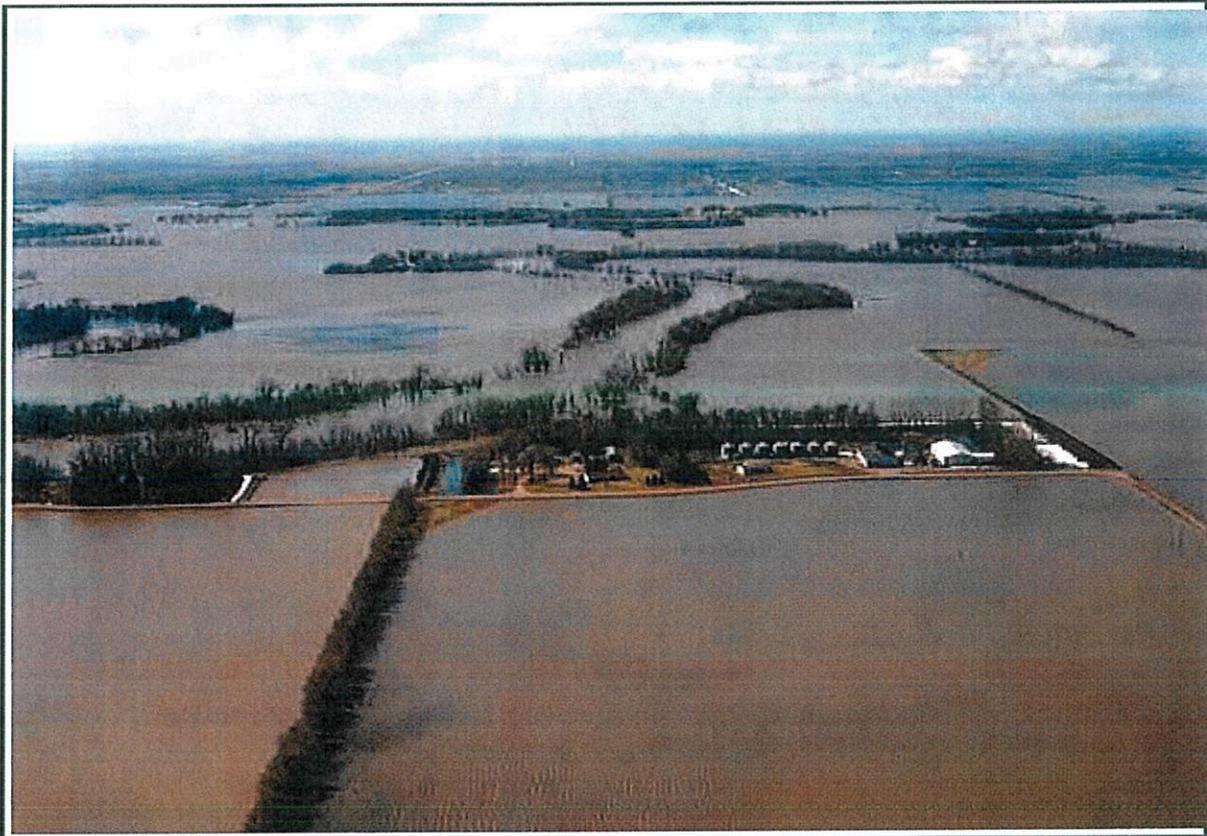
Ponding / Flooding

Ponding of water typically refers to one or more restricted areas within a field. Short duration ponding is usually caused by frequent and/or intense precipitation events that exceed the infiltration capacity of the soils. Long duration ponding is typically associated with restricted drainage areas (often depressions/swales) within a field. **Flooding**, on the other hand, refers to streams that overflow their banks. As such, flooded fields are always located on the floodplain of a river or stream. Top two images courtesy of USDA, NRCS. Bottom image courtesy of Dave Willis, Agassiz Crop Management, Thief River Falls, MN.

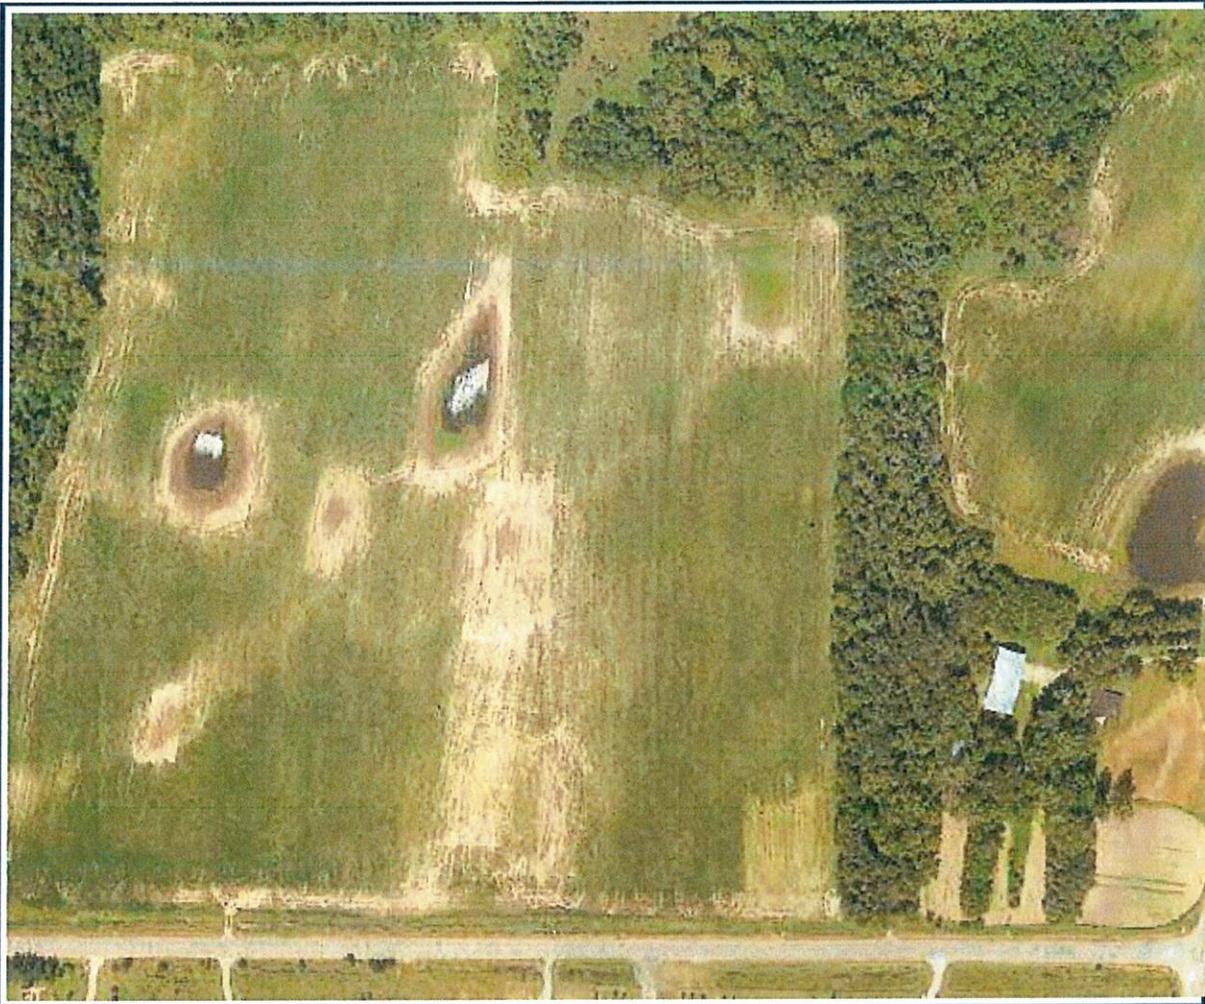
The **Ponding/Flooding** resource concern is illustrated in this image from Anoka County, Minnesota by the physical features of **Standing Water, Drowned Crops and Sediment**. Image courtesy of USDA, NRCS.
