Conservation Practices

There are 167 conservation practices listed in the National Handbook of Conservation Practices. The table below summarizes some of the most common practices that can be interpreted from large-scale aerial imagery.

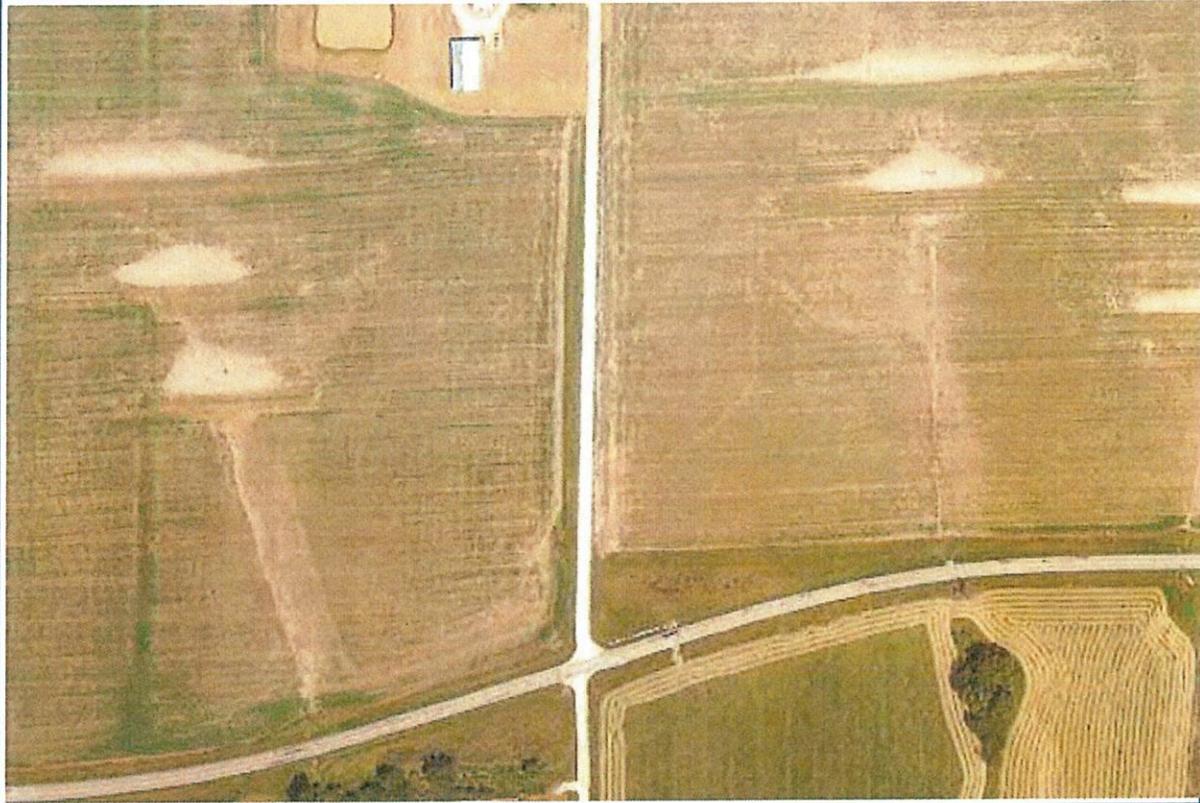
Ponding and Flooding

Here is an example of a resource concern (**Ponding/Flooding**) being associated with a conservation practice (Water-sediment control structures) in Audrain County, Missouri. These control structures have been constructed across several drainage lines. They were effective in ponding water and settling out sediment as evidenced by the physical features of **drowned crops covered with soil**. Image courtesy of USDA, NRCS.

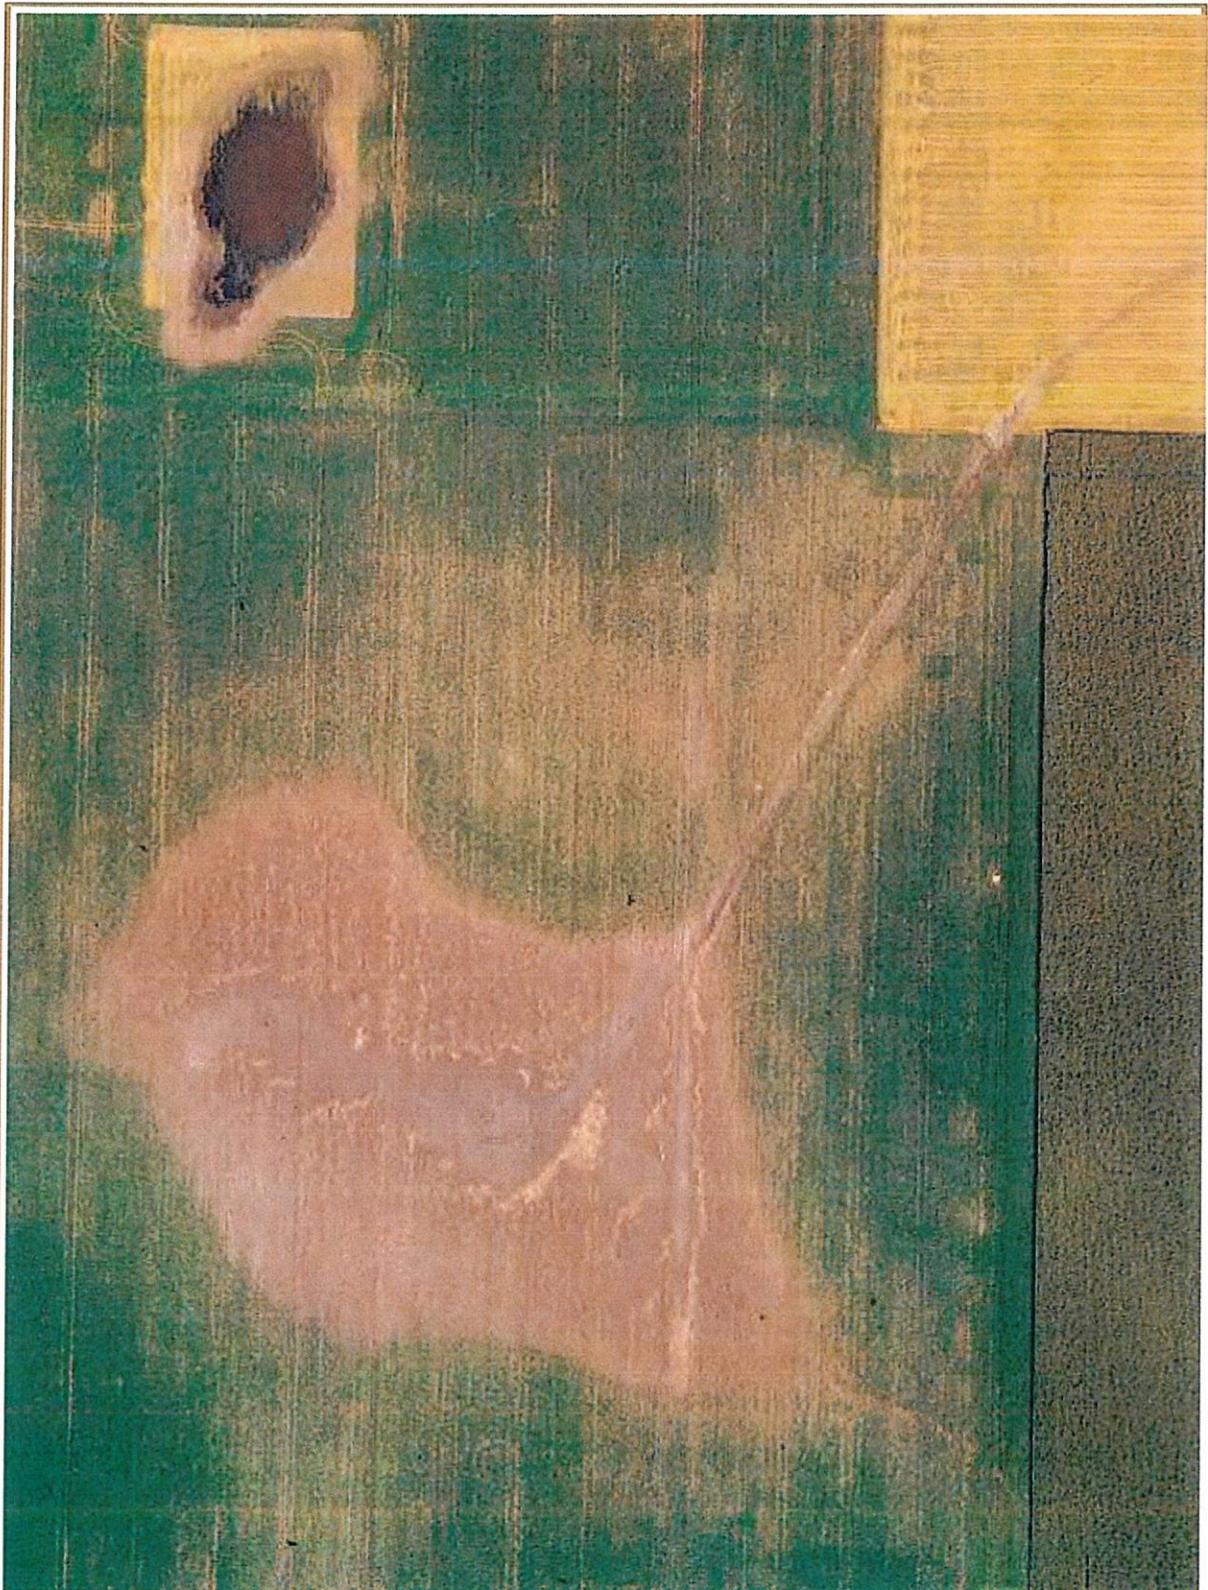
Ponding and Flooding

This example of the **Ponding/Flooding** resource concern from Calhoun County,

Iowa illustrates (in the lower portion of the image) the physical features of **drowned crops, sediment and debris lines**. Image courtesy of USDA, NRCS.

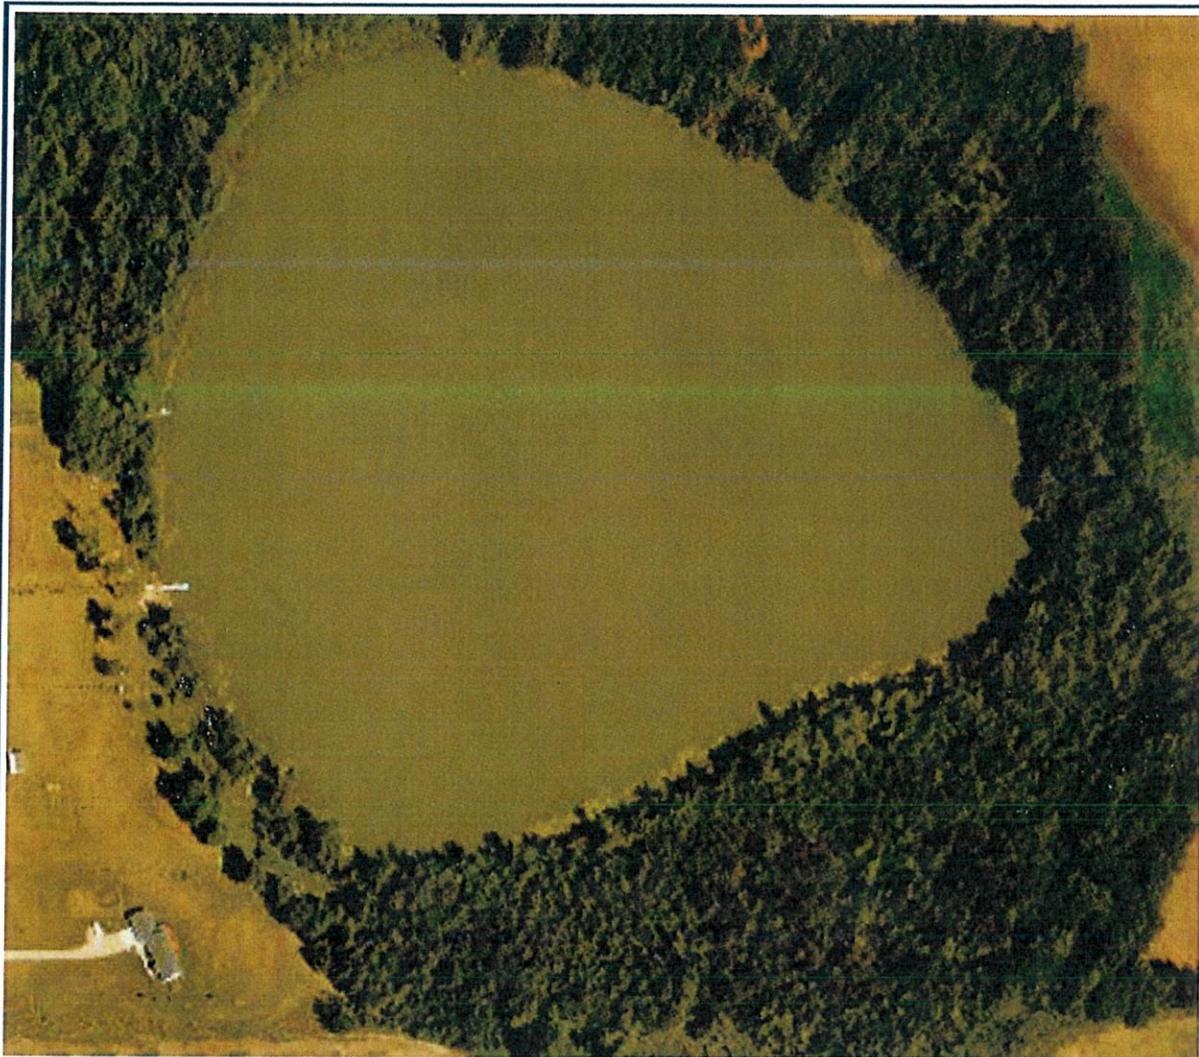
This small lake in Midland County, Michigan exhibits the physical feature of being **bright green due to an algal bloom**. This is evidence of the resource concern: **Surface Contaminants, nutrients and organics**. Image courtesy of USDA, NRCS.

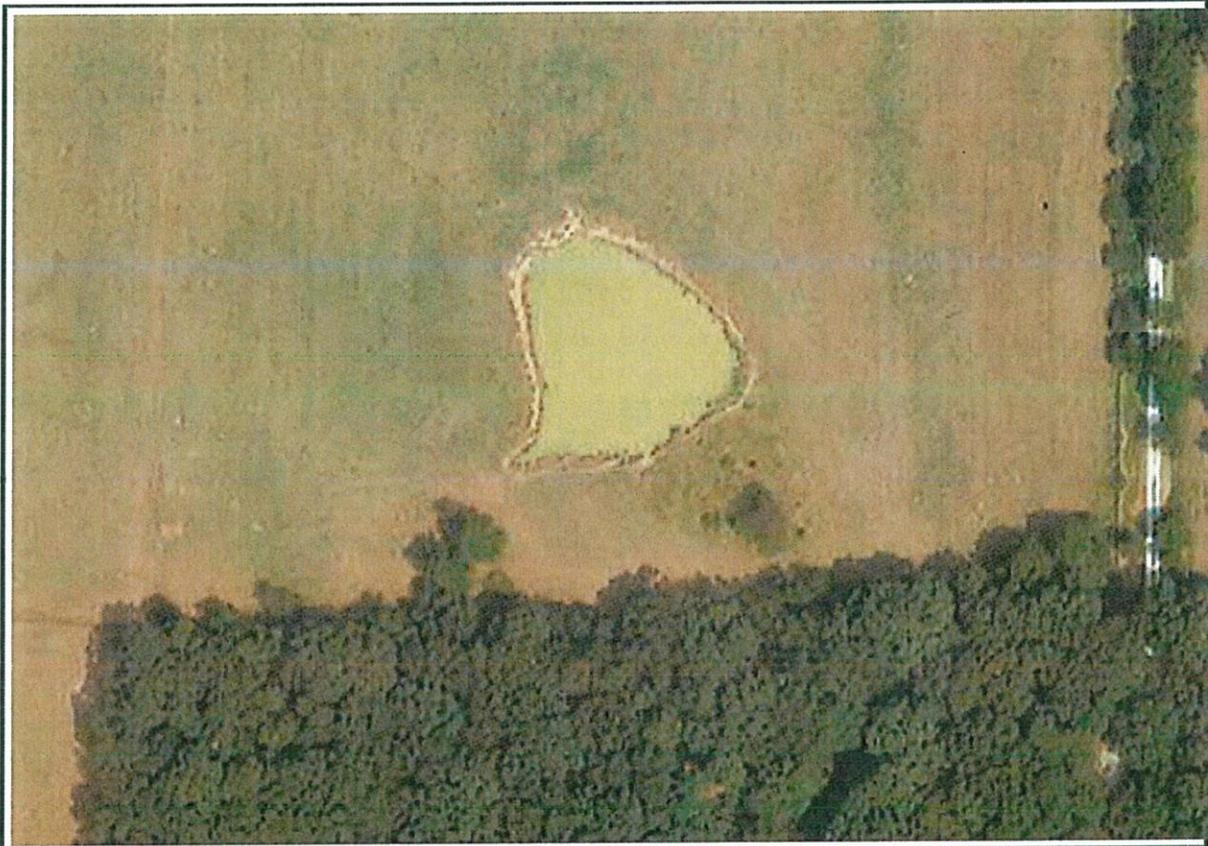
Surface Contaminants, Nutrients & Organics

This green pond in Boone County, Missouri exhibits the physical feature of being **green due to an algal bloom**. This is evidence of the resource concern: **Surface Contaminants, nutrients and organics**. Image courtesy of USDA, NRCS.

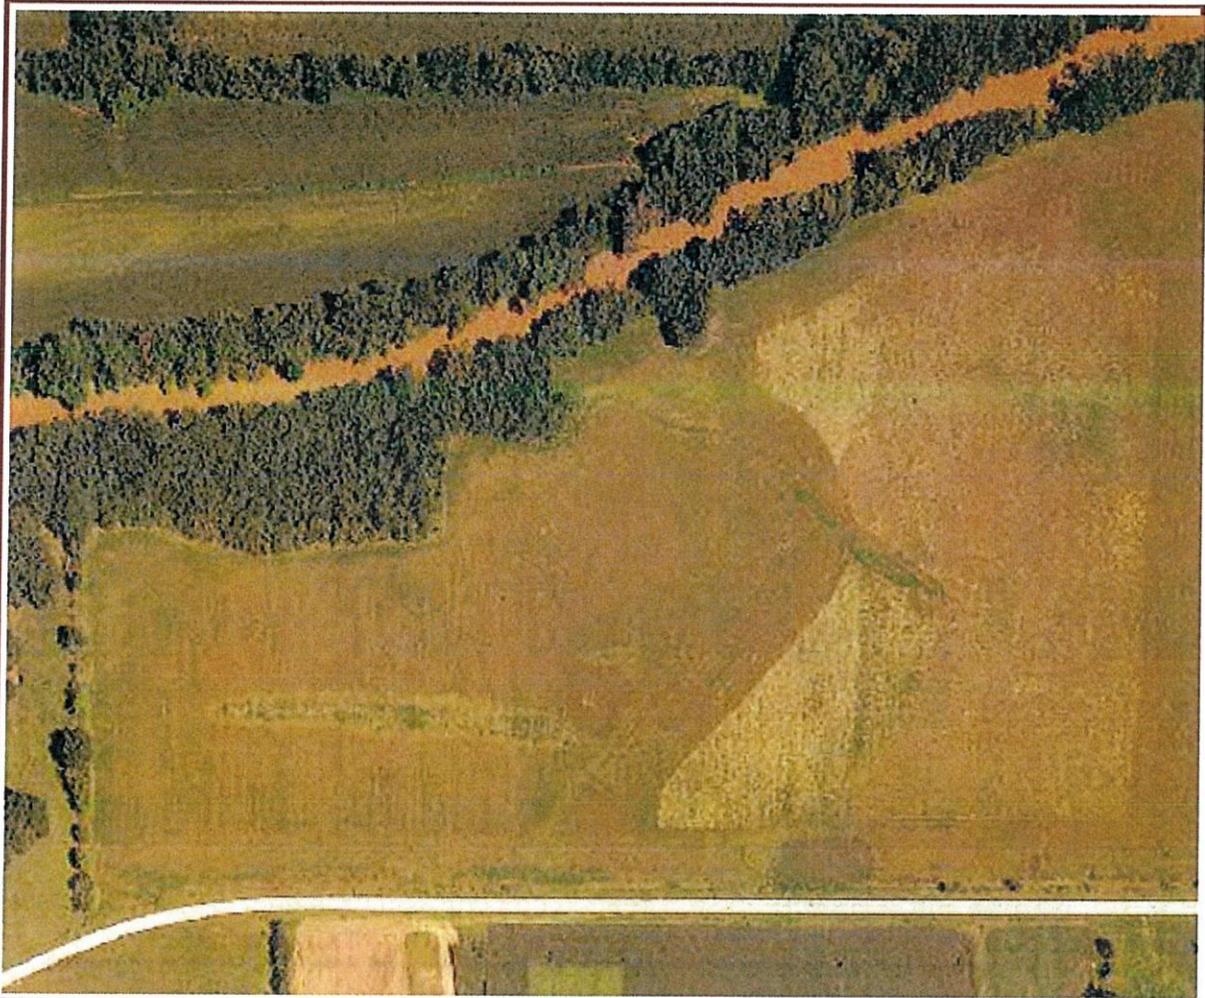
This image from Lewis County, Missouri shows the physical feature of a **reddish brown colored river** - distinct evidence of the **Contaminants, turbidity** resource concern. Although this is a legitimate resource concern, **it is NOT associated with the conservation treatment unit (CTU) in the center of this image**. The turbidity in this river is coming from elsewhere in the watershed. With this insight in mind, image interpreters should use this resource concern sparingly and only when the CTU is obviously delivering sediments to the turbid river or lake. Image courtesy of USDA, NRCS.

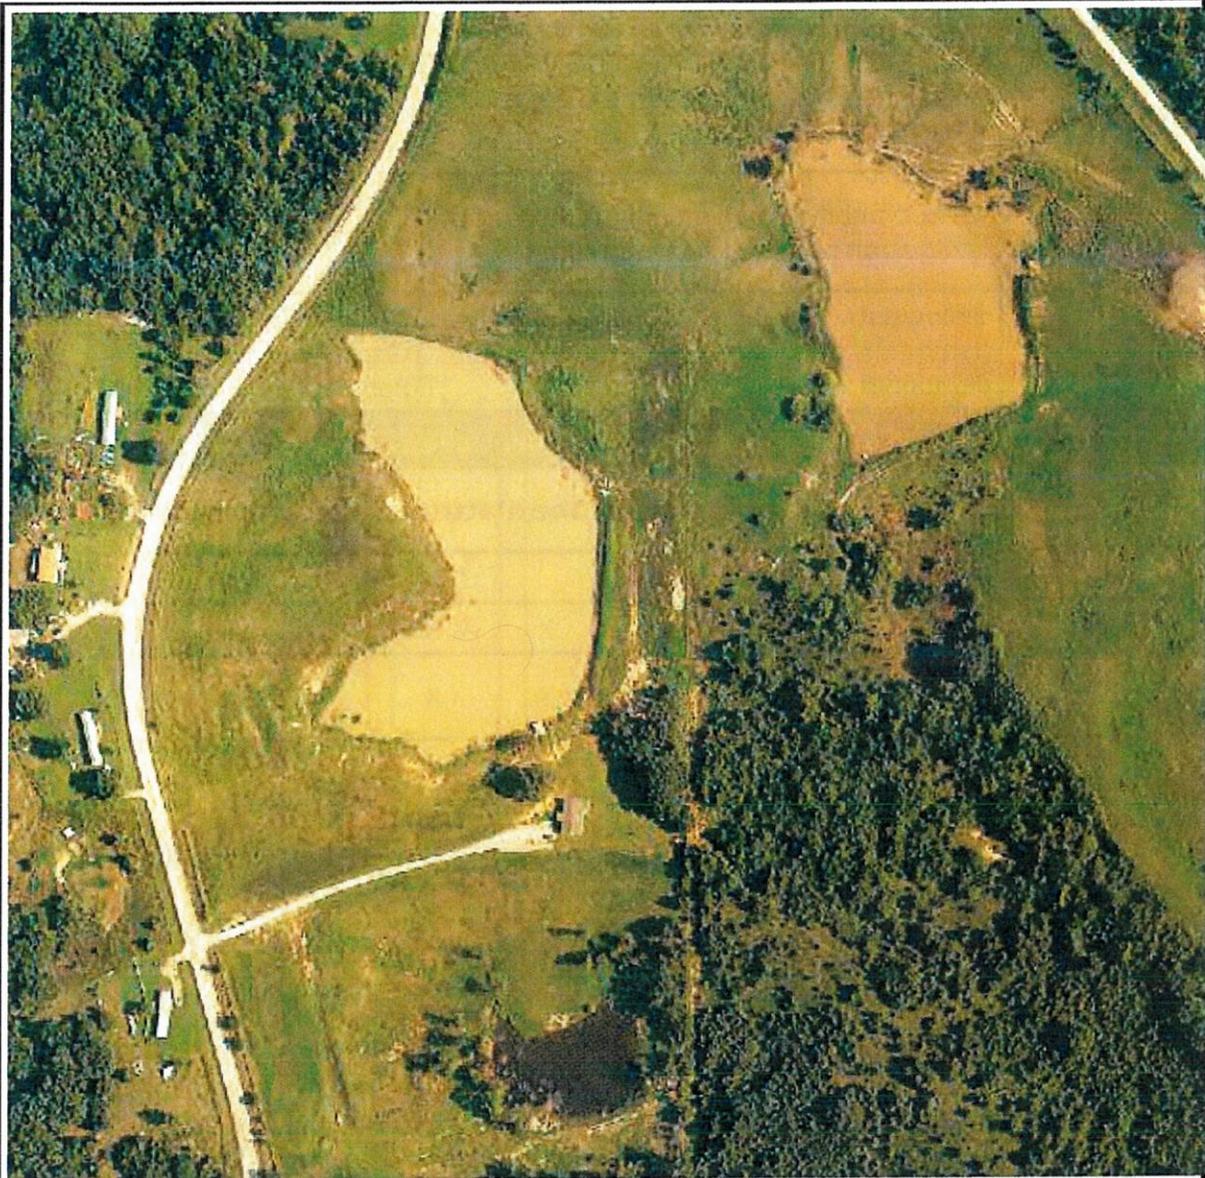
This image from Howard County, Missouri shows the physical feature of **brown ponds** - distinct evidence of the **Contaminants, turbidity** resource concern. Unlike the circumstance pictured above, at this site the conservation treatment unit (CTU) in the center of this image must be contributing sediment to the ponds, since no other watercourse feeds them (i.e., they are runoff retention ponds). Image courtesy of USDA, NRCS.

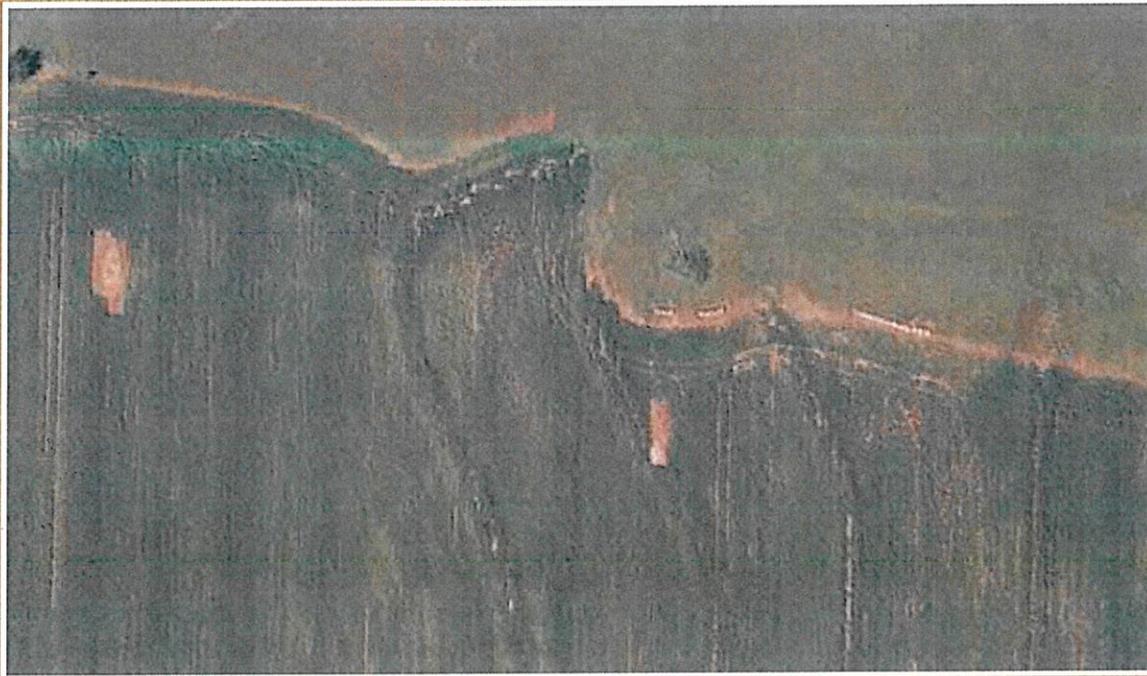
Failed Planting

Both of the rectangular planting gaps in this image from Kansas appear to be a **Failed Planting** feature within the **Plant Adapted To Site** resource concern. **They are NOT.** Both of them are **Tillage Exclusions** (hence, their rectangular shape) associated with either **Ponding/Flooding** or **Excess Subsurface Water** resource concerns. Image courtesy of USDA, NRCS.

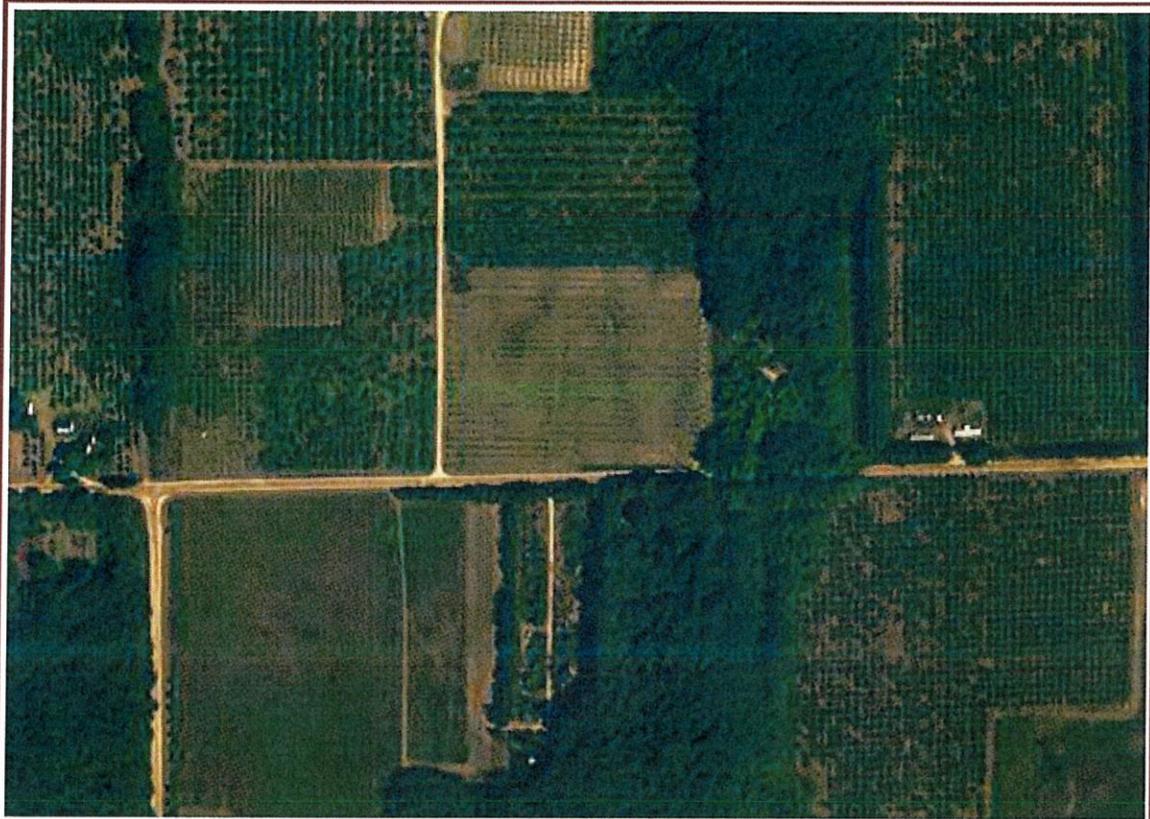
Numerous **orchard gaps** are visible in this image from Grand Traverse County, Michigan (especially obvious in the orchards along the right side of the image). These are physical features suggesting a **Plant Adapted To Site** resource concern. The causes of these gaps include removals of diseased trees and poorly producing trees. Image courtesy of USDA, NRCS.

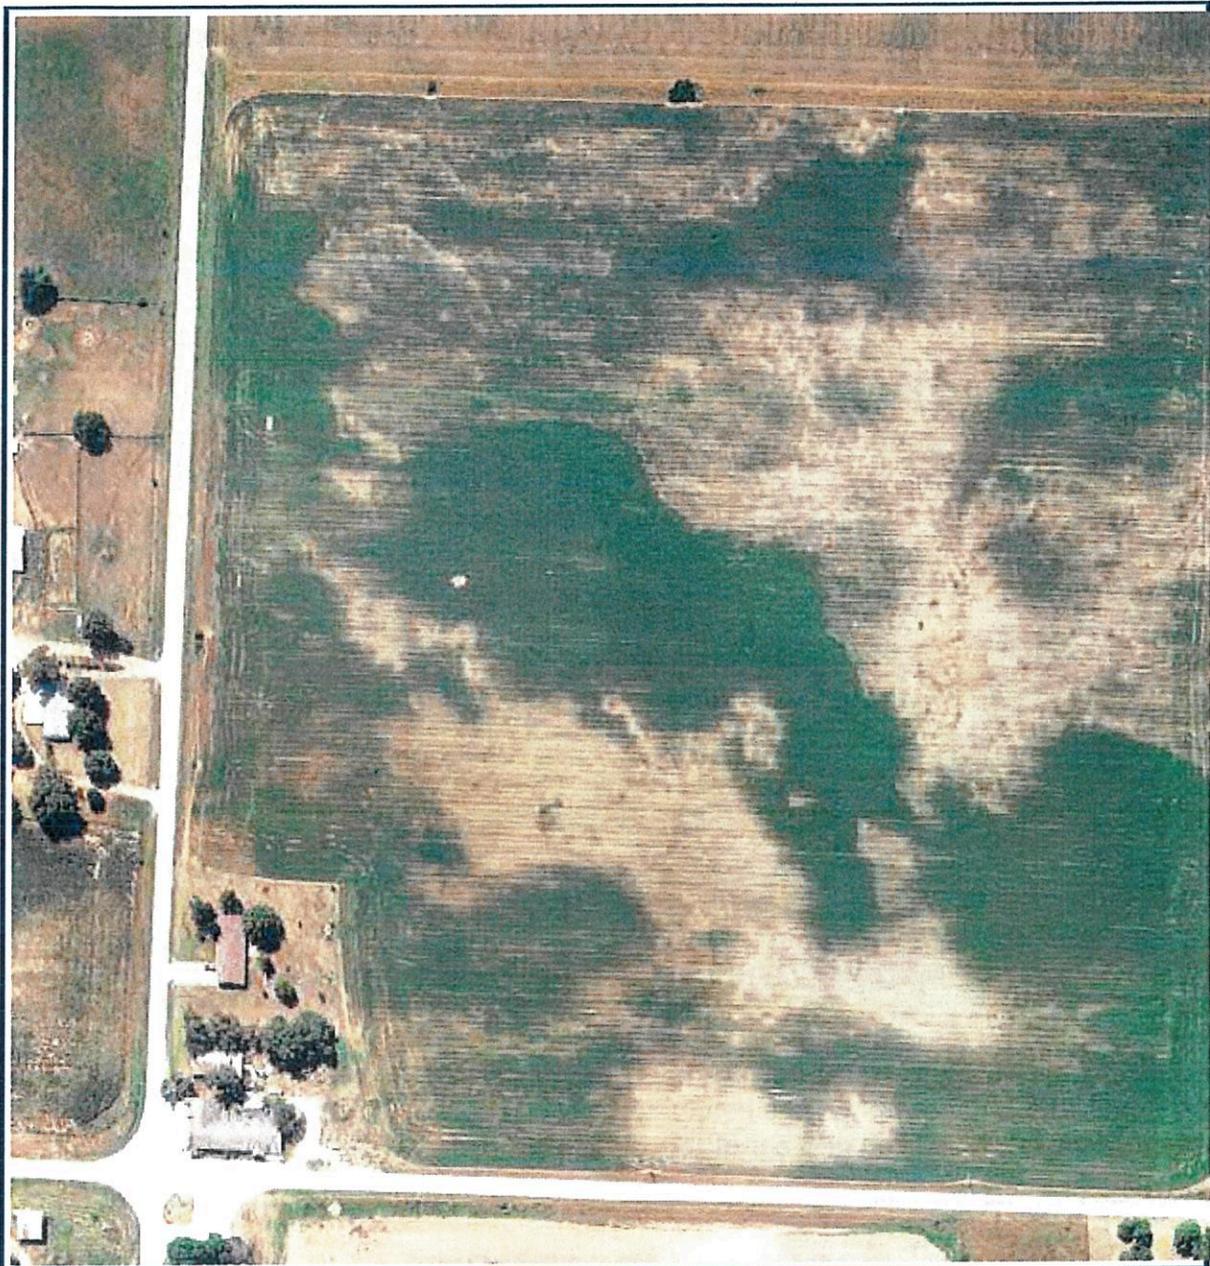
This image from Jasper County, Missouri illustrates the **Plant Health and Vigor** resource concern. The physical feature is **low crop biomass**. Note the pattern of the "thin" parts of the crop canopy - they are all located on the upland swells of this field. The dense biomass portions of the canopy appear to be located in the low swales in the field. Such a pattern is associated with early season drought conditions. The best germination and crop growth occurred in the swale areas due to their greater soil moisture content (in wet times, these same swale areas would drown the crop). Image courtesy of USDA, NRCS.

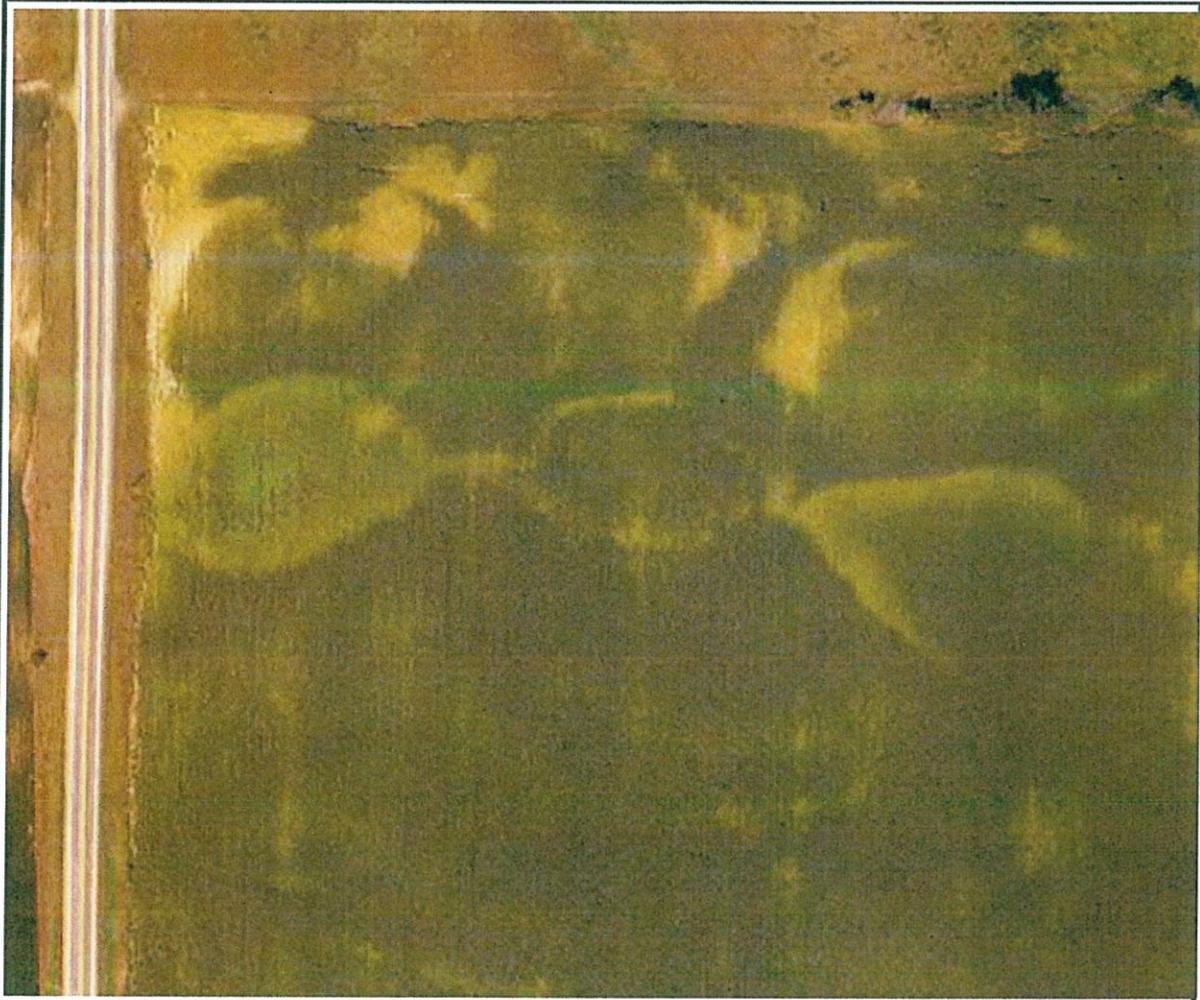
This image from Le Sueur County, Minnesota illustrates the physical feature of a **yellowing corn crop in the somewhat poorly and poorly drained swales** in this field. This physical feature is evidence of two resource concerns: **Plant Health and Vigor**, as well as **Excess Subsurface Water**. Image courtesy of USDA, NRCS.

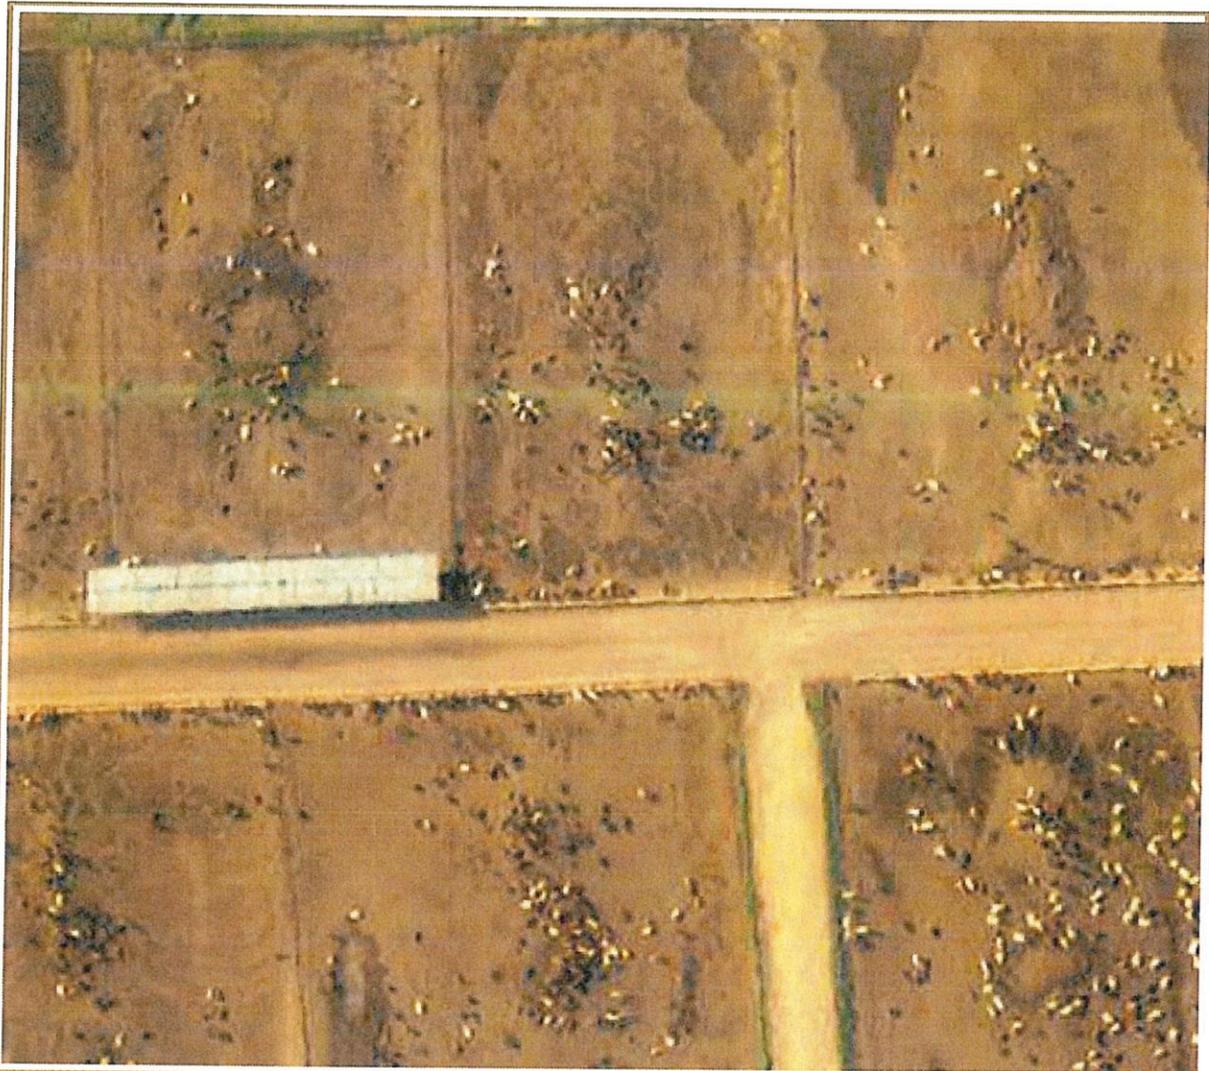
Beef cattle operations generally include several large barns, several long pole barns, groups of silos or ground bunkers, small rectangular fenced areas and, possibly, extensive pasture fields nearby. Dairy operations have similar building infrastructure. Hog farms are also similar, but have fewer barns and usually have numerous small "hog houses" arranged in a geometric pattern near the barn. Poultry farms typically utilize long, rectangular, one-story pole buildings to house the poultry, each of which usually has one or more small, cylindrical grain silos attached at one end to support the mechanized feed-handling and distribution system.

Large beef-cattle feedlot in Kansas. Image courtesy of USDA, NRCS.

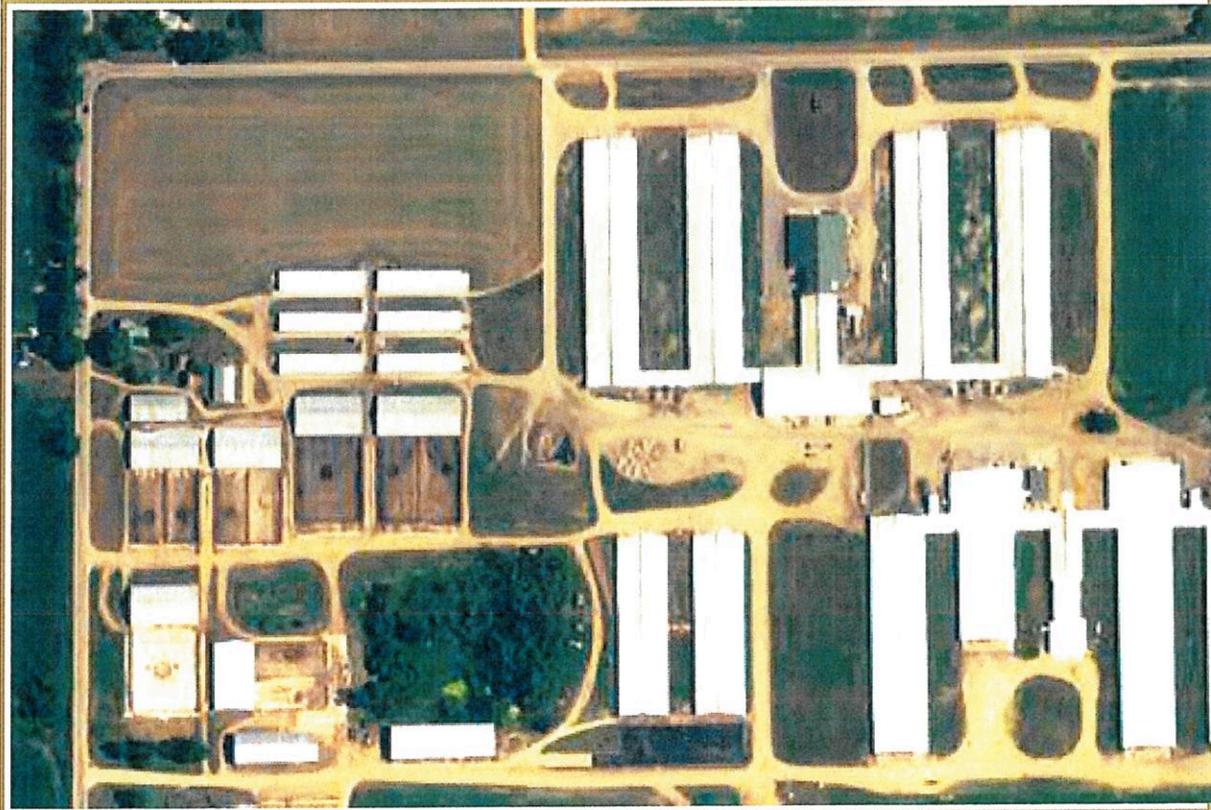
Dairy Farm

Large dairy farm in Clinton County, Michigan. Note the "breeze-way" corridors connecting the stall galleries with the milking parlors. Image courtesy of USDA, NAIP.

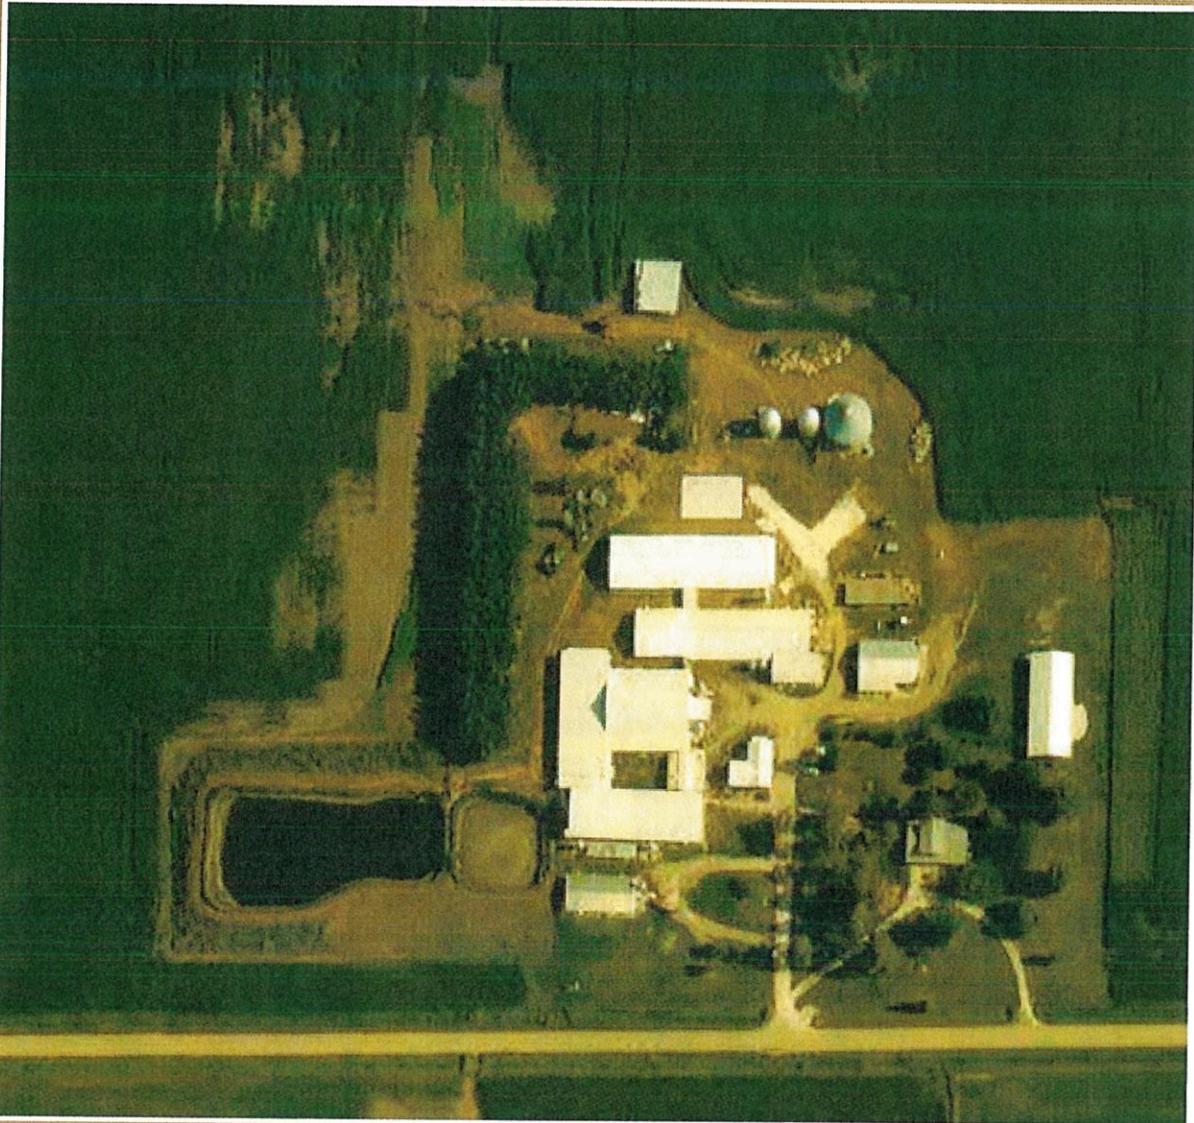
Dairy Farm

Medium-size dairy farm in Iowa. Note the "breeze-way" corridors connecting the stall galleries with the milking parlors. Image courtesy of USDA, NRCS.

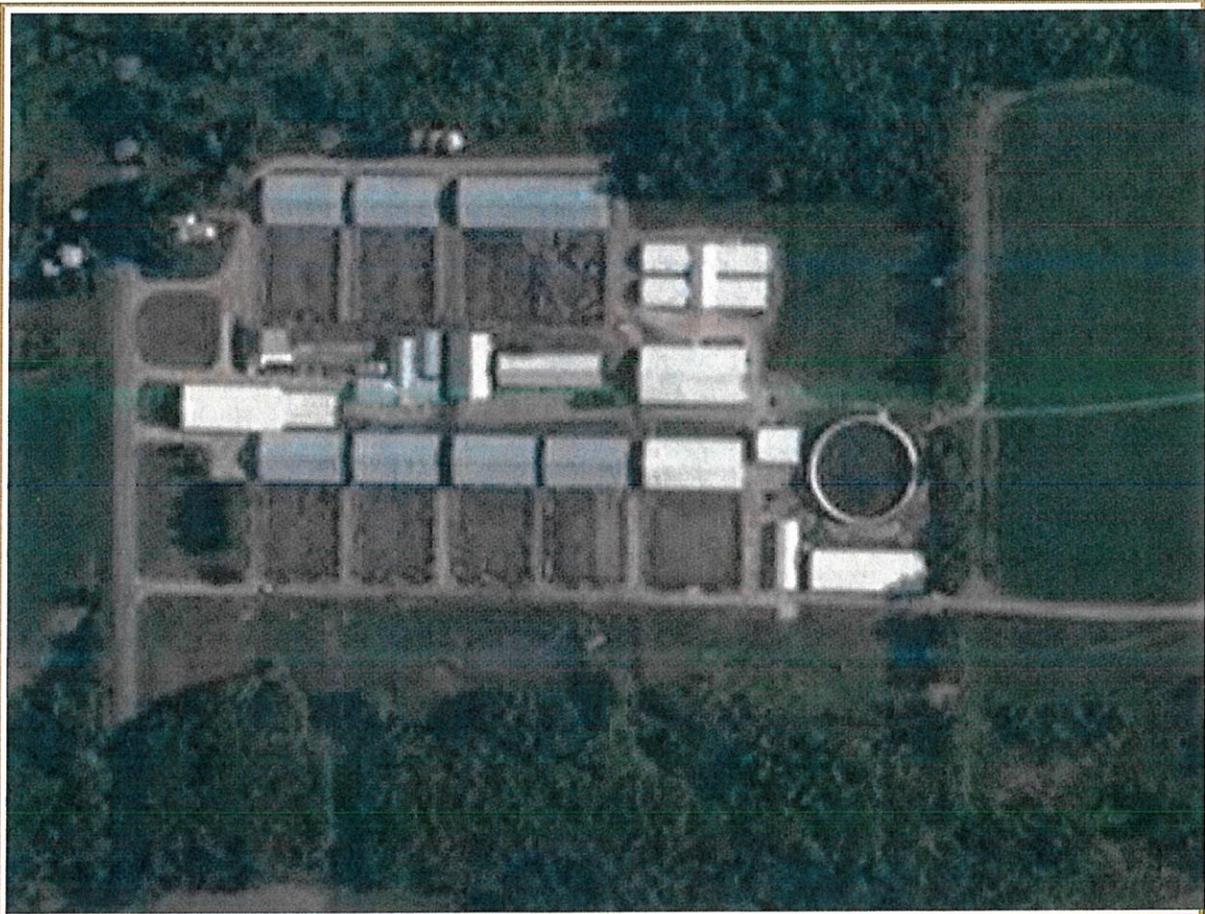
Swine farm in Michigan.

The circular feature at the right-center is a liquid-waste storage pit. Image courtesy of USGS.

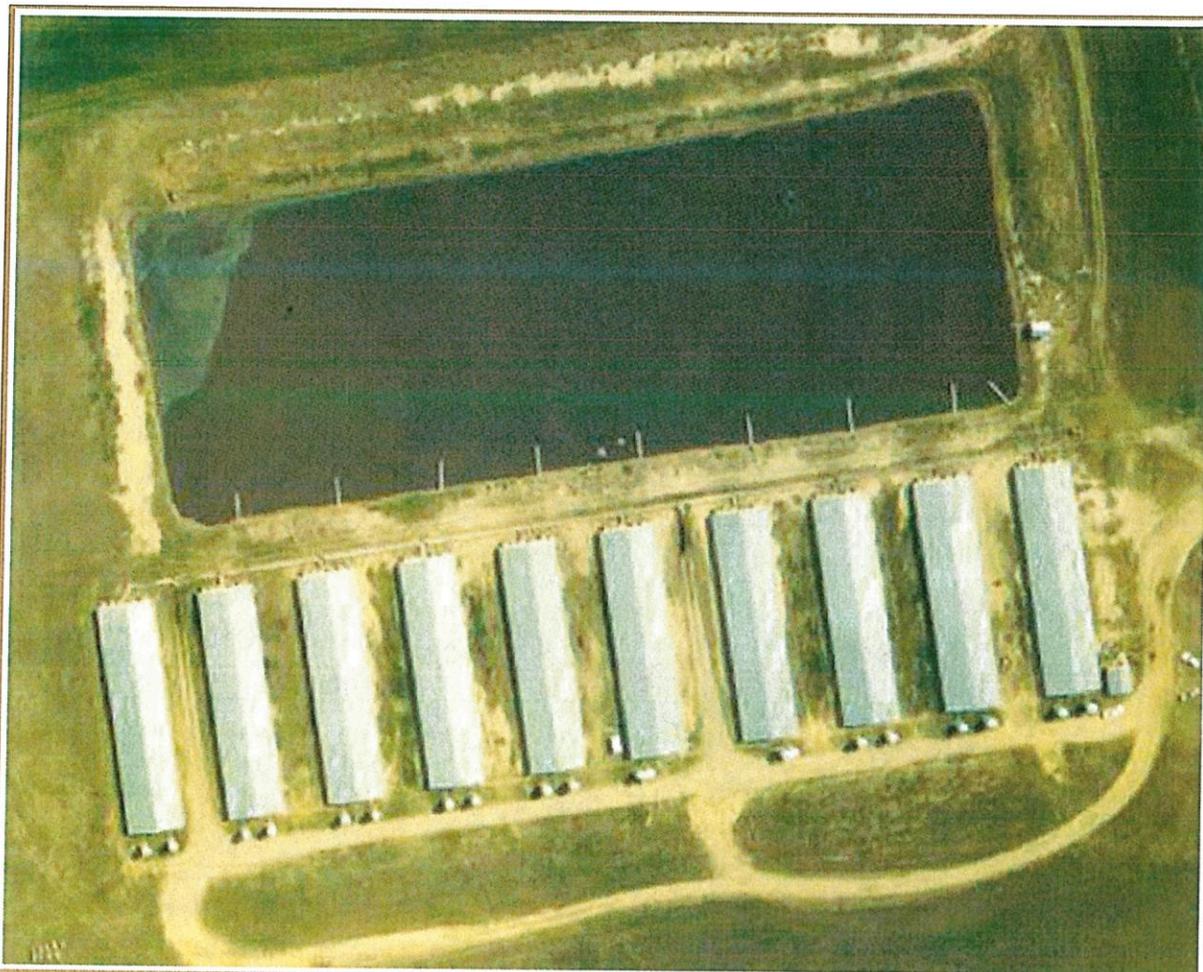
Swine Farm in North Carolina

In this large facility, there are two grain bins per building - either for capacity or to facilitate the various rations used in modern swine production. Note the size of the liquid-waste storage pit. Image courtesy of USDA, NRCS.

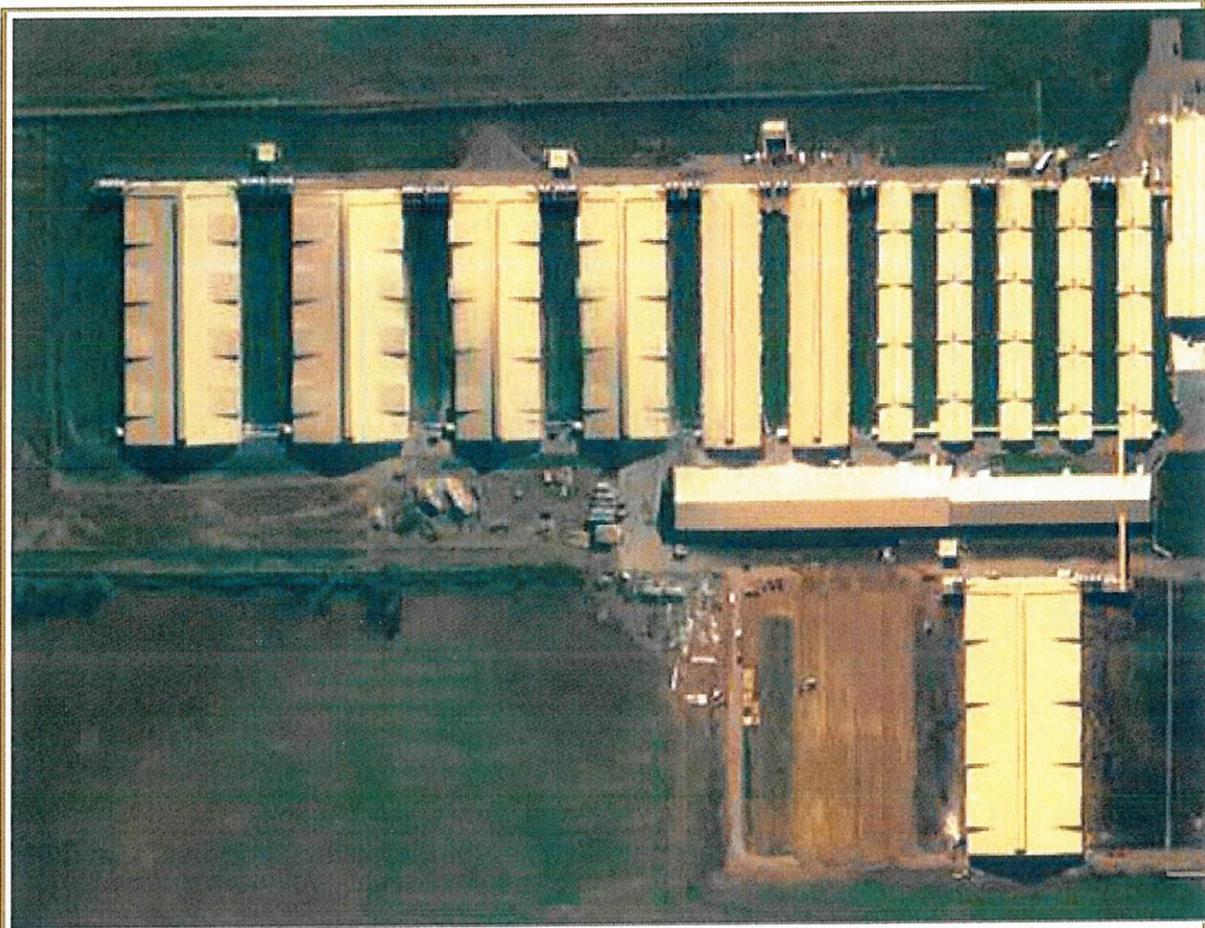
Poultry Operation

Very large poultry operation in Ionia County, Michigan. Note the grain bins attached to most buildings and the ventilation dormers. Image courtesy of USDA NAIP.
