BMP Verification Program

Ad Hoc BMP Verification Meeting

November 12, 2020

Satellite remote sensing analysis of winter cover crop planting, performance, and termination on the Delmarva peninsula, 2018-2021

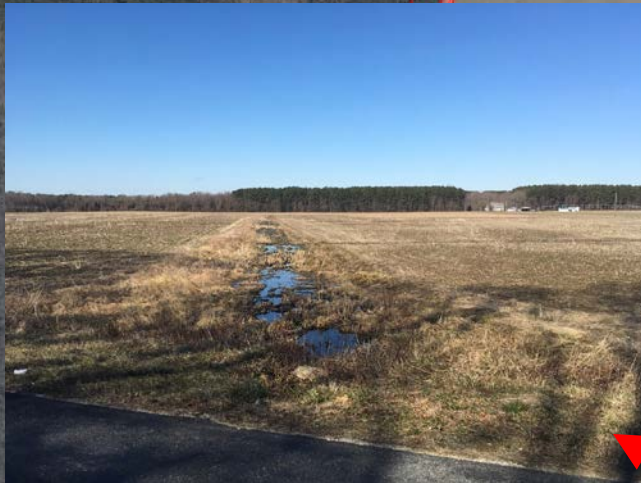
Polygon_BMPs: 135,317

BMPID	135,317
STATUS	Meets Standard
NOTES	Waterway 99-1836
INSPECTION_DATE	3/5/2019
admin	
admin_type1	
admin_type2
