Restoring One of America's Greatest Rivers

-Elizabeth River -

Money Point – A Story of Environmental Restoration

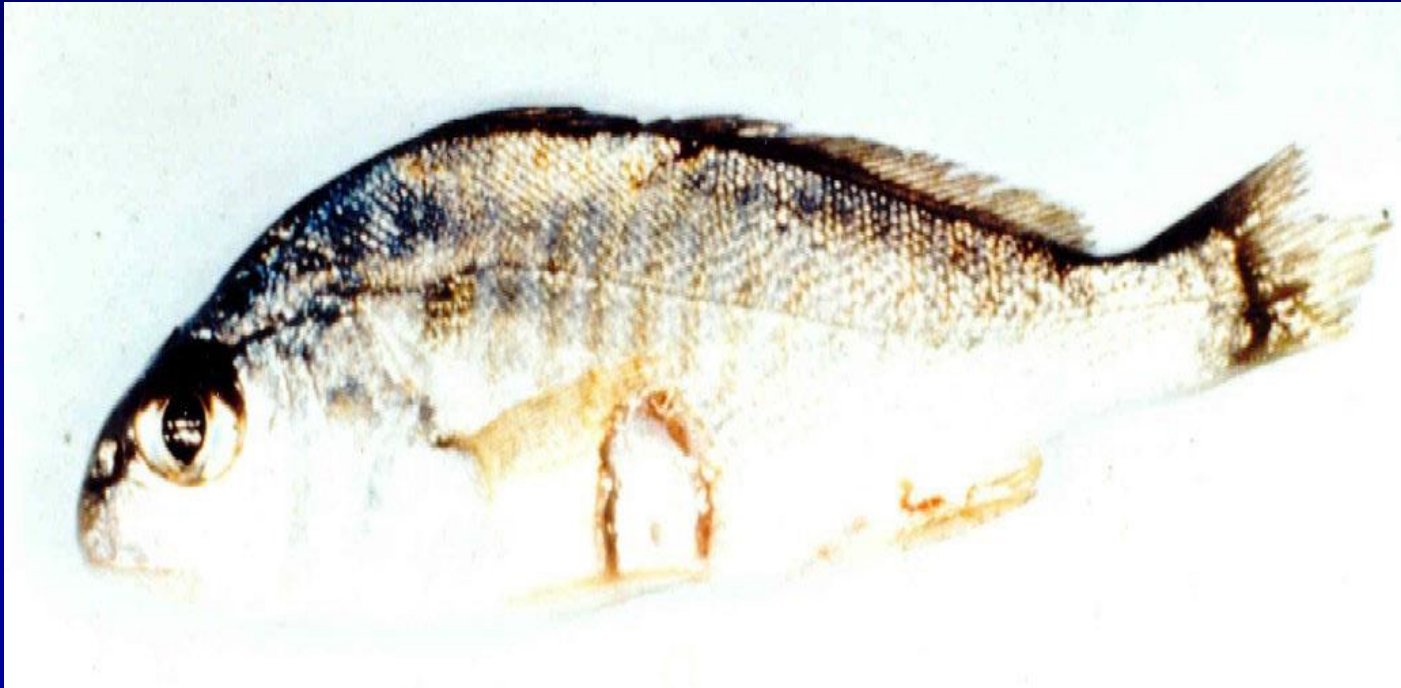
Elizabeth River Sediments

**Contamination from PAH - highest in
the Chesapeake Bay**
(463 times average for bay)

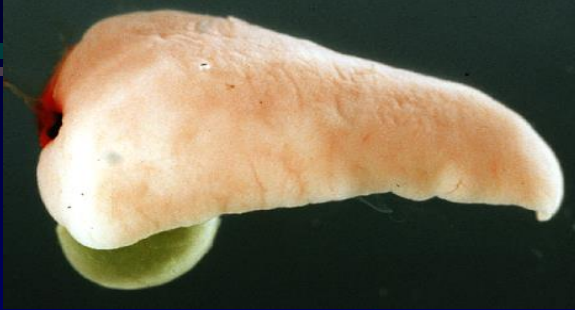
Healthy Mummichog Liver

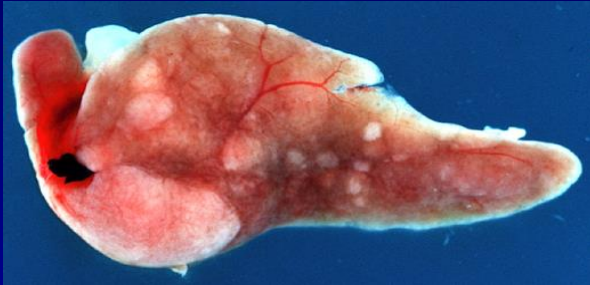
Pre-Cancerous Mummichog

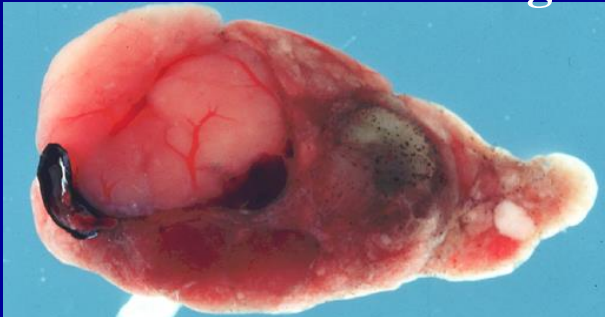
Cancerous Mummichog Liver

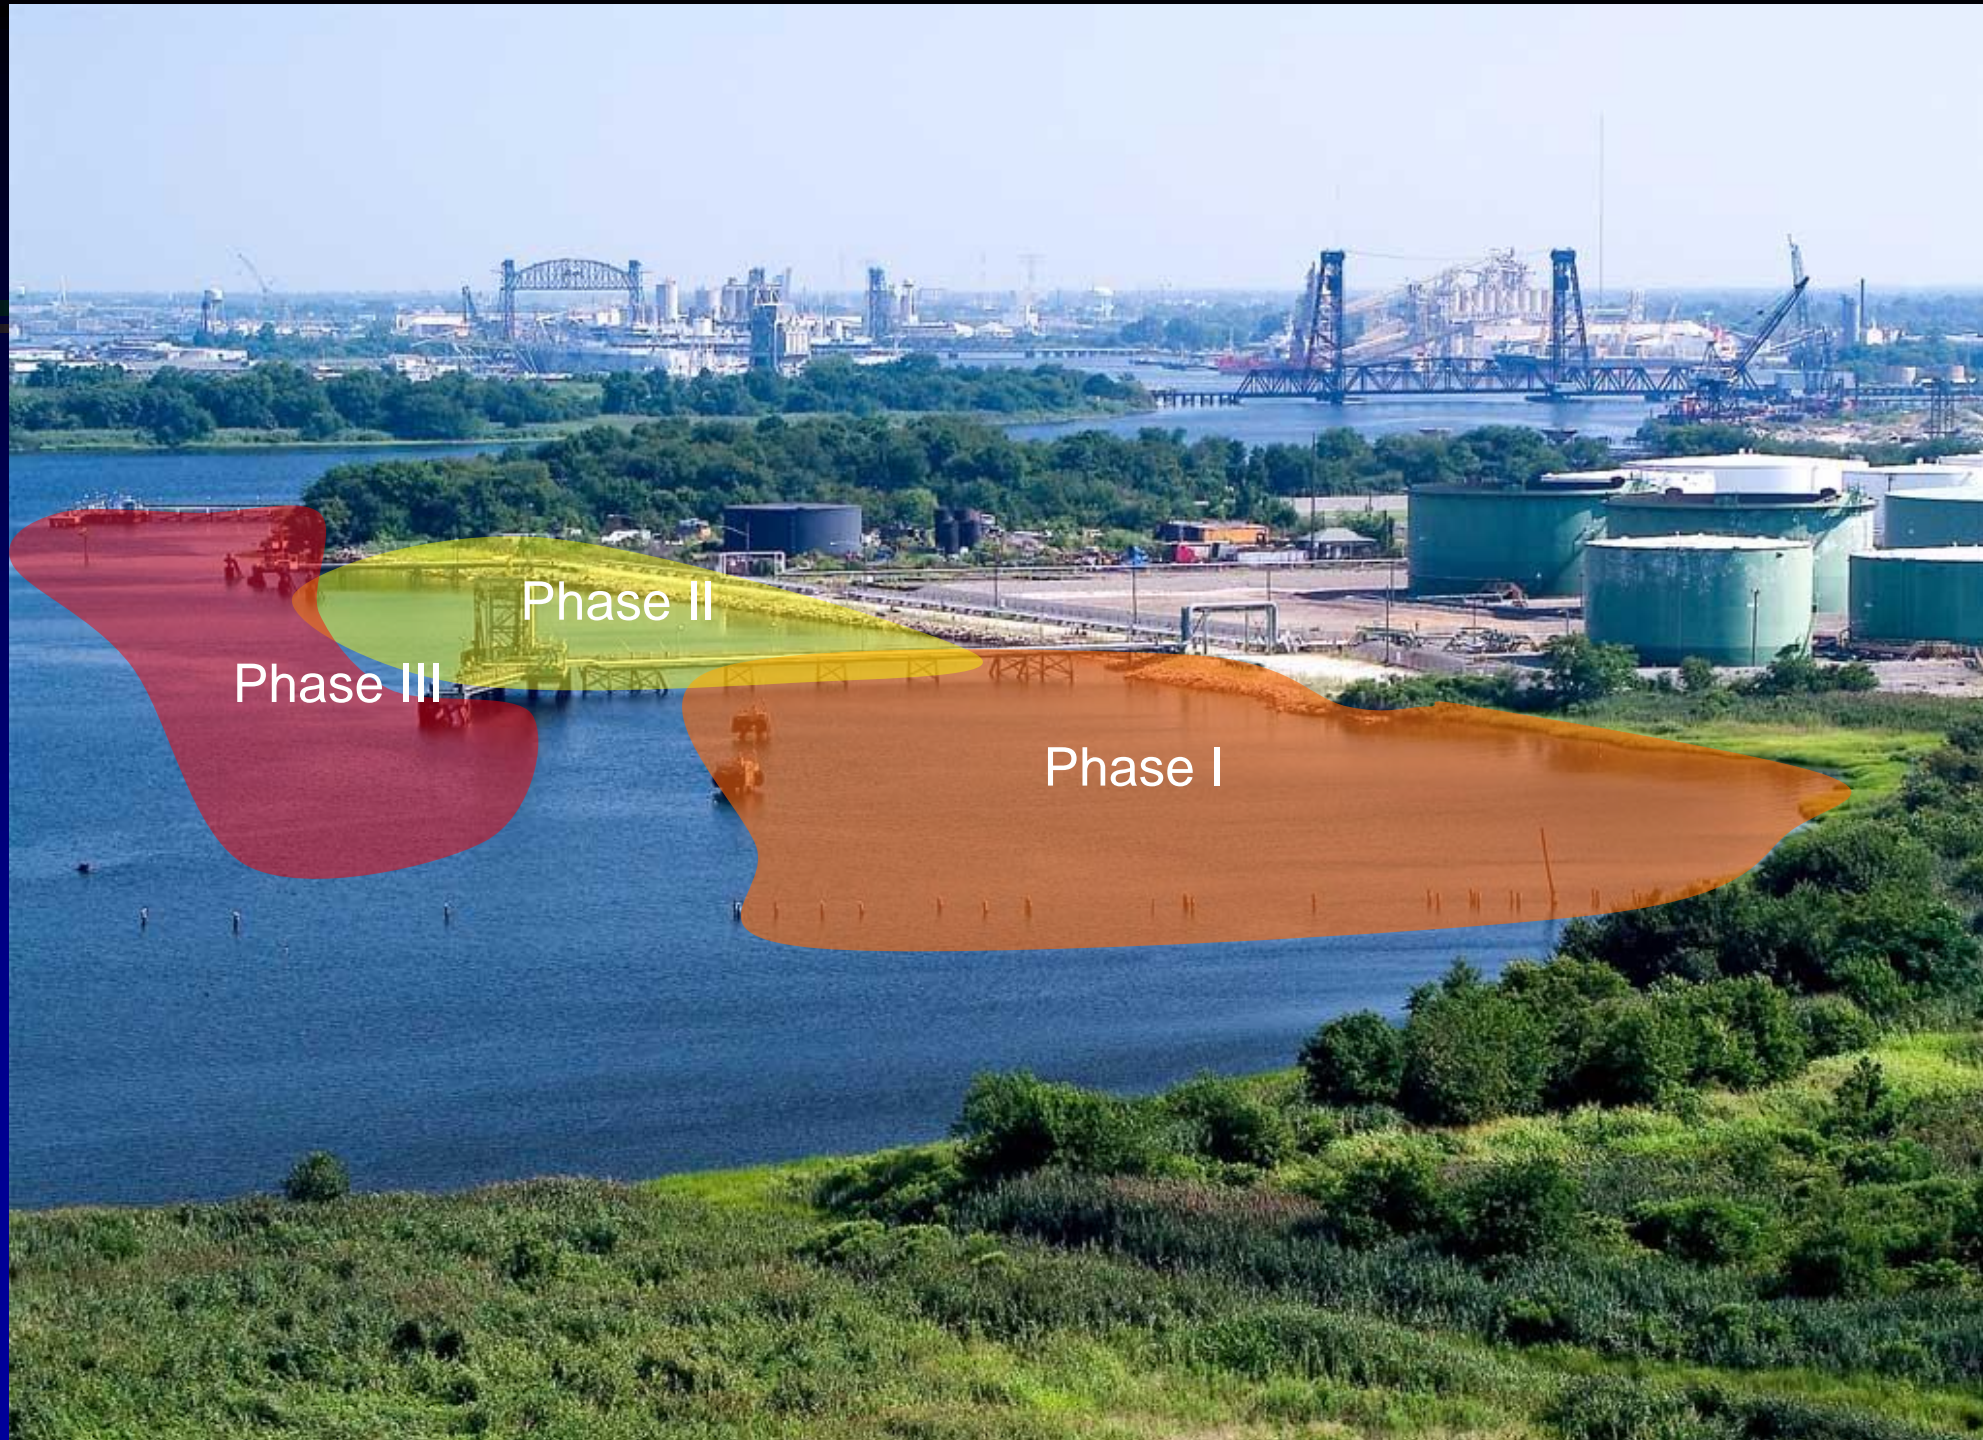
Phased Approach

Phase III

Phase II

Phase I

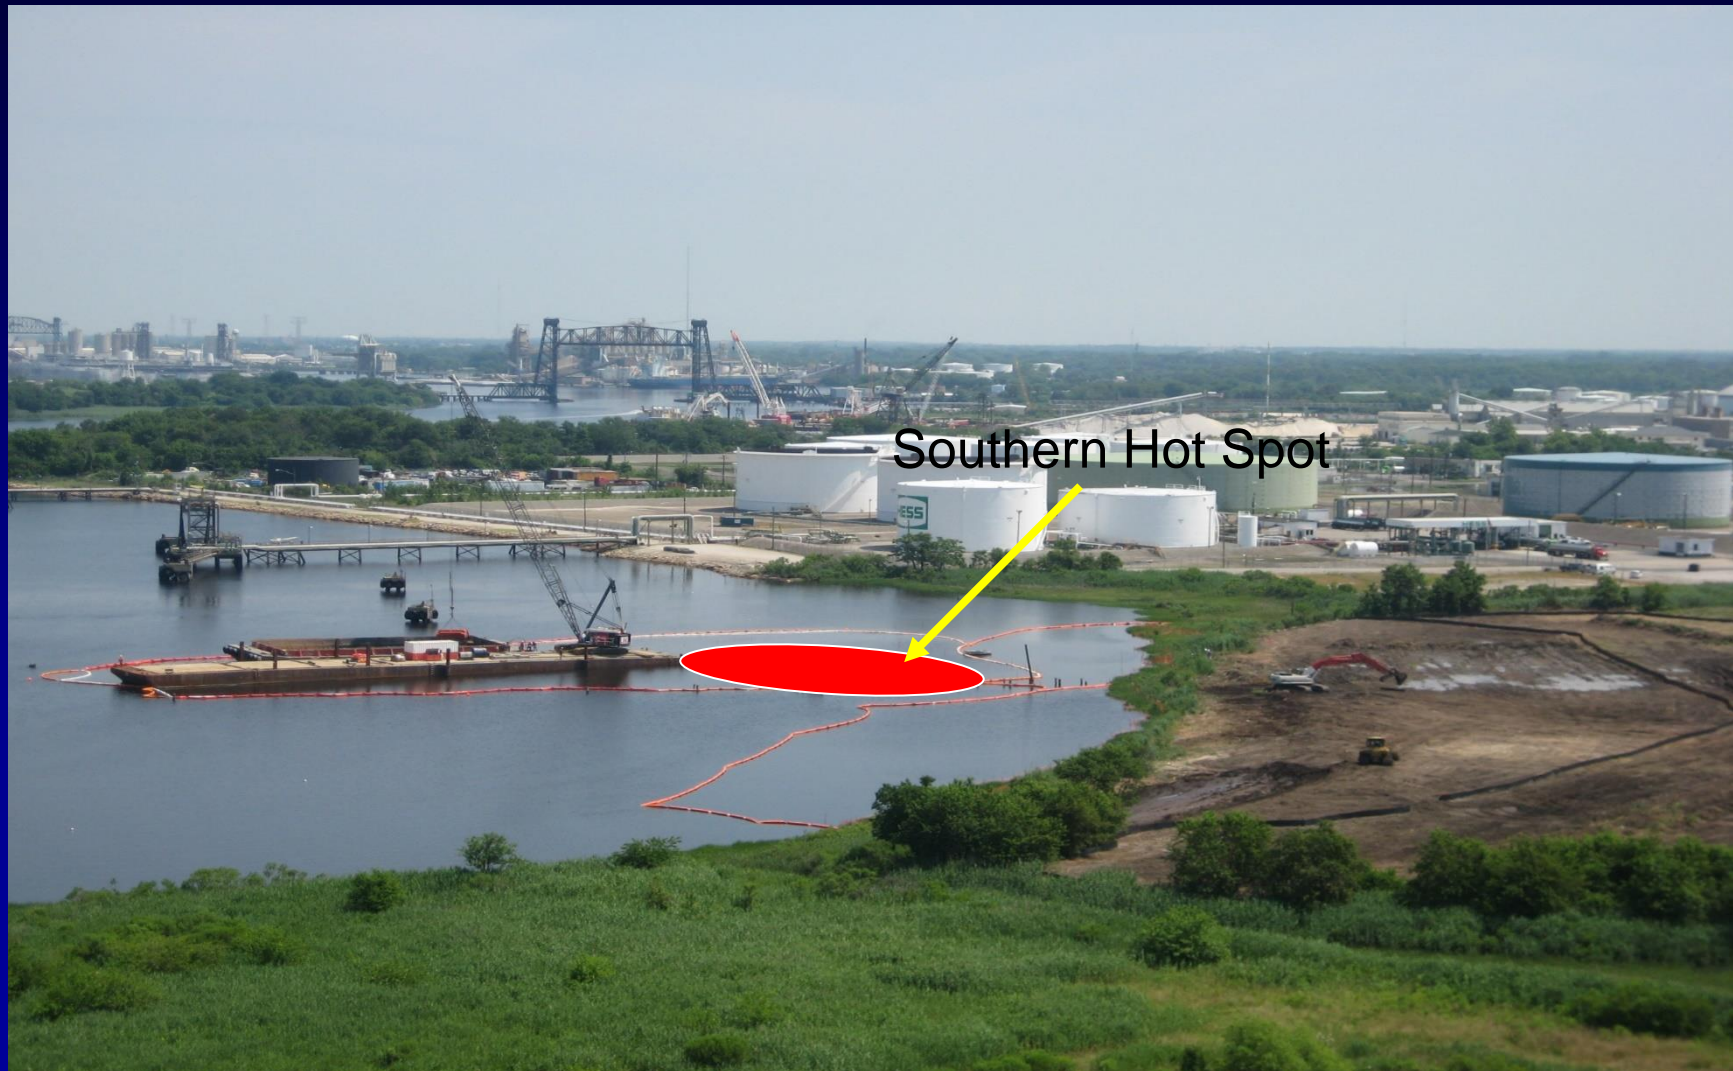
Phase I - Dredging

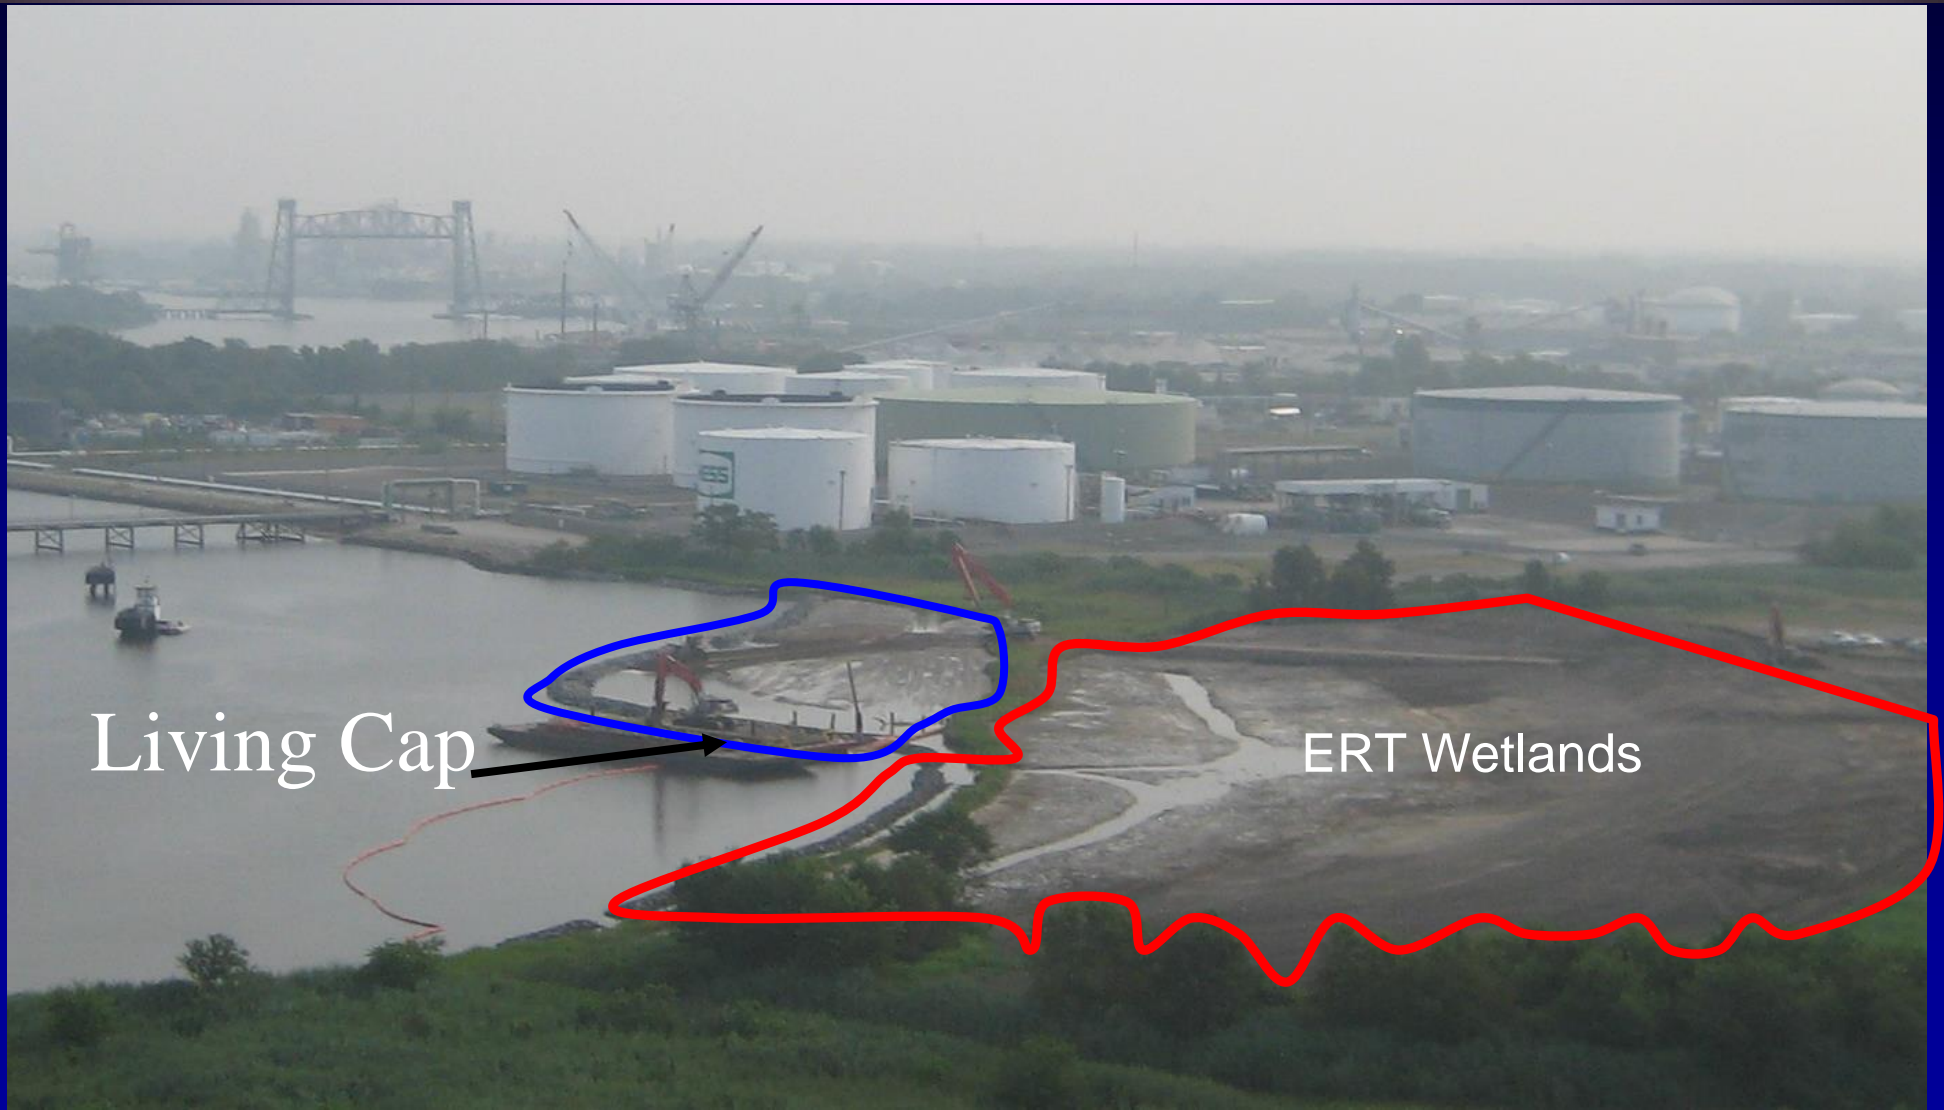
Phase I - Living Cap and Wetlands Restoration

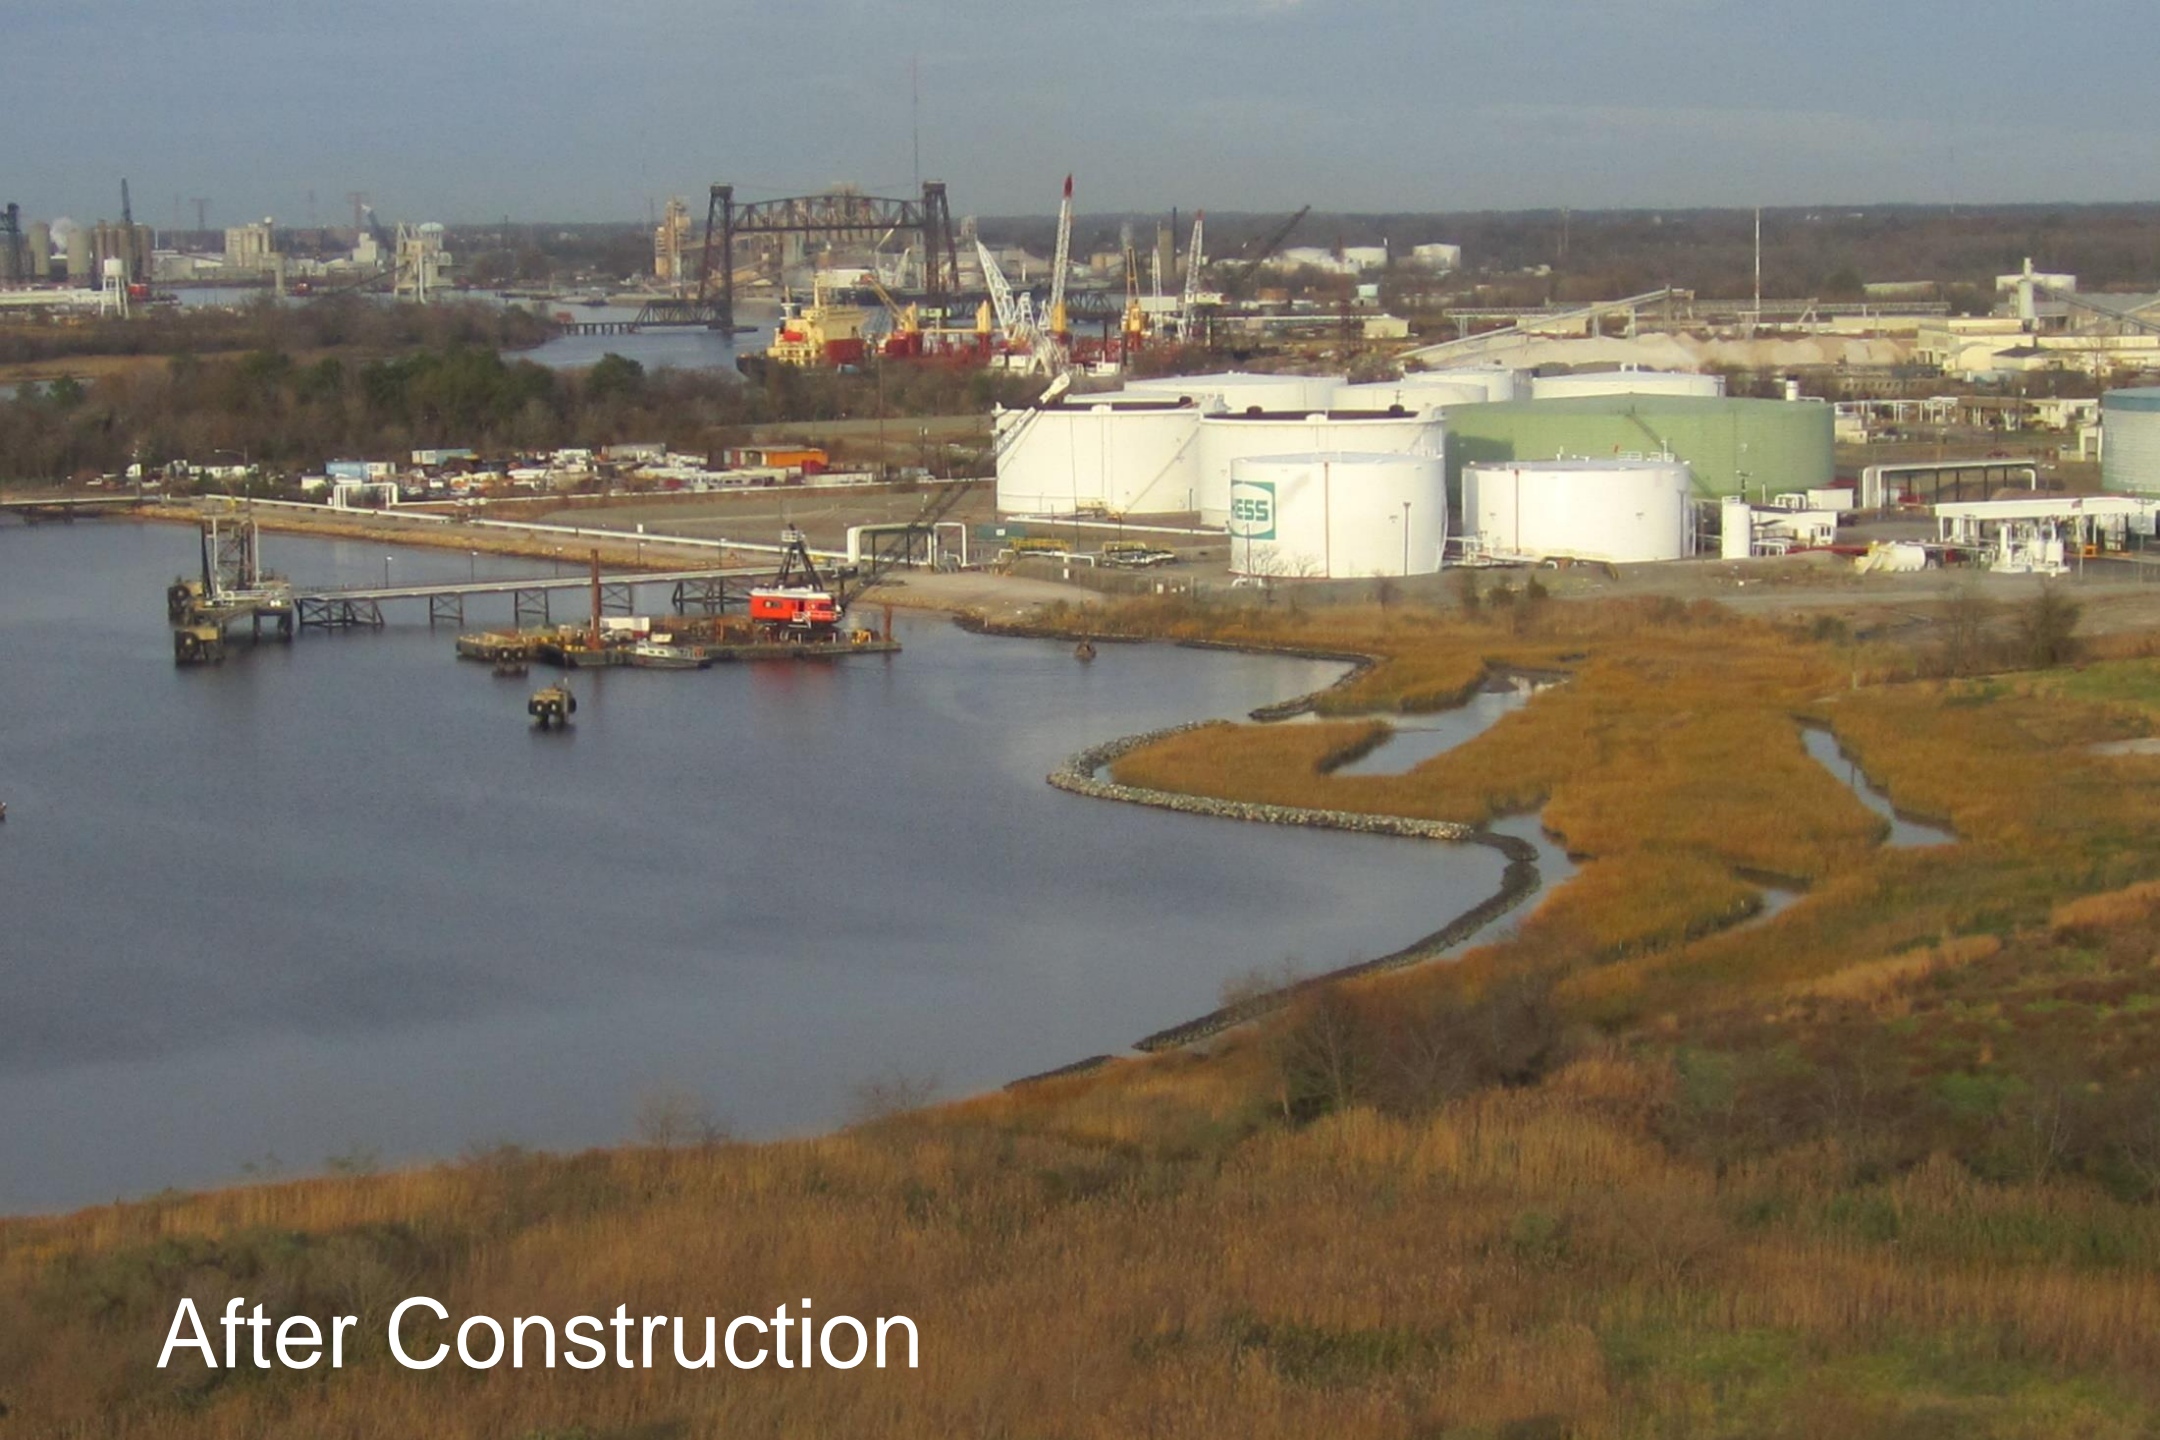
Living Cap

ERT Wetlands

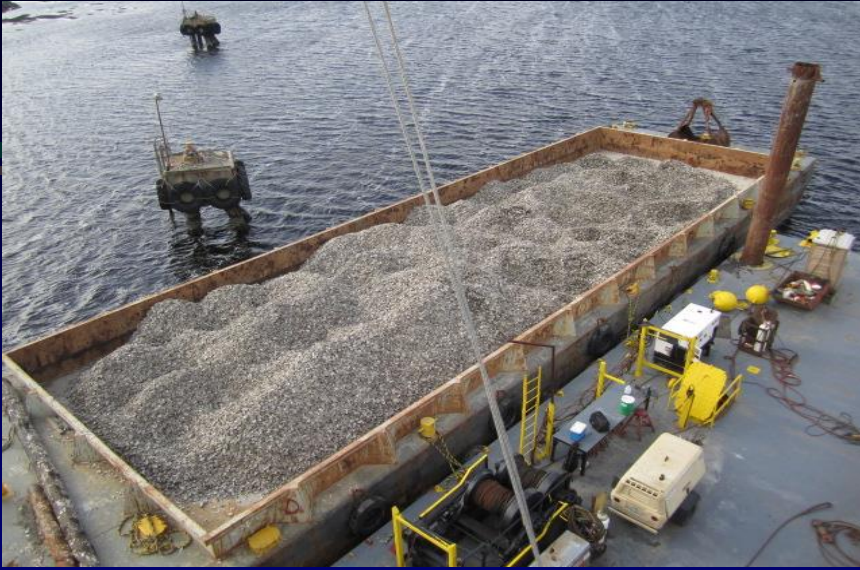
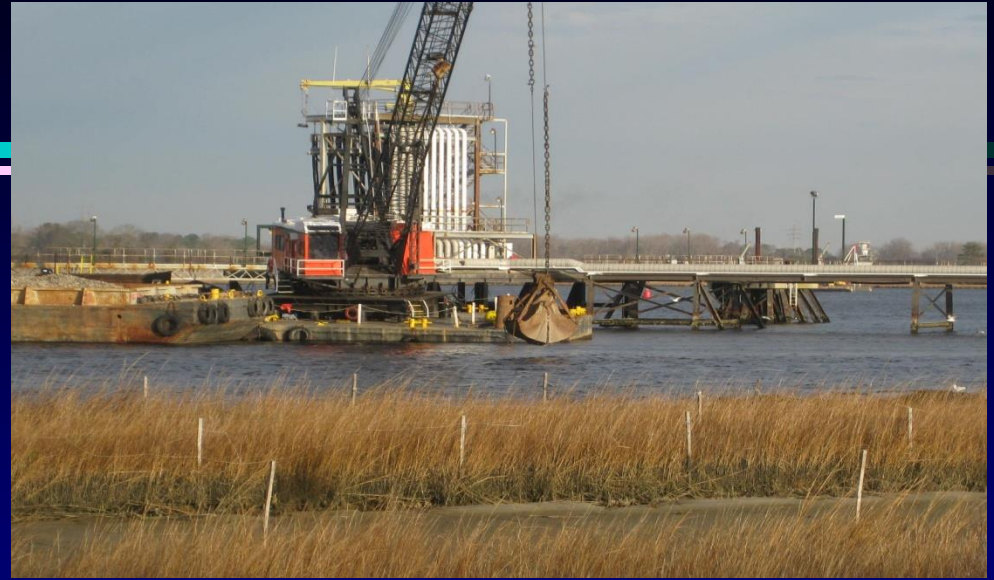
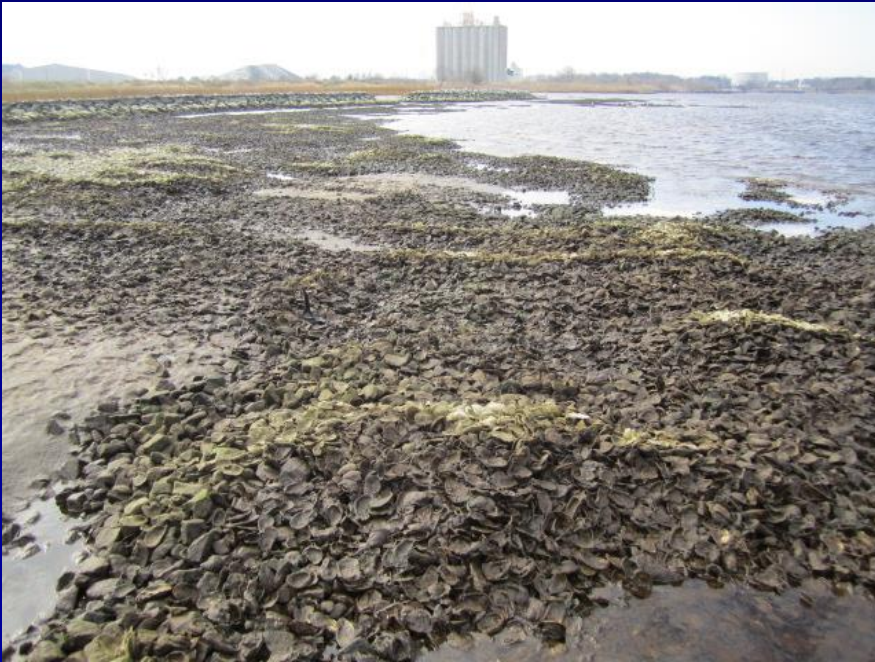
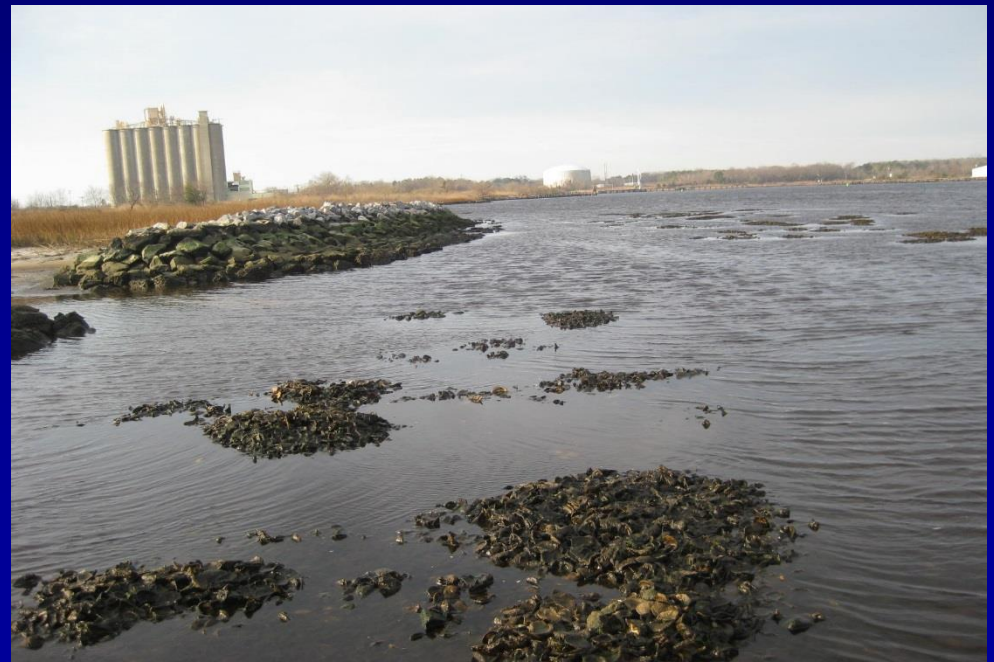
After Construction

Sand Cap With Oyster Reef

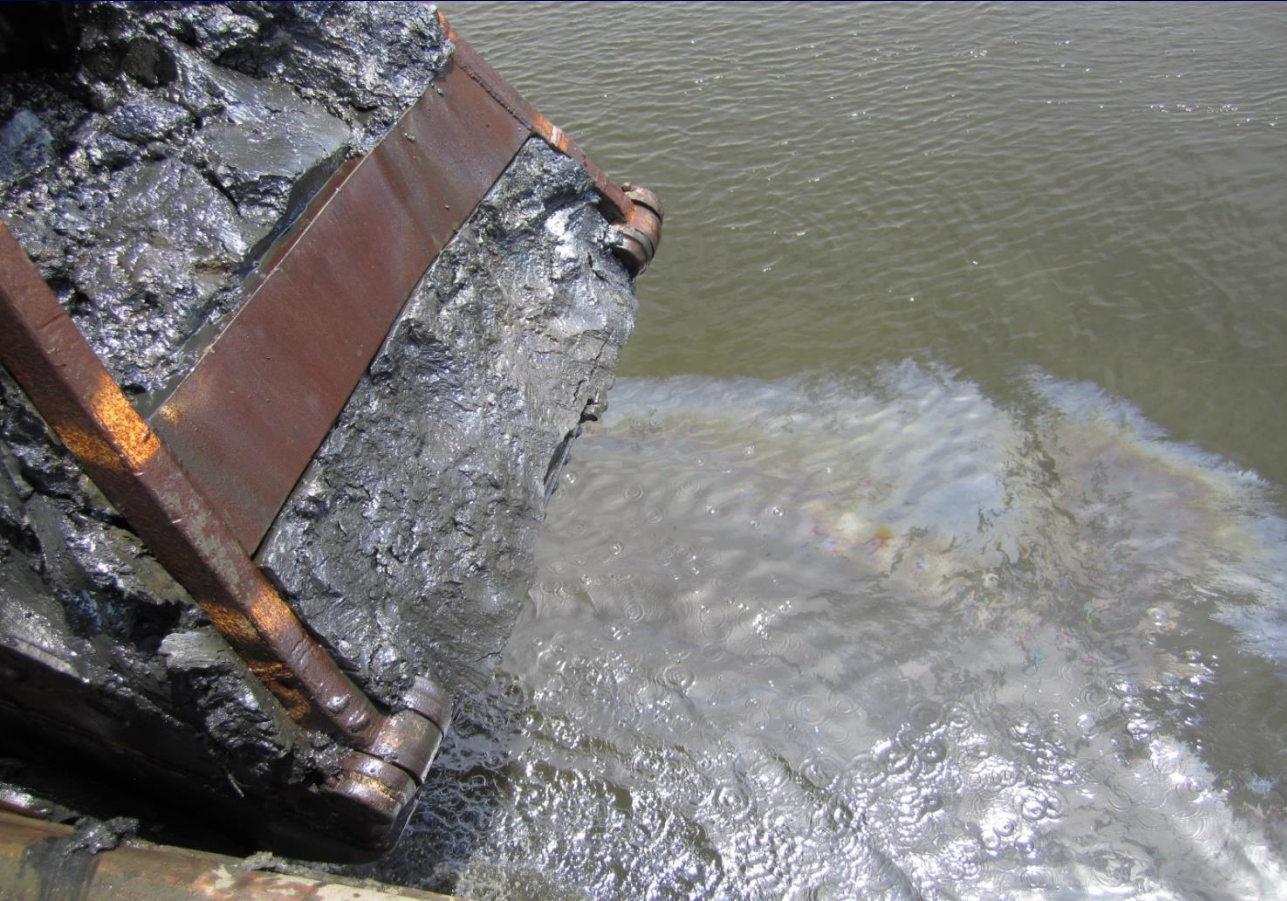
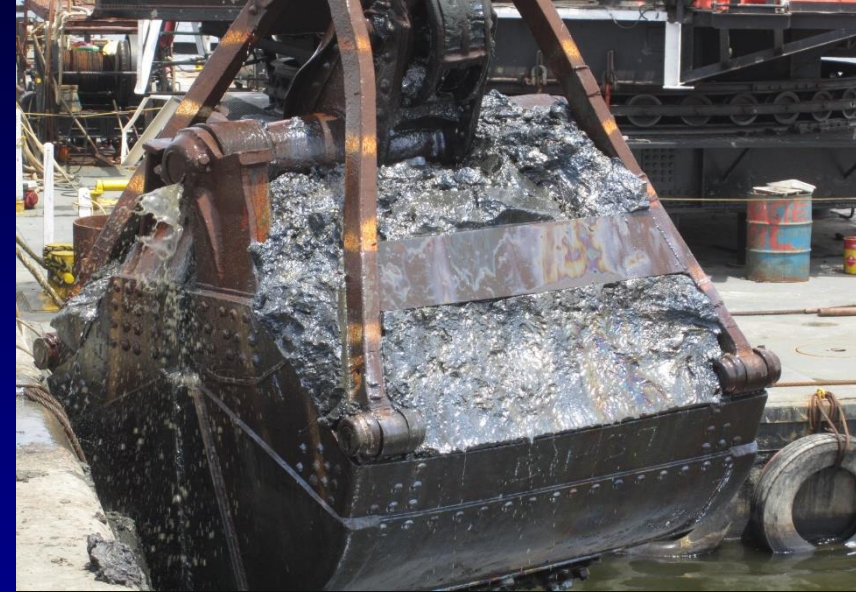
Phase II Dredging of 15,000 cy

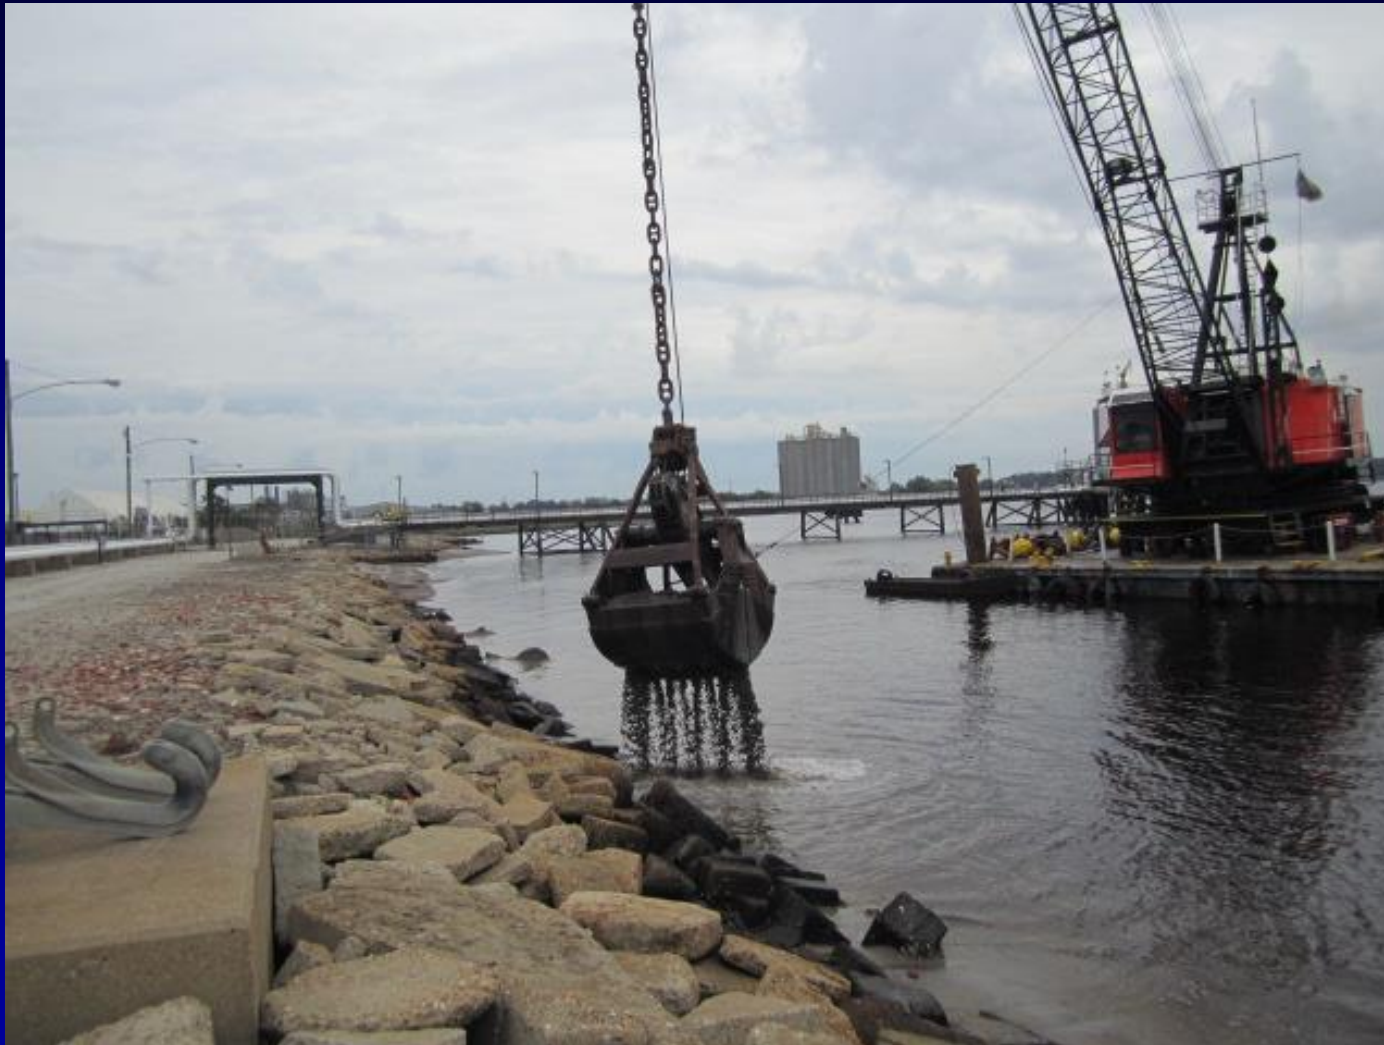
Phase II - Clean Sand Placed

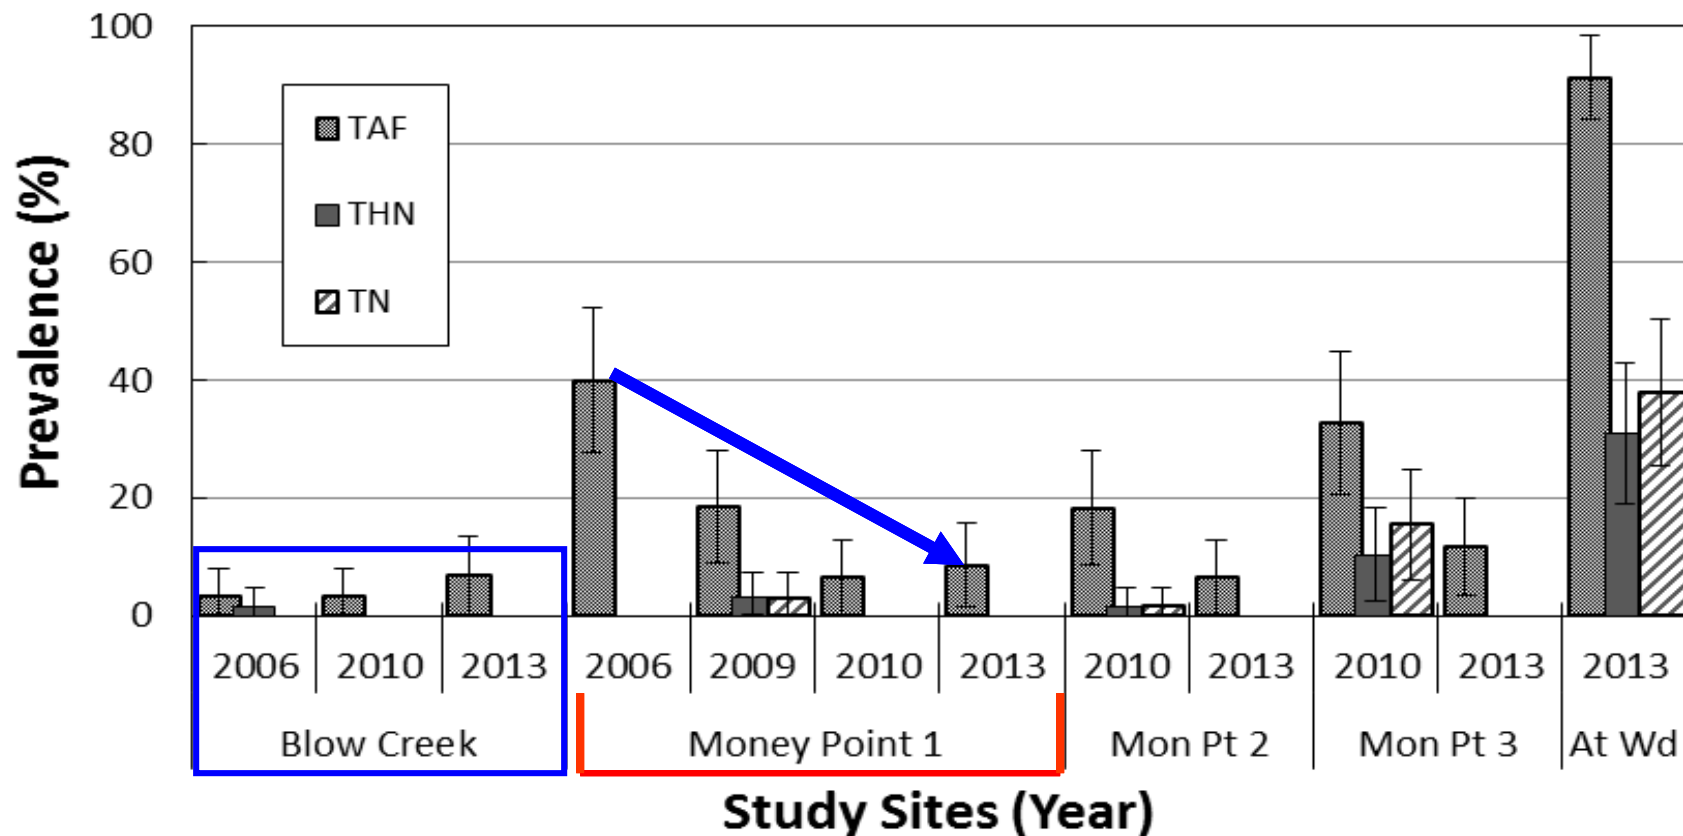
Mummichog Monitoring Results

Liver Lesion Prevalence: Money Point

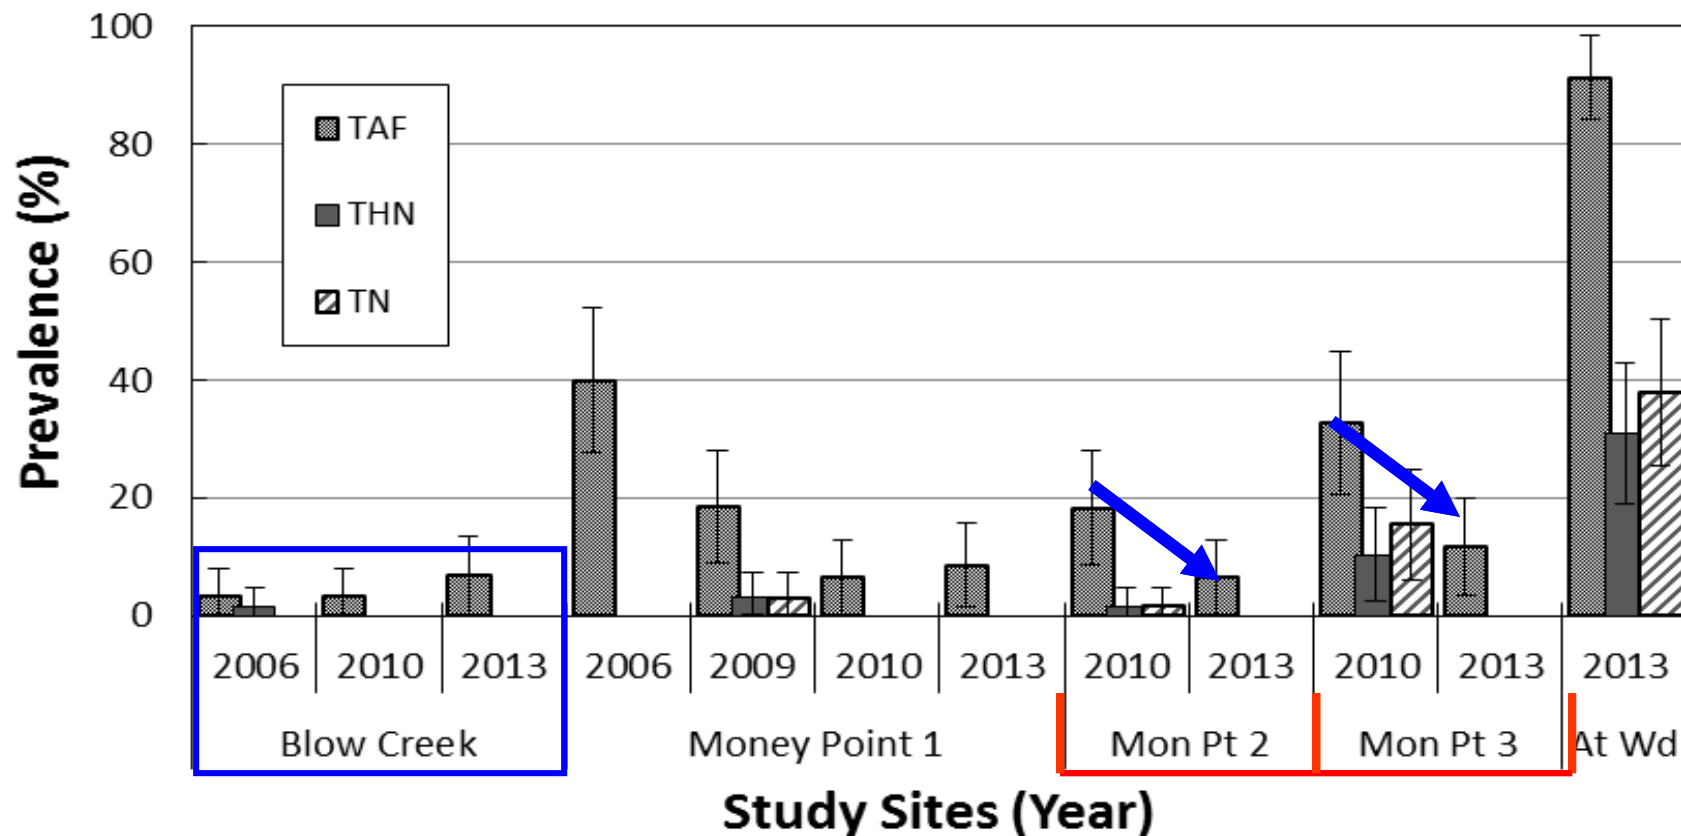
Mummichog Monitoring Results

Liver Lesion Prevalence: Money Point

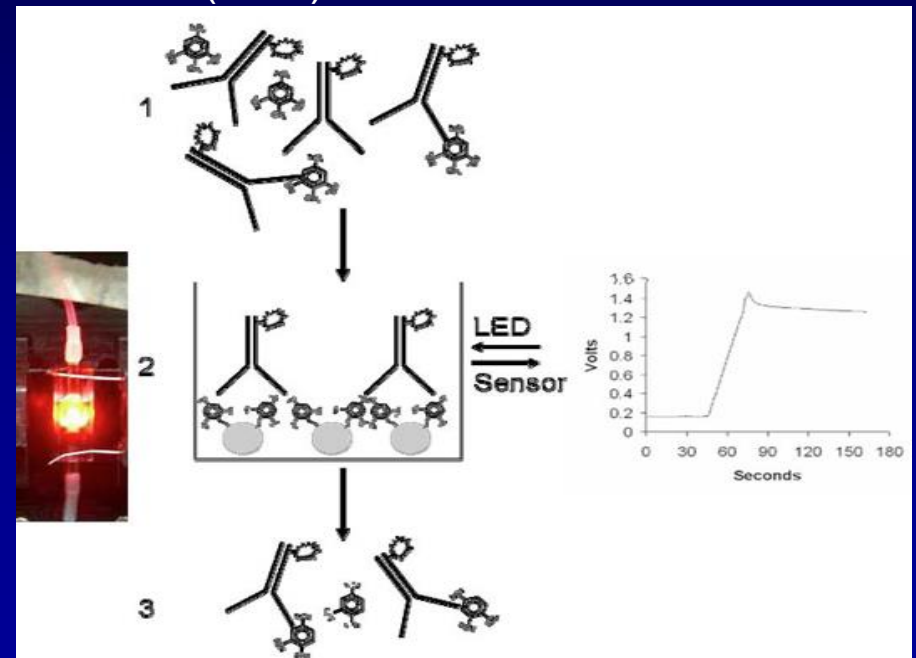
Inline Sensor

KinExA Inline Sensor

Fluorescence detection, rapid (minutes), quantitative, sub-ppb from small sample volume (1mL)

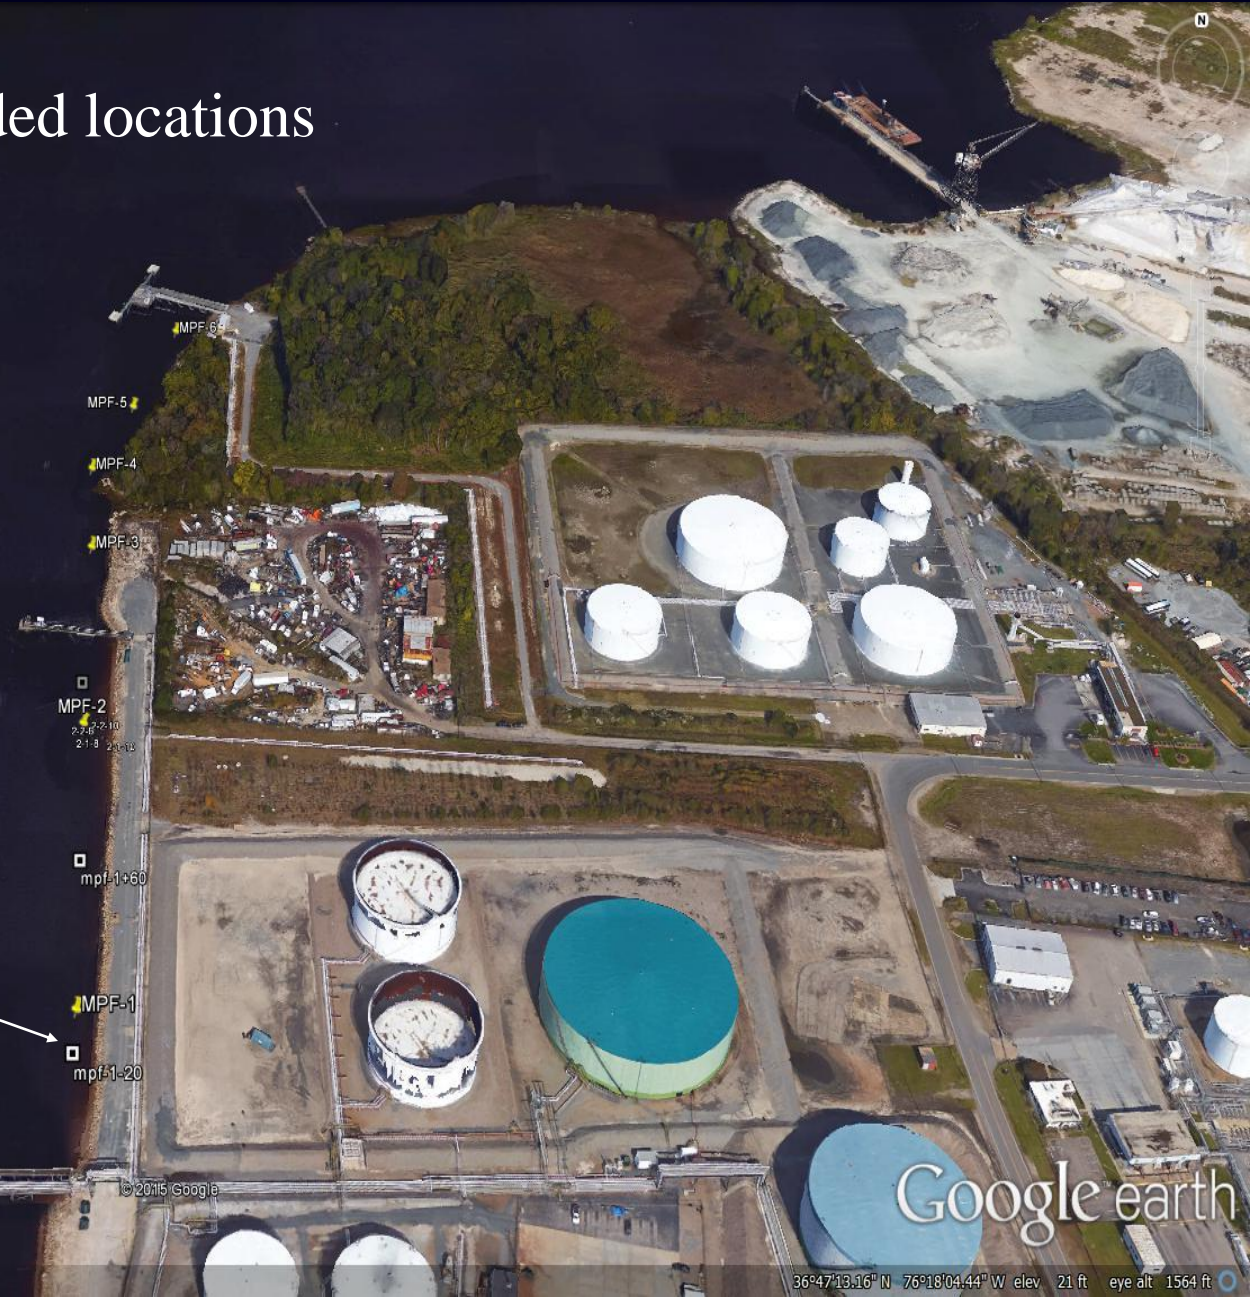
PAHs in Groundwater

Seepage meters at 6 recommended locations

Seepage Meter	Position	
Station Id	Latitude	Longitude
MPF-1	36°47' 7.77"N	76°18' 5.58"W
MPF-2	36°47' 11.90"N	76°18' 5.82"W
MPF-3	36°47' 15.25"N	76°18' 5.95"W
MPF-4	36°47' 17.07"N	76°18' 6.09"W
MPF-5	36°47' 18.62"N	76°18' 5.40"W
MPF-6	36°47' 20.68"N	76°18' 4.63"W
