Restoring One of America's Greatest Rivers

-Elizabeth River -

Money Point – A Story of Environmental Restoration

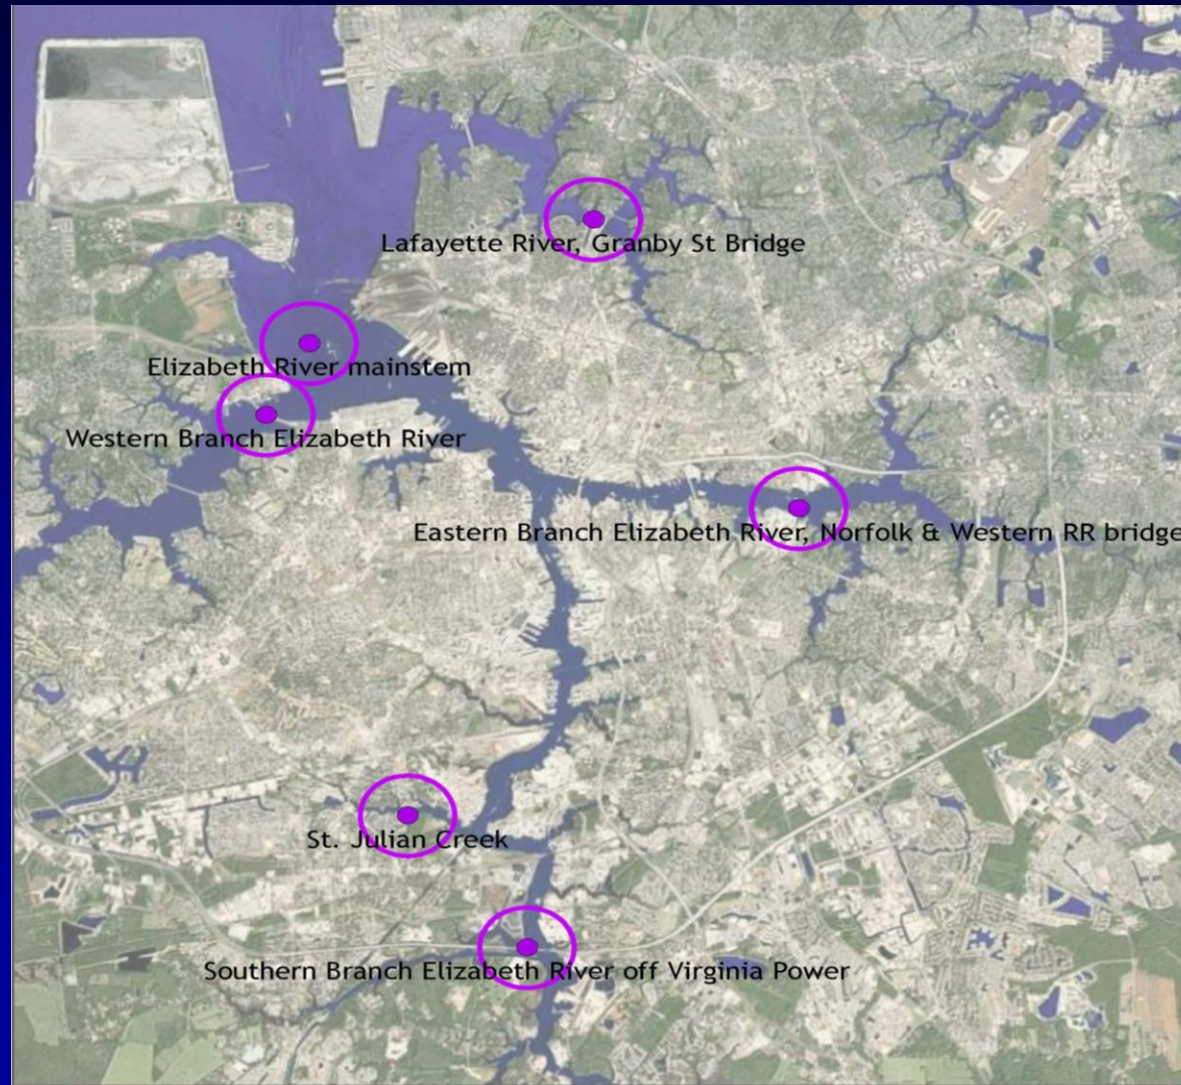
Sample Locations

Above DEQ screening value (20 ppb)
Above VDH lower limit of concern (50 ppb)
Above VDH upper limit of concern (500 ppb)
