Marsh Loss in the Maryland Coastal Bays And Restoration Efforts to Reverse the Loss

**Rich Mason- US Fish and Wildlife Service
Chesapeake Bay Program, Wetland Workgroup
August 17, 2021**

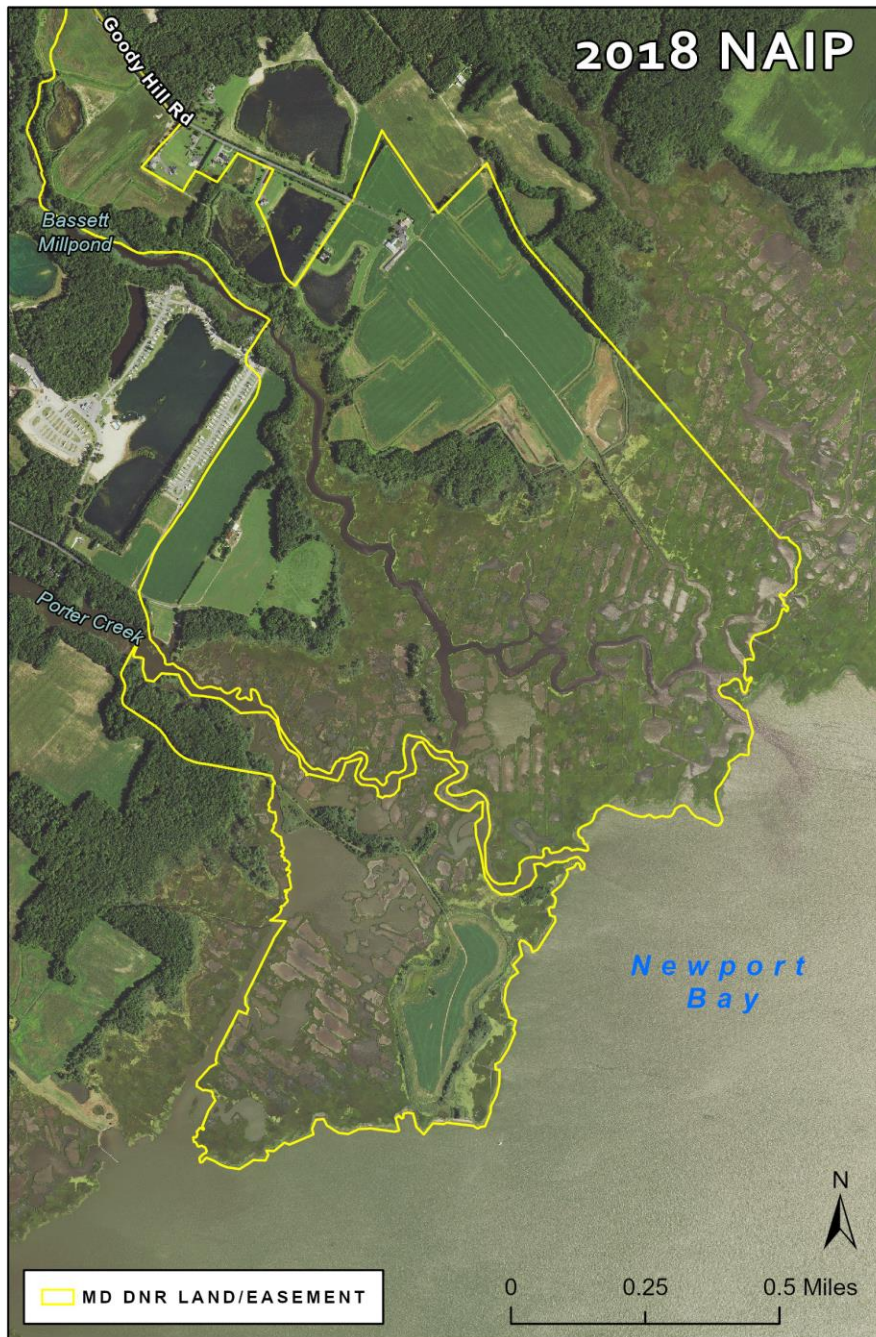
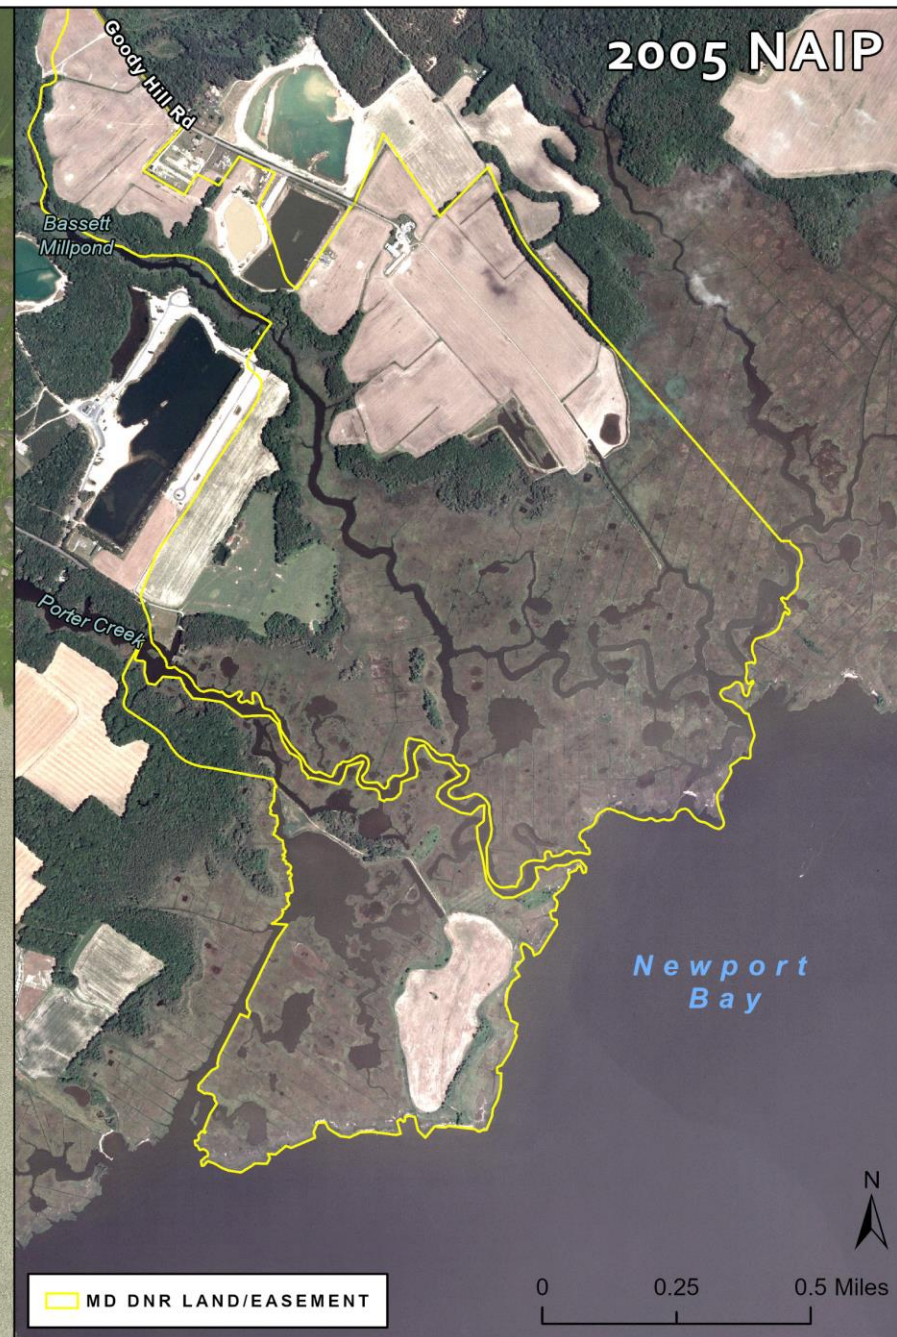
Coastal Marsh in Virginia

Natural Drainage Patterns

Natural Marsh drainage

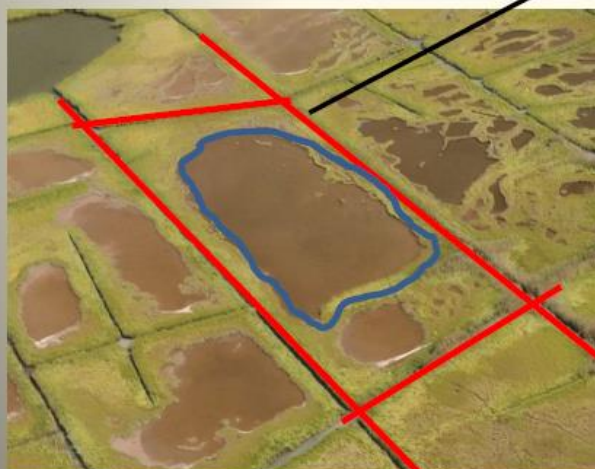
Ditched Marsh Panne Formation

Problem – Marshes have mosquito ditches that are linear and often grid ditched, no meanders; SLR and sediment issues allow pannes Marsh turns into a 'waffle'

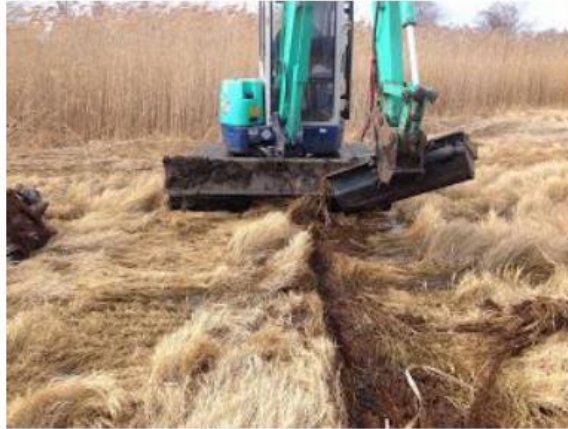
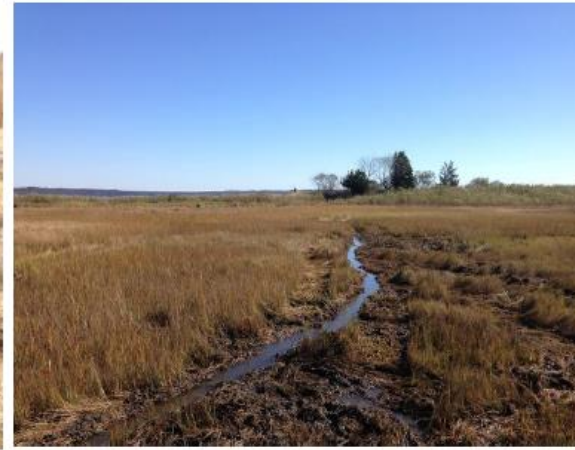
small runnels

Runnel range of profiles

6-8"

10"

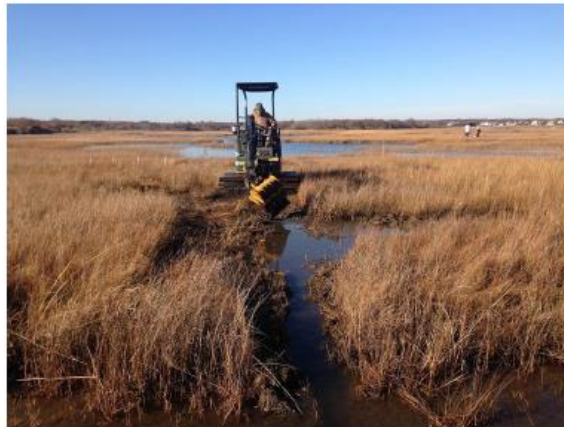
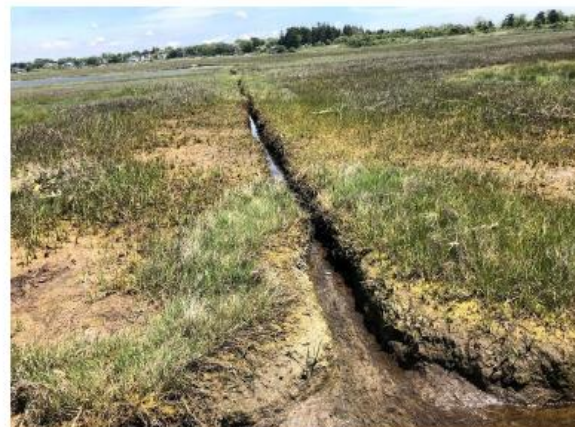
large runnels

12"

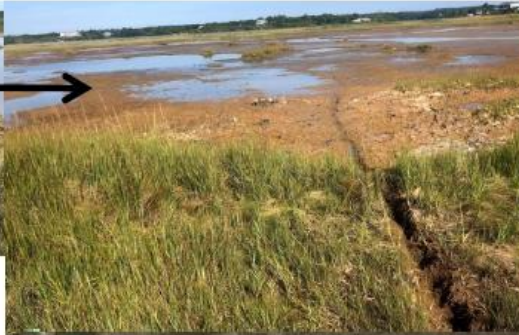
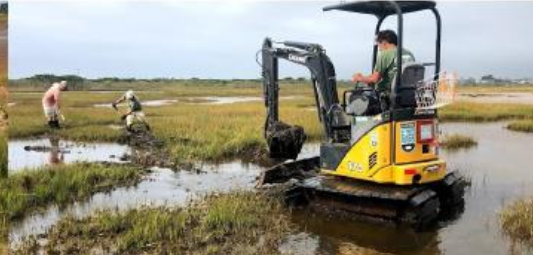
Conduct project in phases; shallow drainage can prevent loss of sediment and reduce loss of elevation

Runnel excavation by hand in summer of 2018

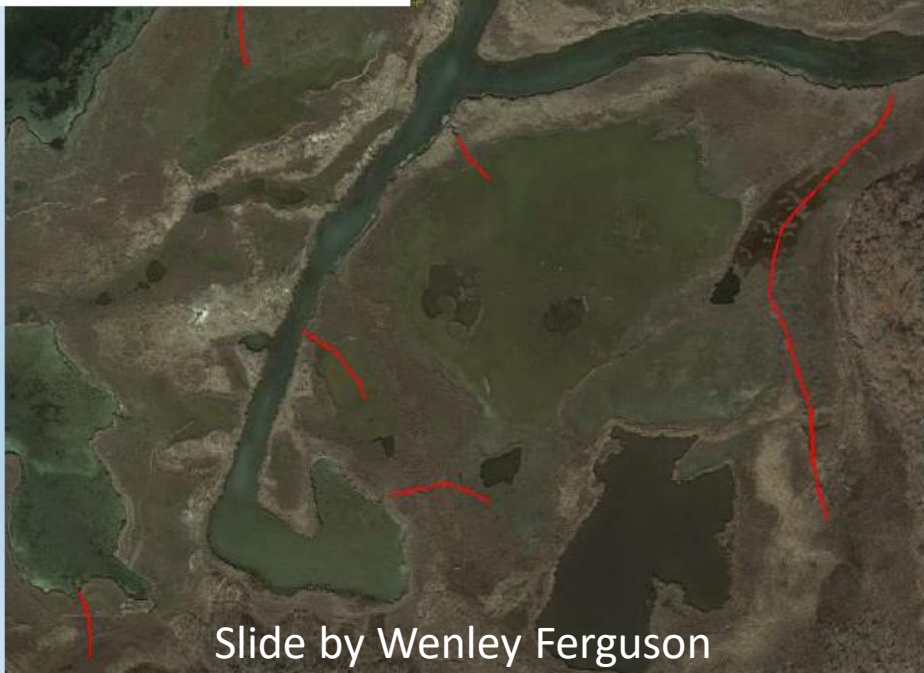
Creek excavation in fall of 2018 with low ground pressure excavator

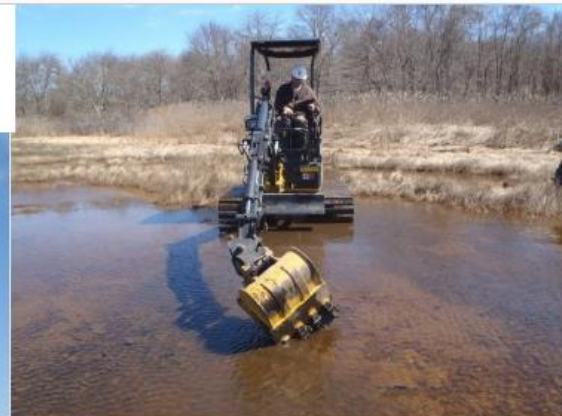
Narrow River runnels: *Use excavated peat to create microtopography*

Peat island with *S. patens*

Runnel

Runnels in upper marsh had greater recolonization than lower elevation areas

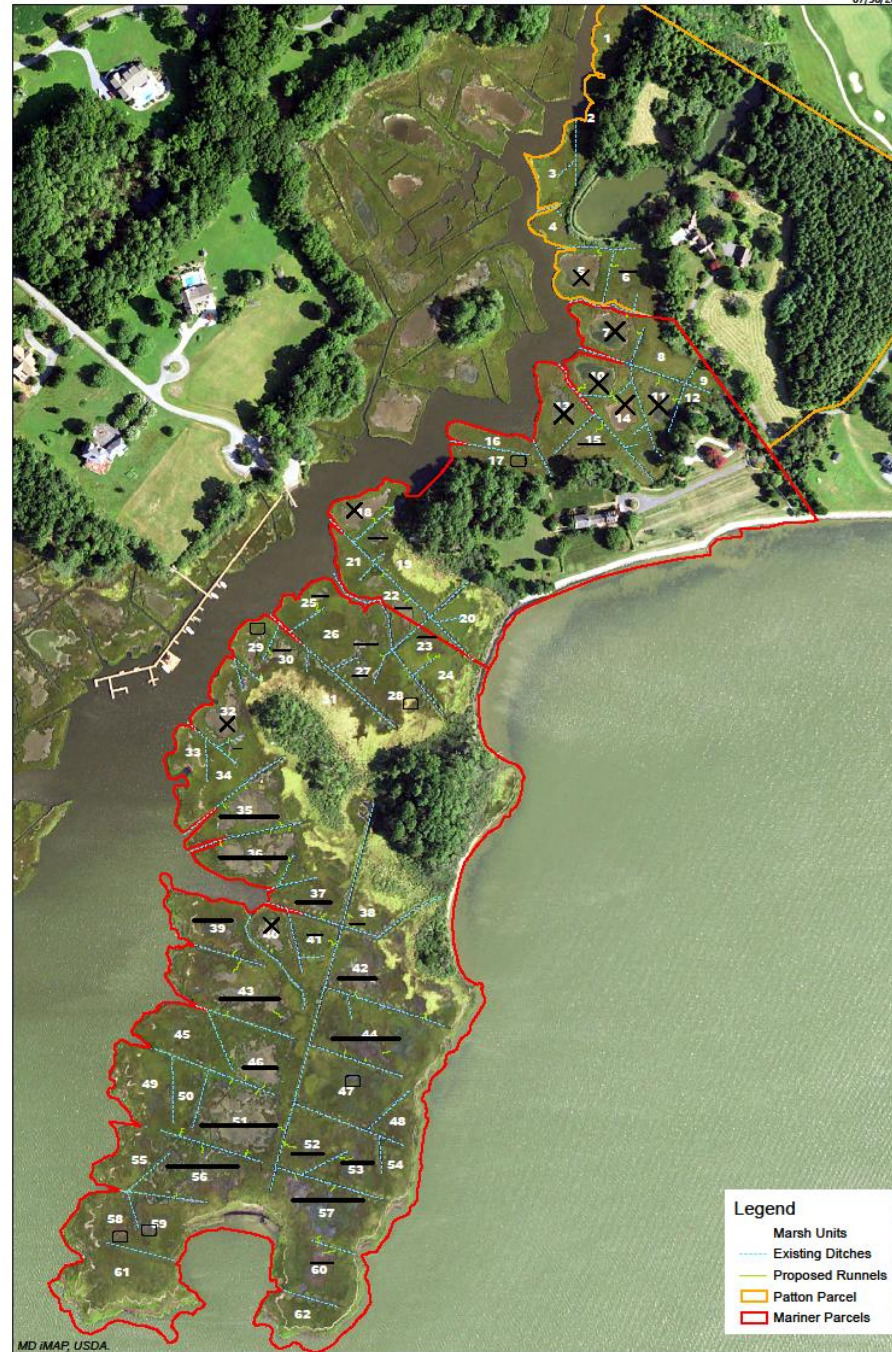
Deal Island WMA

Grid Ditching
