2019 Oyster Reef Monitoring Report

Analysis of Data from Large-Scale Sanctuary Oyster Restoration Projects in Maryland Collected from Fall 2019 through Summer 2020

December 2020

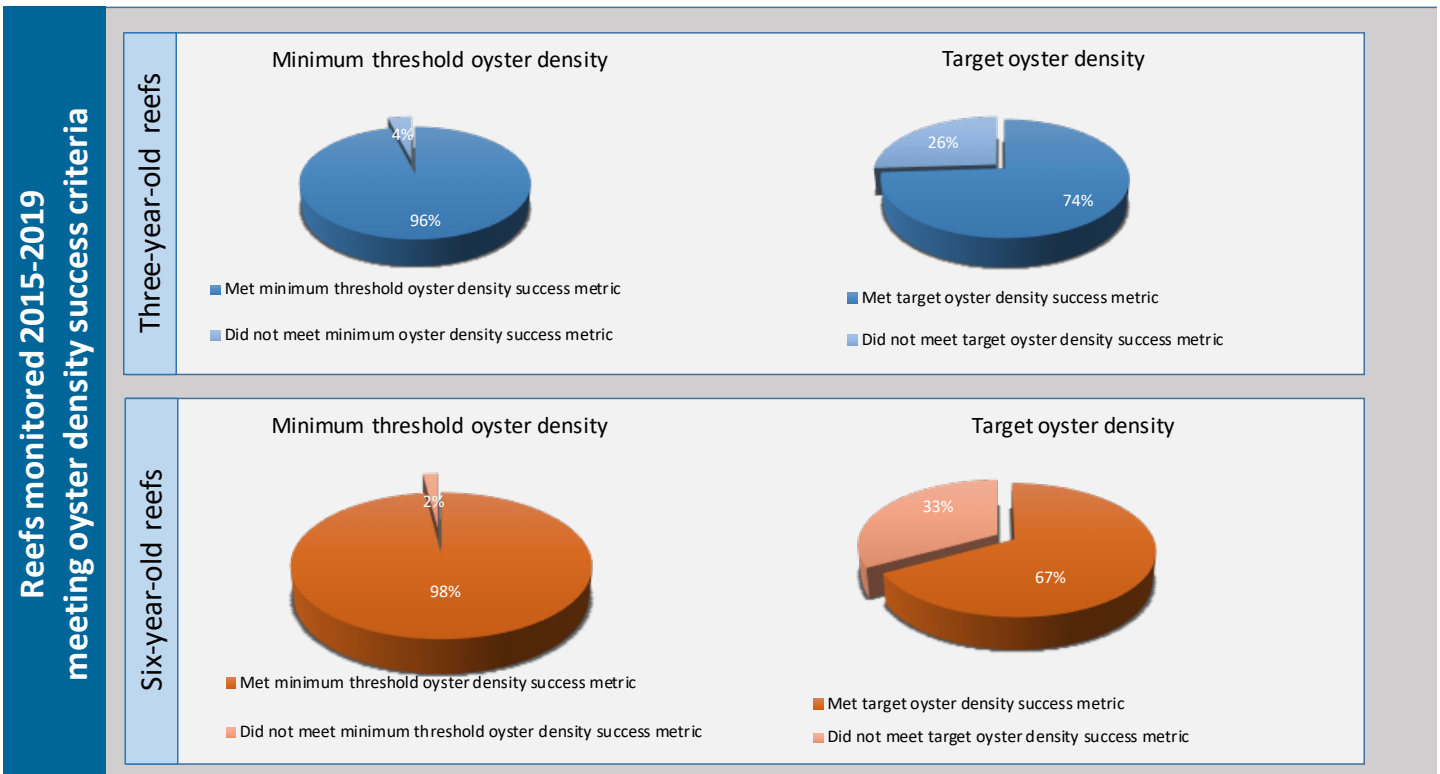
- The figure below shows the percentage of all three-year-old and six-year-old restored reefs monitored to date that meet the oyster density minimum threshold (15 oysters per m²) and target (50 oysters per m²) success criteria.

- More than 96% of all restored reefs monitored in 2015-2019 met the minimum threshold oyster density success criterion, and more than 65% met the ideal target oyster density. Oyster density tracked closely with oyster biomass.

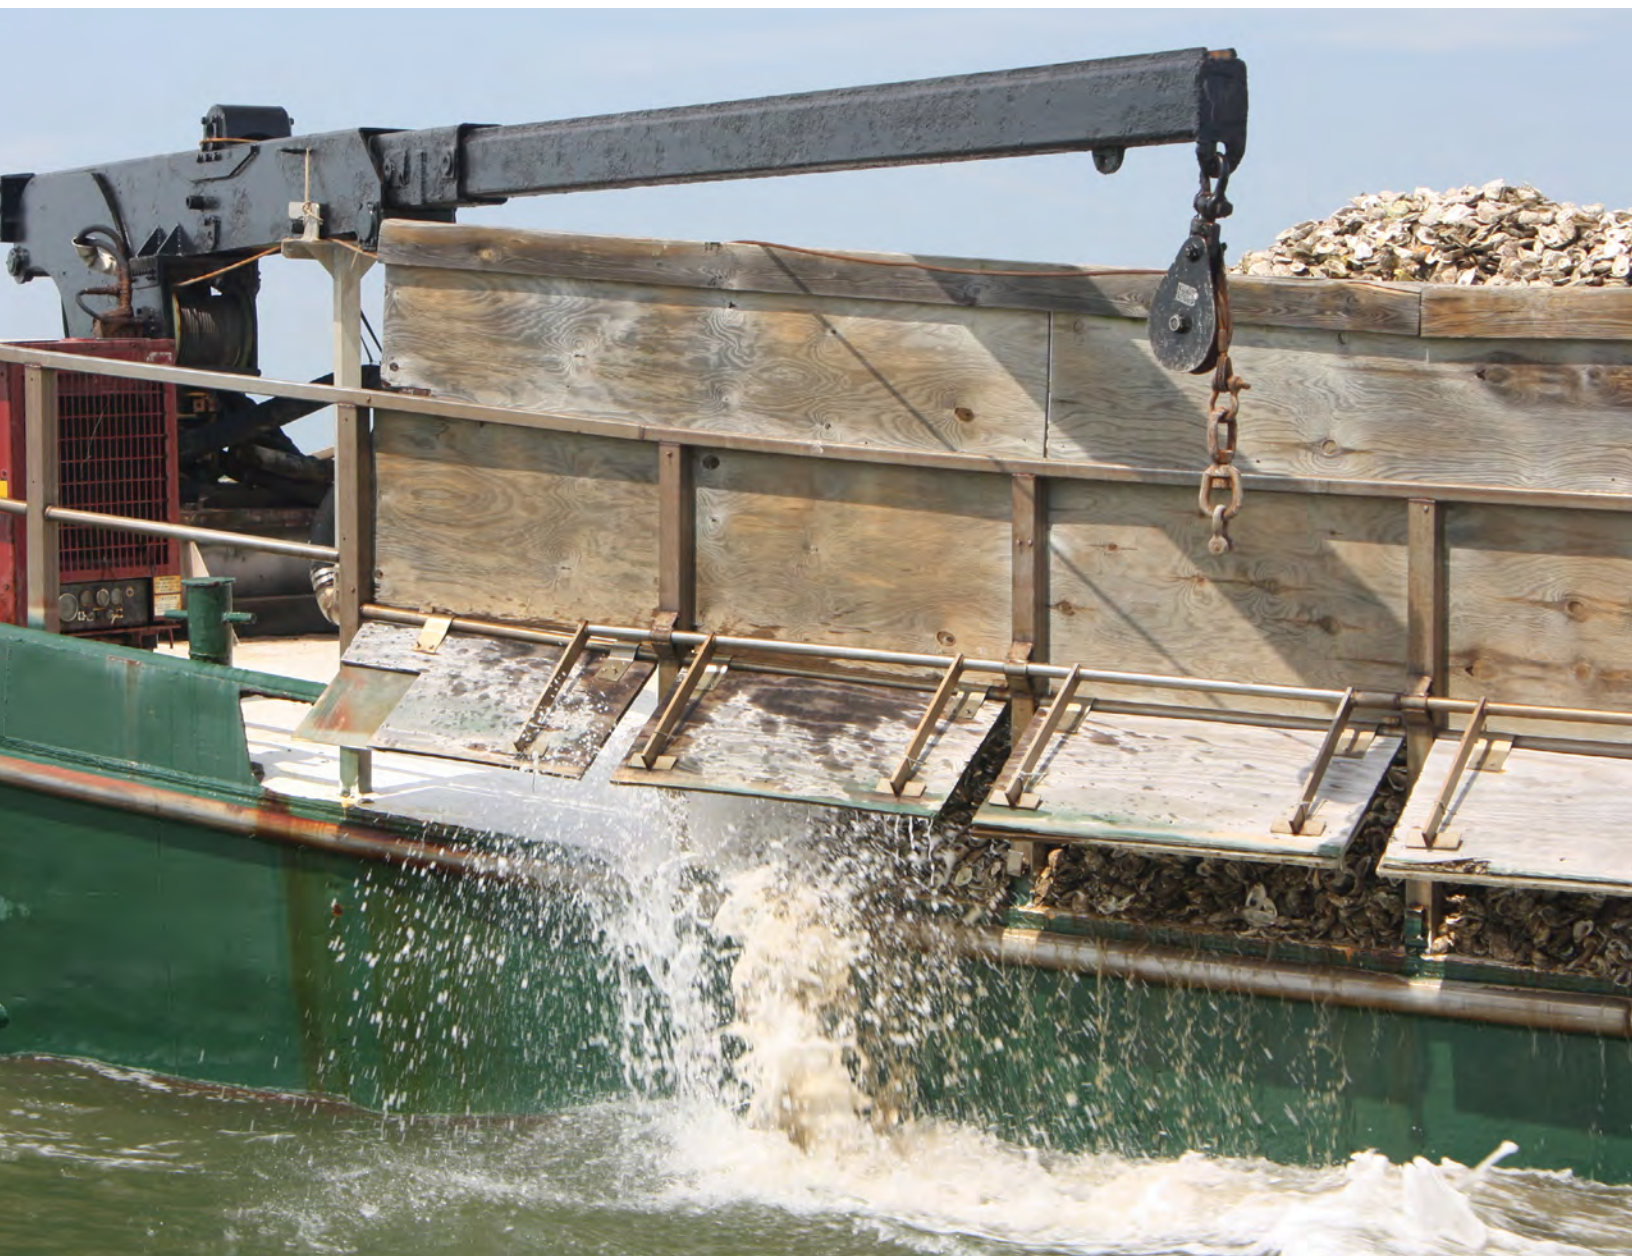
***Planting spat-on-shell in Harris Creek from the Oyster Recovery Partnership's Robert Lee.
Photo: NOAA Chesapeake Bay Office.***

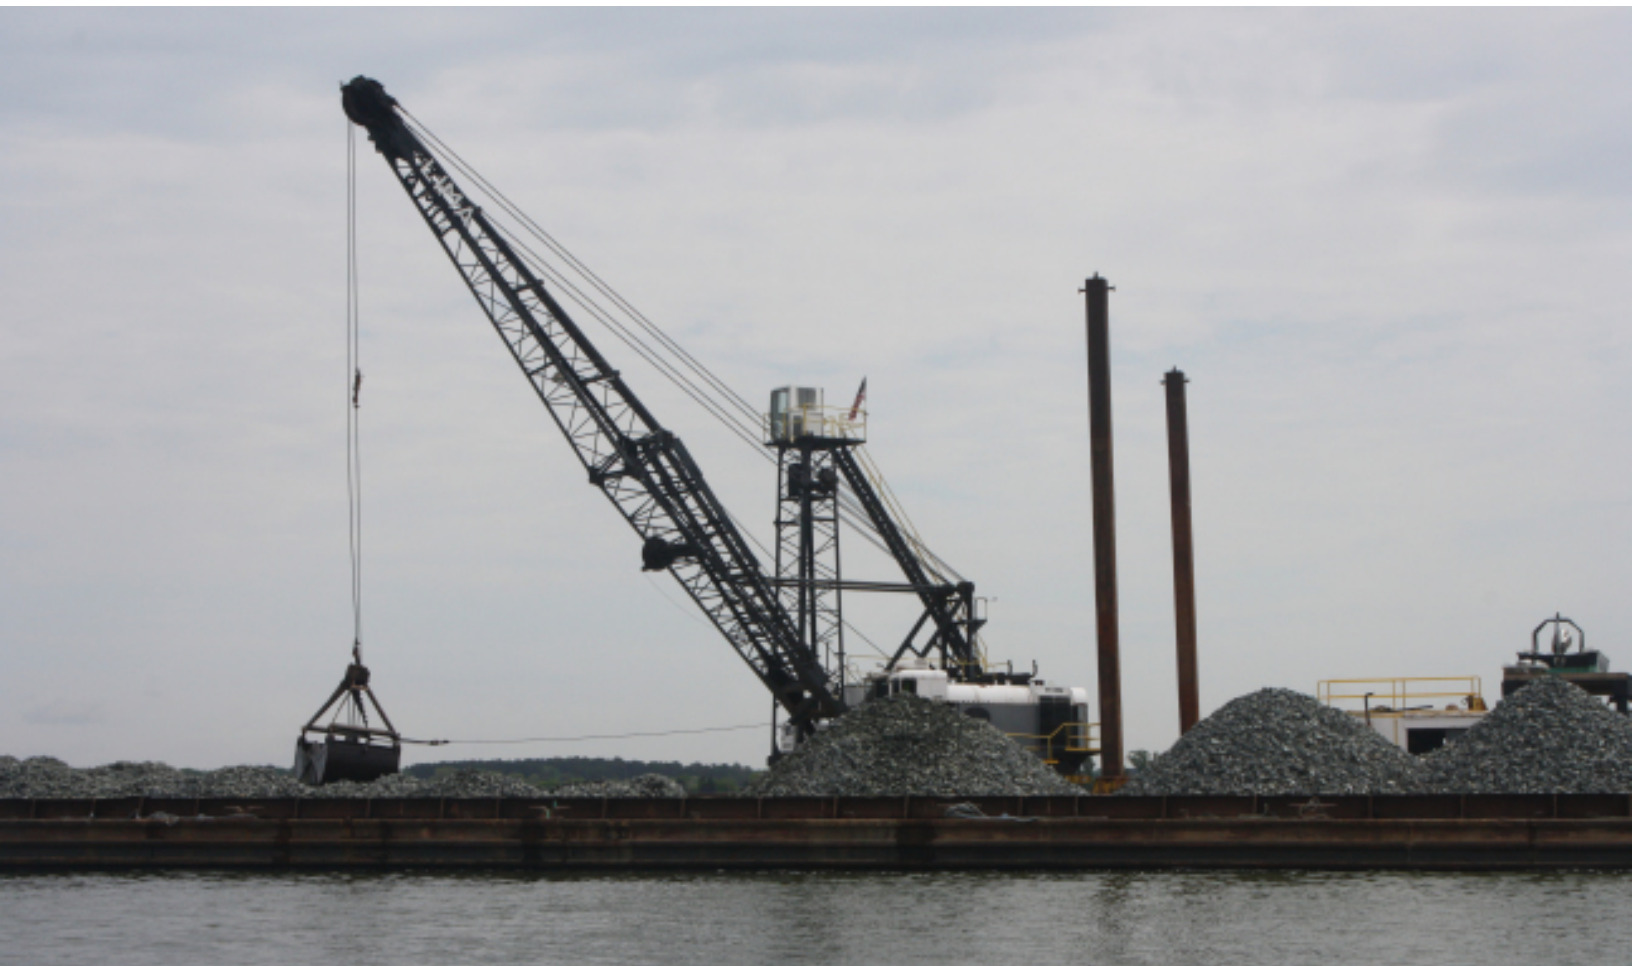
Placing substrate to form a reef in Harris Creek. Photo: NOAA Chesapeake Bay Office.
