COMMUNITY-BASED RESTORATION MONITORING ORIENTATION

BACKGROUND

MONITORING COMPONENTS

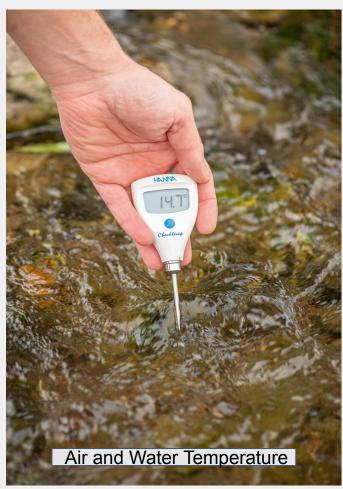
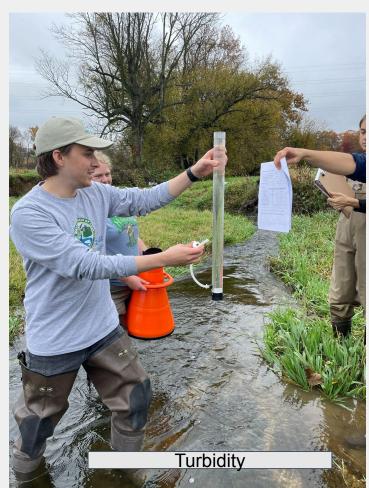
WATER QUALITY INDICATORS

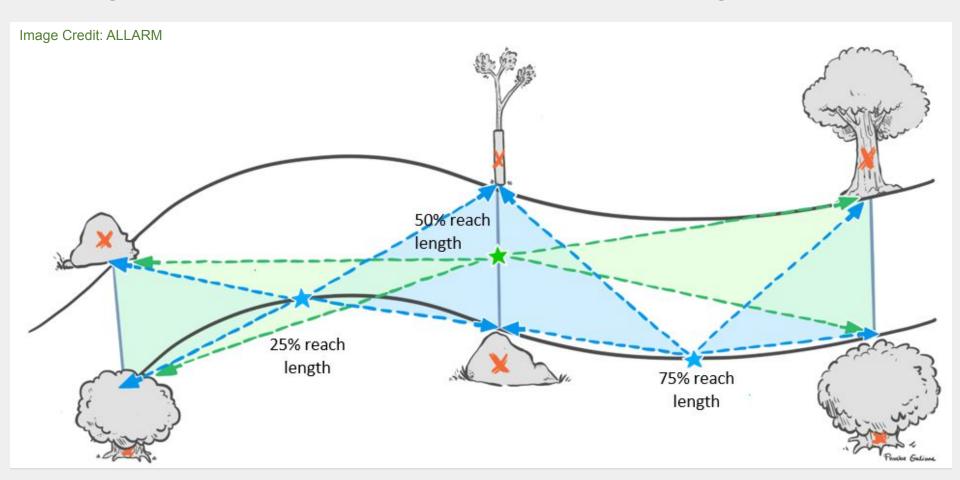
STANDARDIZED PHOTOS

Six standard stream reach photos from the bank at the 25% reach length, mid-channel at the 50% reach length and the bank at the 75% reach length.

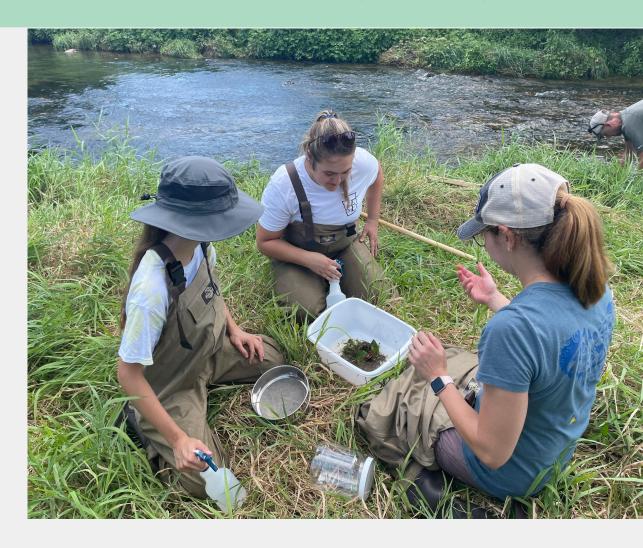
BENTHIC MACROINVERTEBRATES (SPRING)

CBP BenthicMacroinvertebrateSampling Protocol

•Samples collected in the field, preserved and sent to EPA Wheeling Lab for family level identification.

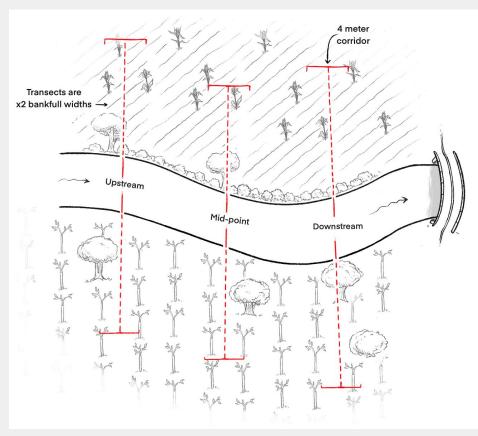
RIPARIAN AREA

Transect length = bankfull width x2, then create a corridor 4 m wide (2m on either side of the transect line.

- # of pre-established trees
- # of planted trees (post-restoration)
- Dead or fallen trees
- Invasive species
- Concerns

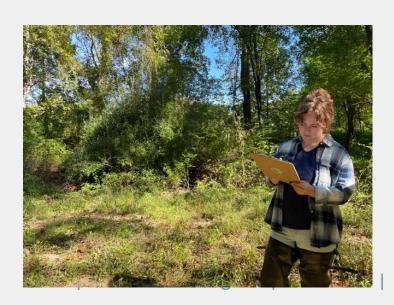
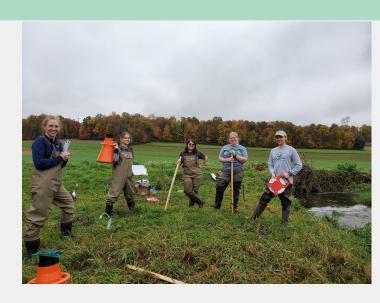
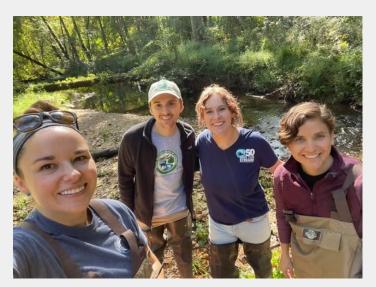
GENERAL REACH CHARACTERISTICS

- Riffles/pools/runs
- Aquatic vegetation
- Bank Conditions and Impacts
- Floodplain inundation
- Impacts of animals
