Promoting living shorelines for shoreline protection: understanding potential impacts to and ecosystem trade-offs with adjacent submersed aquatic vegetation (SAV)

Cindy Palinkas, Lorie Staver

University of Maryland Center for Environmental Science
Horn Point Laboratory
Cambridge, MD

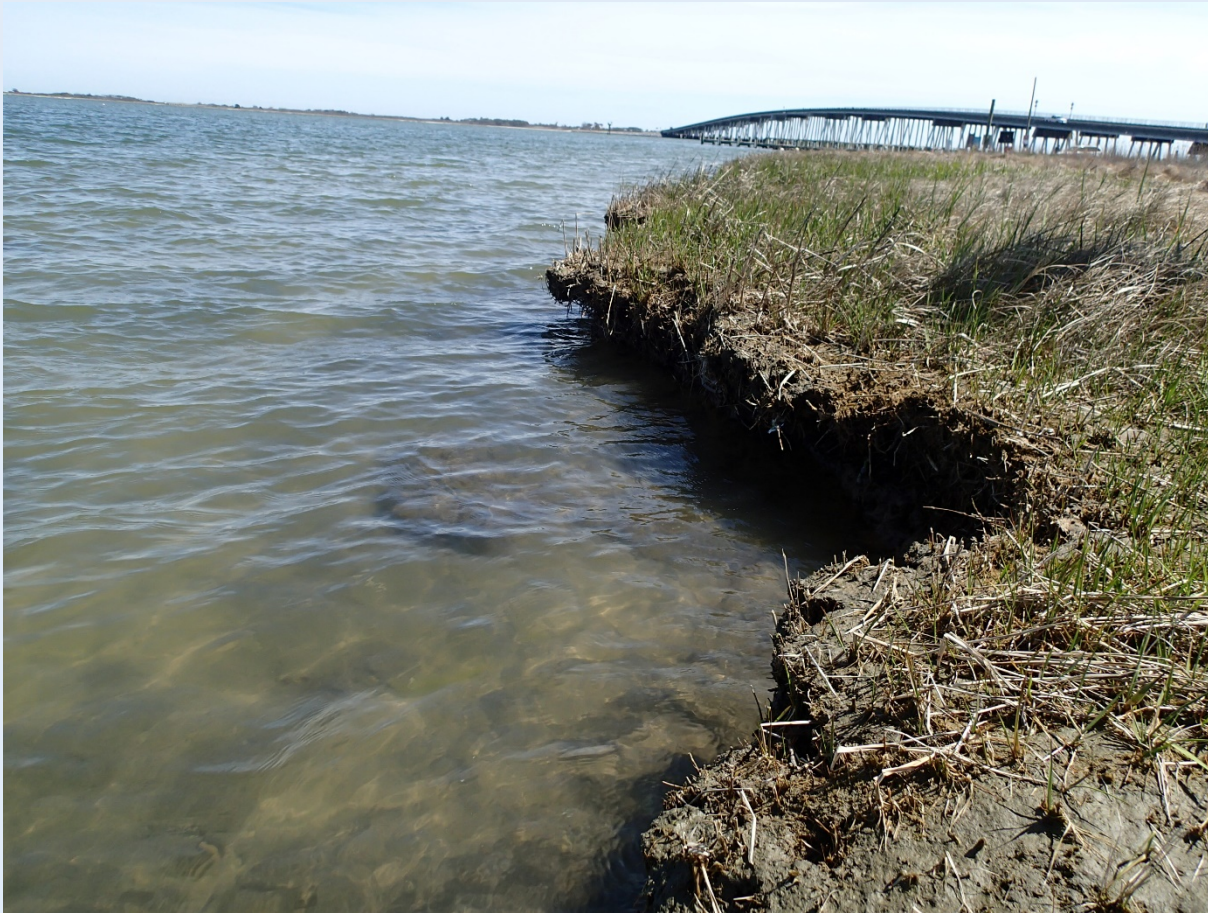
1. Chesapeake Bay (CB) focus but ubiquitous problem
 - 33% of CB's shoreline is eroding; 70% of the Maryland portion
 - 85% of CB's shoreline is privately owned
2. Past efforts focused on “hard” approaches like breakwaters and rip rap
 - ~25% of CB shoreline already hardened, up to >50% in some areas

HOW GREEN OR GRAY SHOULD YOUR SHORELINE SOLUTION BE?

GREEN - SOFTER TECHNIQUES

GRAY - HARDER TECHNIQUES

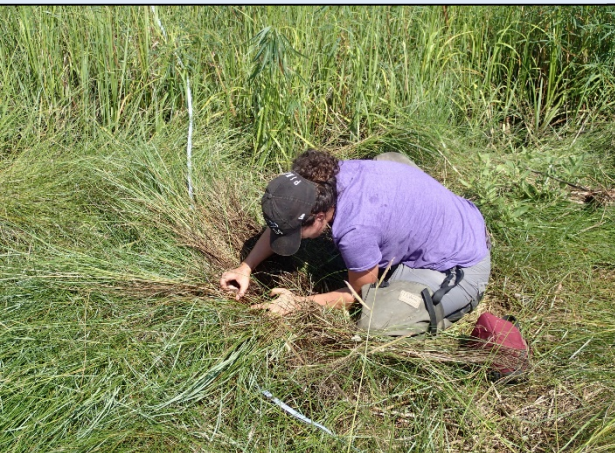
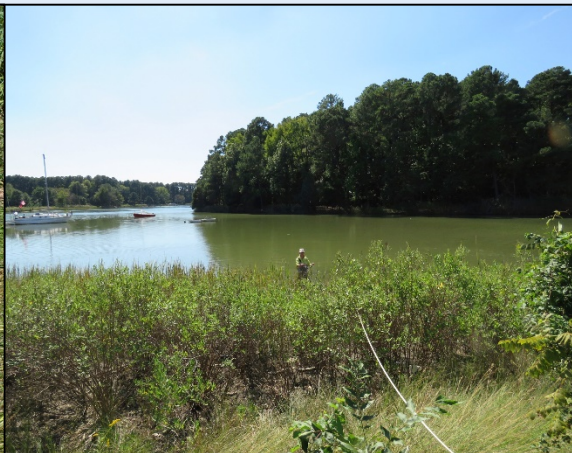
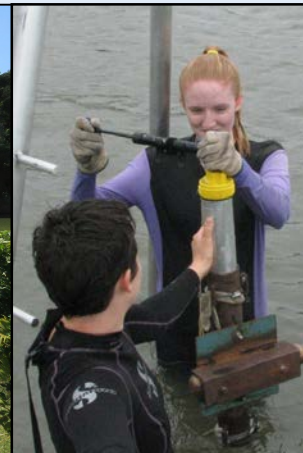
The Approach: Site Selection, Field Work, Data Analysis!

Site selection – control for as many variables as possible (e.g. fetch, LS age, length and design)

Sediment cores and plant surveys in subtidal (SAV) and intertidal (LS)
