Where did all that sediment go?

Jeffrey Halka Maryland Geological Survey

Sediment Sampling After Tropical Storm Lee

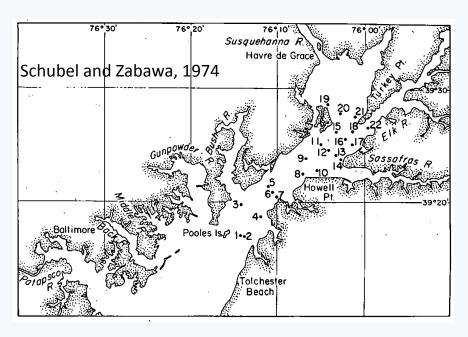
17 gravity core locations

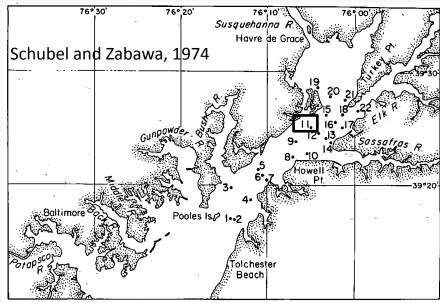
Gravity coring with MGS Total of 17 cores

Reoccupied some post-Agnes stations Looked for typical flood sediment signatures...

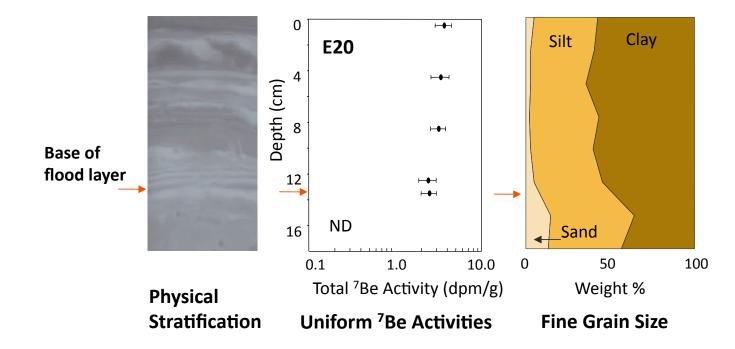
Po River

Flood Sediment Characteristics

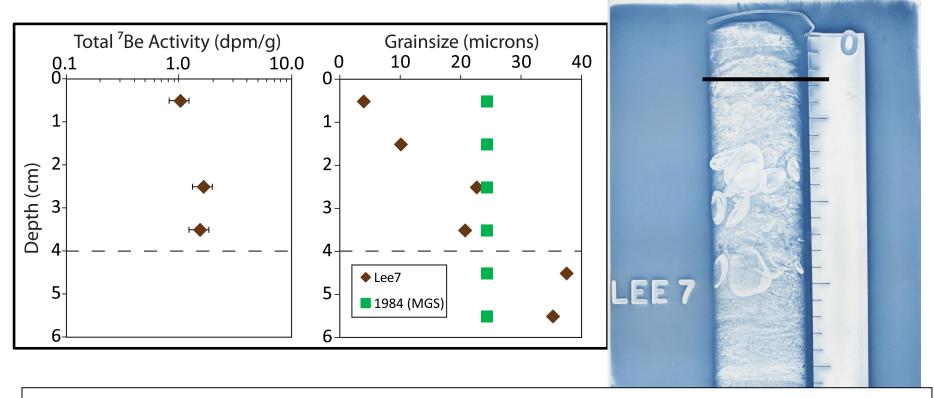
Flood Sediment Signature After Tropical Storm Lee

- •Classic flood-sediment signatures present in Lee cores
- •Lee7 ~ Site 11 in post-Agnes study (Schubel and Zabawa, 1974), where 20-30 cm was found
- •Lee = $^{\sim}1/5$ of Agnes deposition in upper Bay?
- •Problem: many cores only have detectable ⁷Be in upper 1 cm...

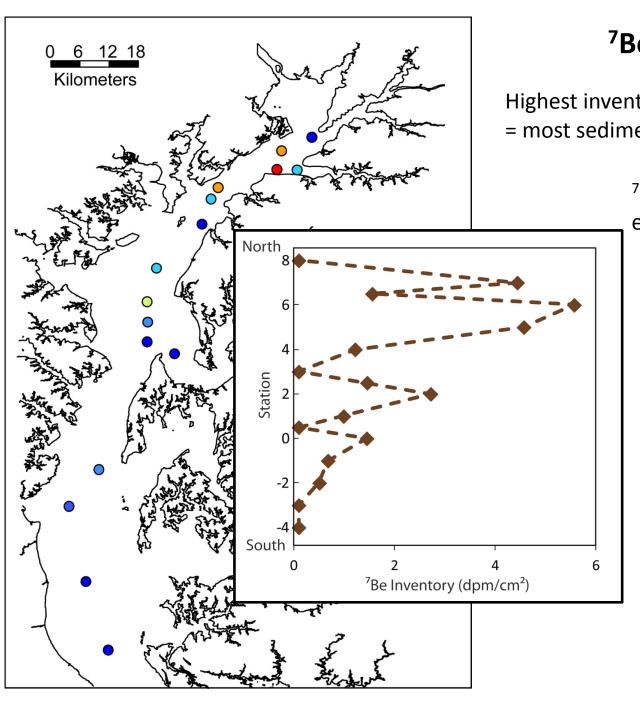
⁷Be Inventories

Highest inventories are in the upper Bay = most sediment deposition

⁷Be was not detectable everywhere:

- Erosion? Lee8(SusquehannaFlats), Lee3 (Poole's Island)
- "Dusting" of sediment?
- •Conowingo Dam sediment?

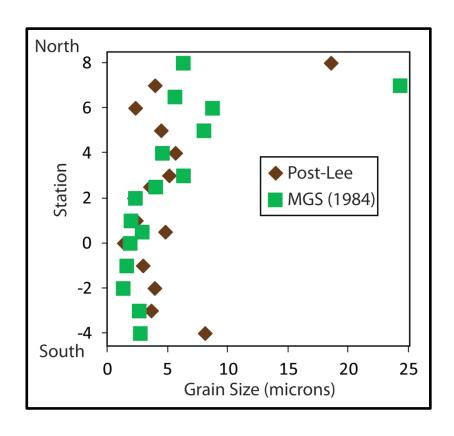
Grainsize Trends

Comparison with previous data:

- •Upper Bay: post-Lee sediments are finer (except near Susquehanna Flats)
- •Mid-May: post-Lee sediments are about the same as previous observations
- •Lower Bay: post-Lee sediments are somewhat coarser

Note: post-Lee data are for surficial (0-1 cm) sediments; MGS data are from grab sampling (typically ~5 cm)

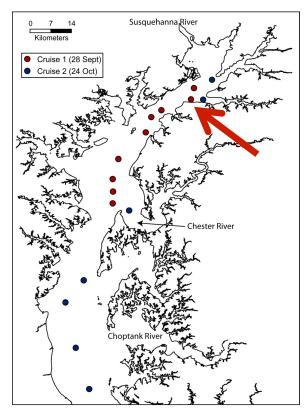
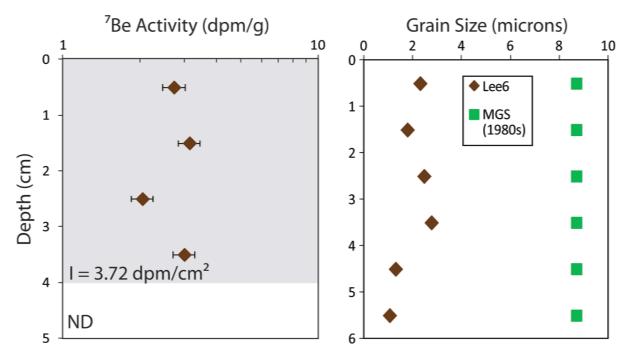
Lee6

Similar to S&Z Site 10: 15-20 cm; noted that it could be overestimated

Lee deposition: 4 cm But could be overestimate due to mixing

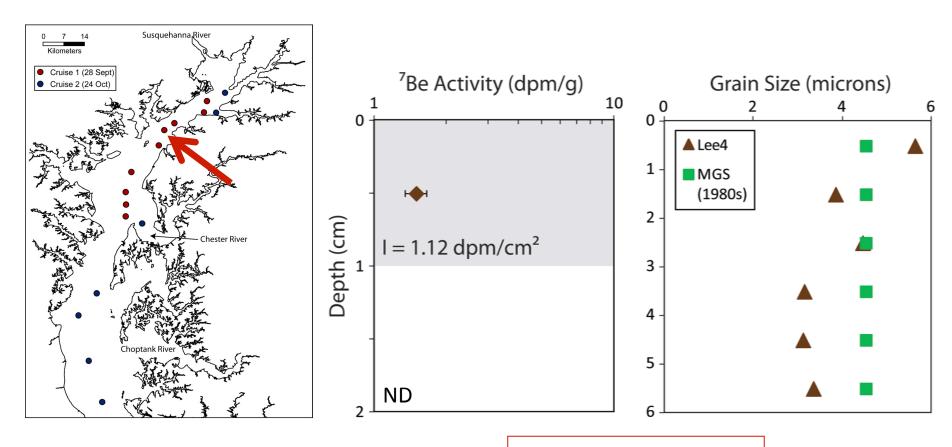
Lee4

Lee deposition: <1 cm

Similar to S&Z Site 2: 4-6 cm

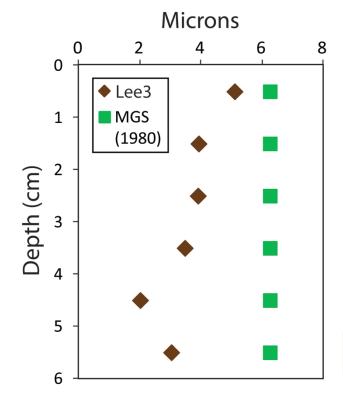
Lee3

⁷Be not detectable

No Lee deposition

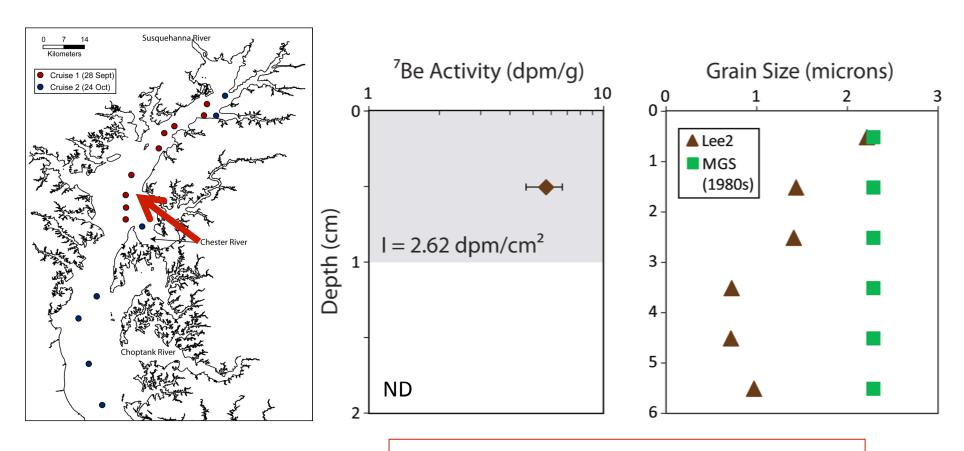
Lee2

Lee deposition: <1 cm but more than Lee4

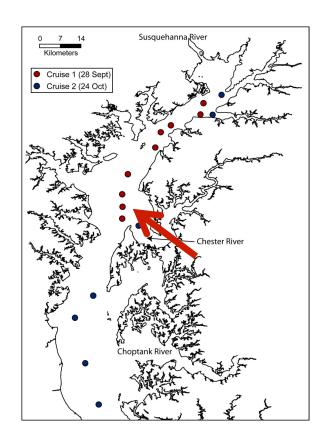
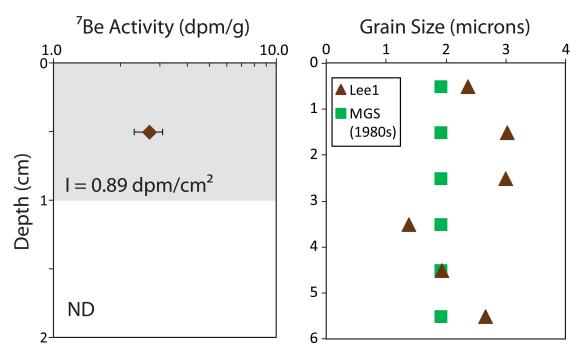
Lee1

Lee deposition: <1 cm but less than Lee2
