# Technical Report

## Stormwater BMPs in Virginia's James River Basin: An Assessment of Field Conditions & Programs

(part of the *Extreme BMP Makeover* project)

June 2009

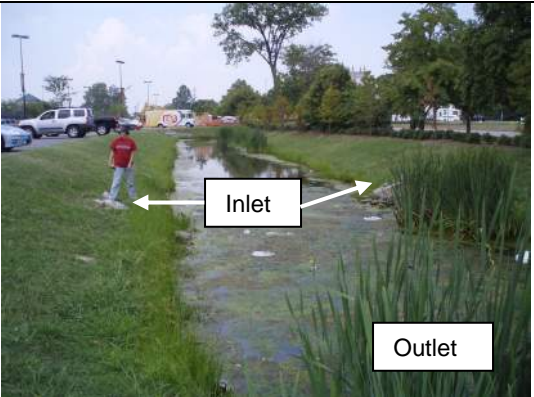
<p data-bbox="224 709 771 787">Very long wet pond with very short flow path; shortest flow path is 25 feet out a total pond length of 315 feet.</p>

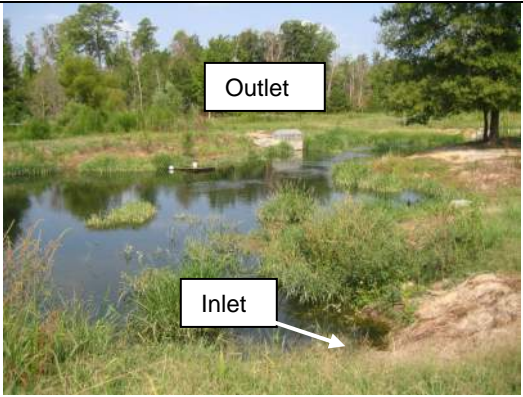
<p data-bbox="820 703 1339 735">Wet pond with a good length/width ratio of 3.4:1</p>

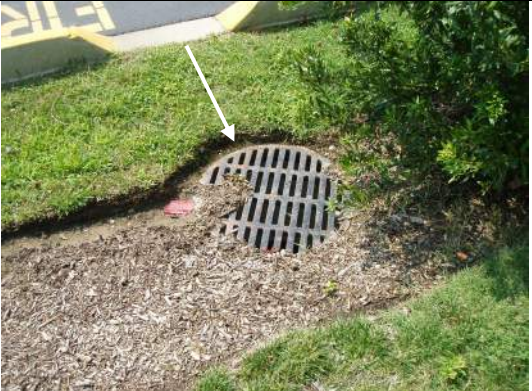
<p data-bbox="224 1192 771 1249">Dry pond with curb cuts very close to outlet, bypassing treatment mechanism.</p>

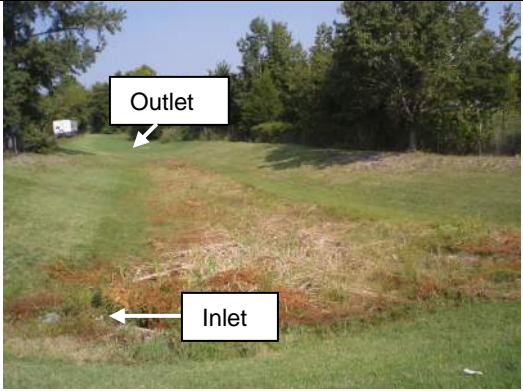
<p data-bbox="820 1186 1388 1218">Dry pond with L/W ratio of 8.9 and a long flow path.</p>

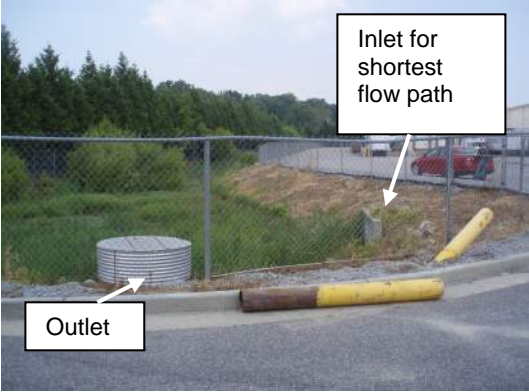
<p data-bbox="228 709 786 768">Stormwater pond/wetland – shortest flow path is 25' out of a total length of 1000'.</p>

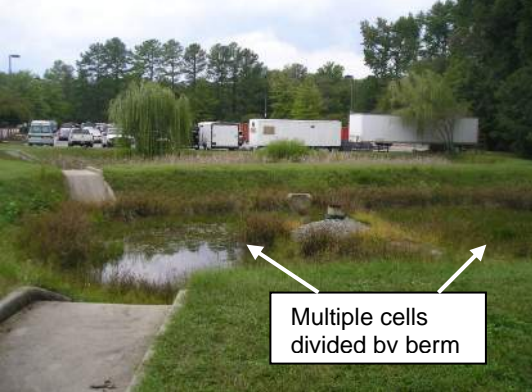
<p data-bbox="820 709 1365 768">Stormwater wetland with multiple cells to lengthen flow path and enhance treatment.</p>

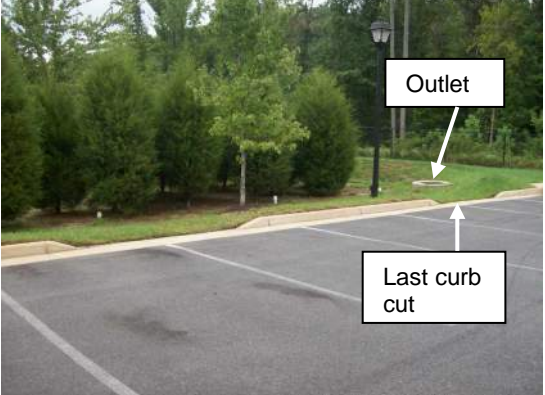
<p data-bbox="228 1176 786 1260">Good bioretention area, but the last curb cut is very close to the outlet. This issue may be hard to resolve for curb cut designs.</p>

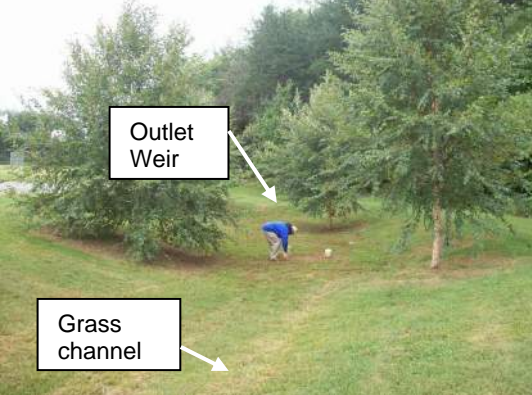
<p data-bbox="820 1176 1365 1239">Bioretention with long flow path – entry channel is grass swale, which provides pretreatment.</p>

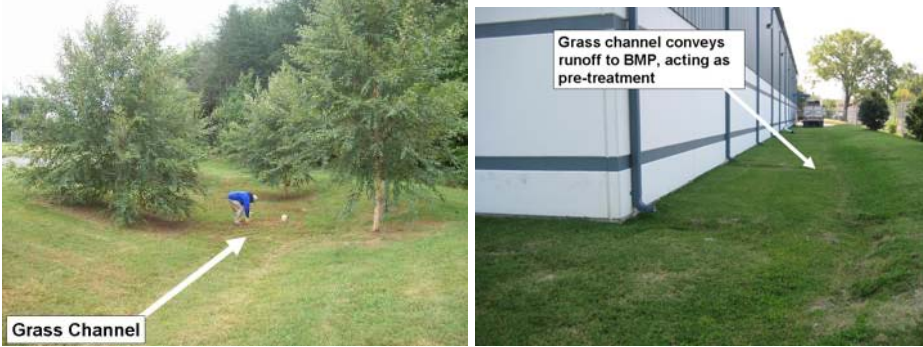
Figure 11. A variety of pretreatment measures used in the James River basin.

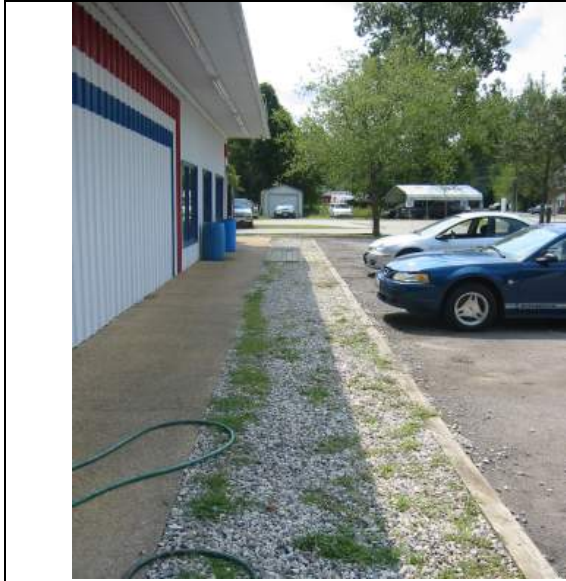
**BMP does not treat more polluted parts of site.** This infiltration trench treats just the roof, but the parking lot is left untreated.

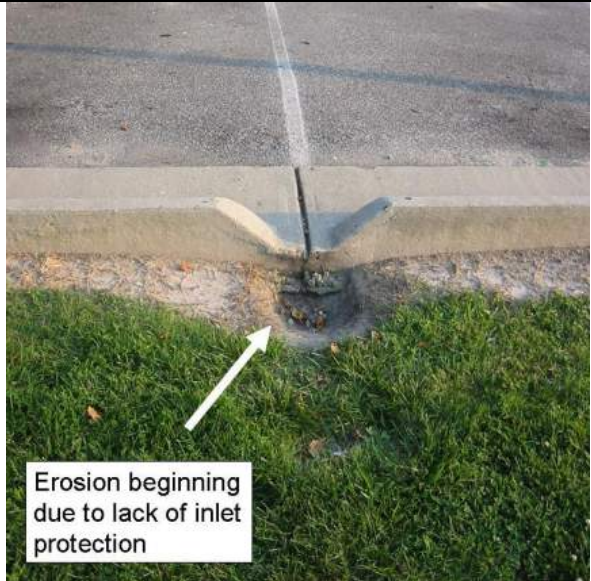
**Inlet not well reinforced to prevent erosion.** This infiltration trench inlet is relatively steep – some inlet protection is required to prevent erosion here.

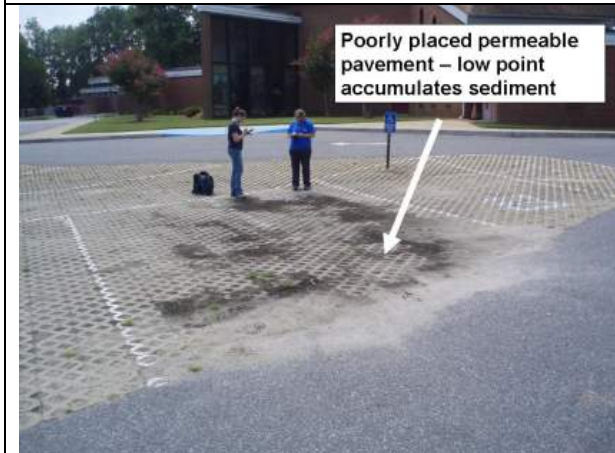
**Poor placement of BMP.** These paver blocks are down-gradient from asphalt portions of parking lot, accumulating fine sediment from the asphalt over time.

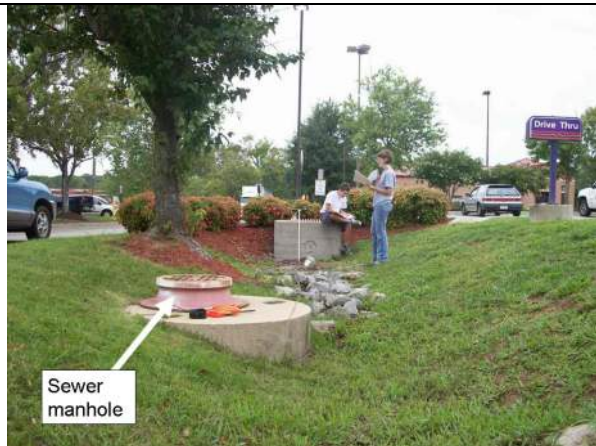
**Sewer or other utility infrastructure in BMP.** This sanitary sewer manhole located below elevation of BMP outlet, therefore at risk of taking in water and overflowing to surface.

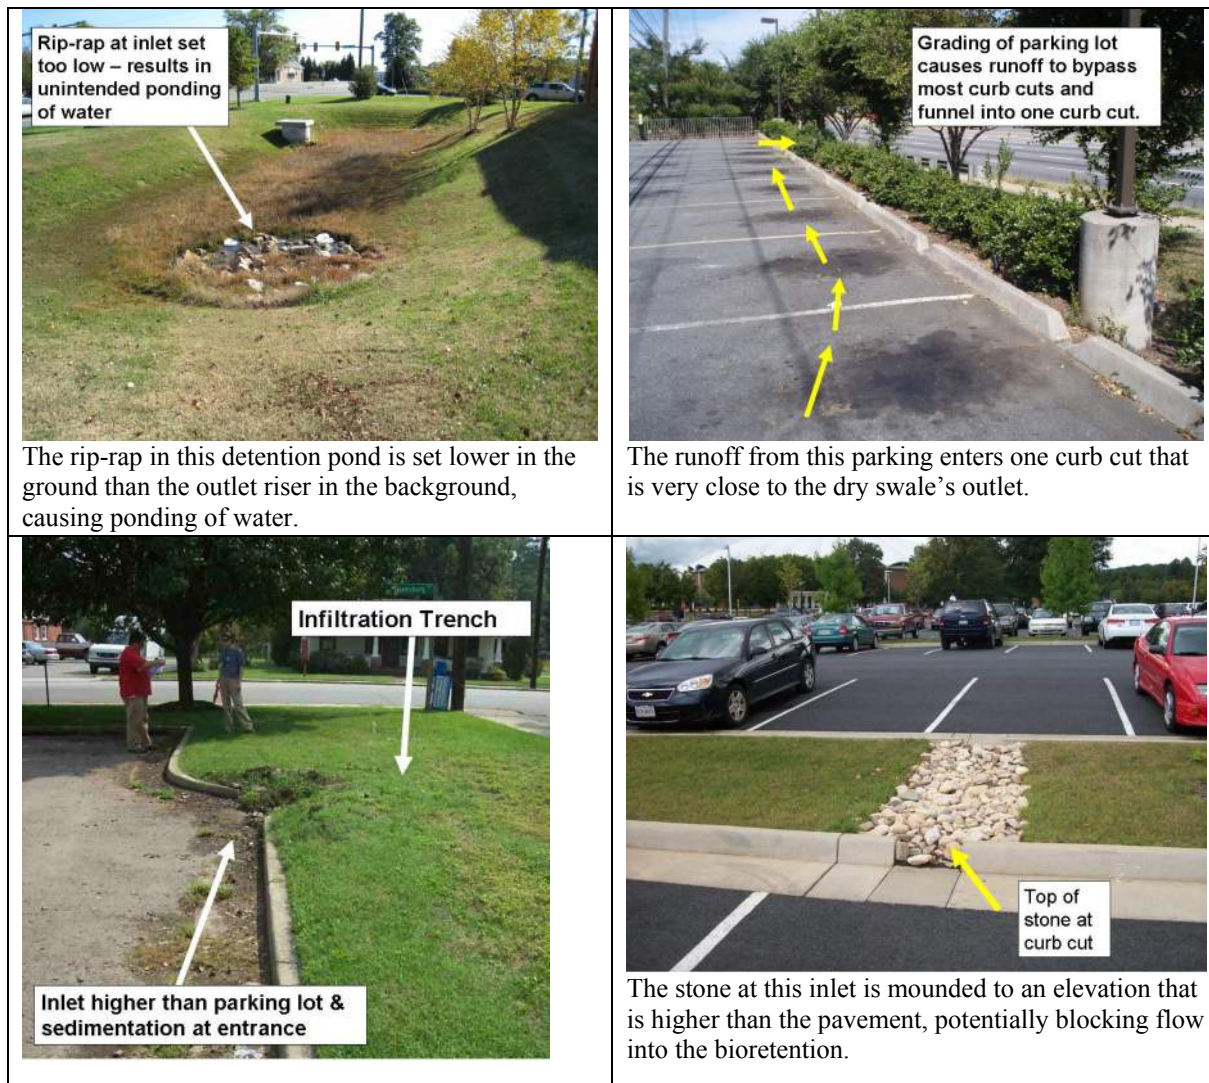
The rip-rap in this detention pond is set lower in the ground than the outlet riser in the background, causing ponding of water.

The runoff from this parking enters one curb cut that is very close to the dry swale's outlet.

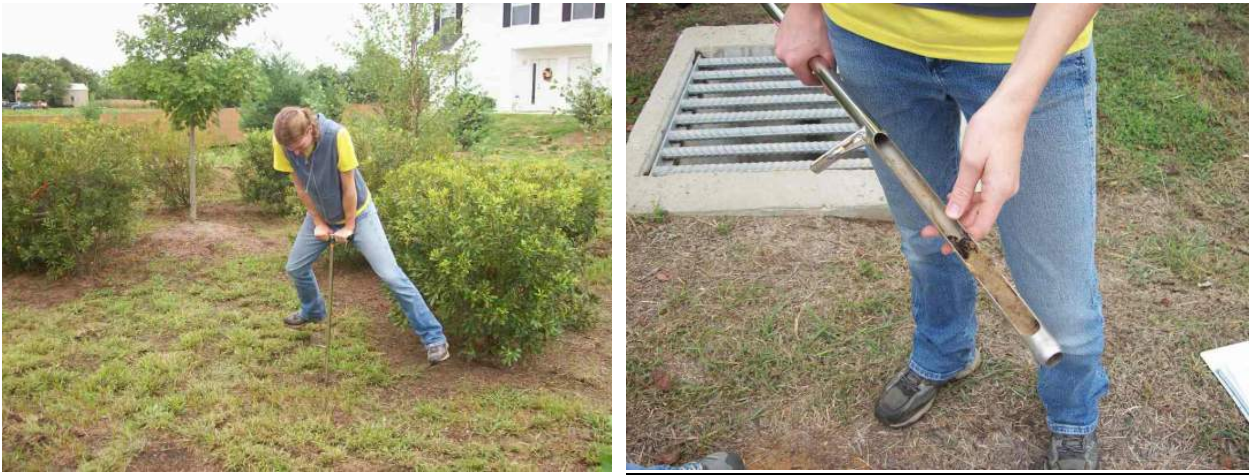
The filter media for most BMPs appeared to be functioning properly and installed according to design specifications. The filter media components for only 10% of the BMPs deviated from what was shown on their design plans. Of those, some BMPs were missing filter media components, such as a layer of gravel or sand in the soil media. The most common filter media problem was an overabundance of clay in the soil media. In some instances, BMP soil media appeared to have been overly compacted by equipment during construction and/or mowers over time, decreasing the potential for infiltration (see Figure 19 below).

**Figure 19. Compacted bioretention soil (left) with high clay content (right).**

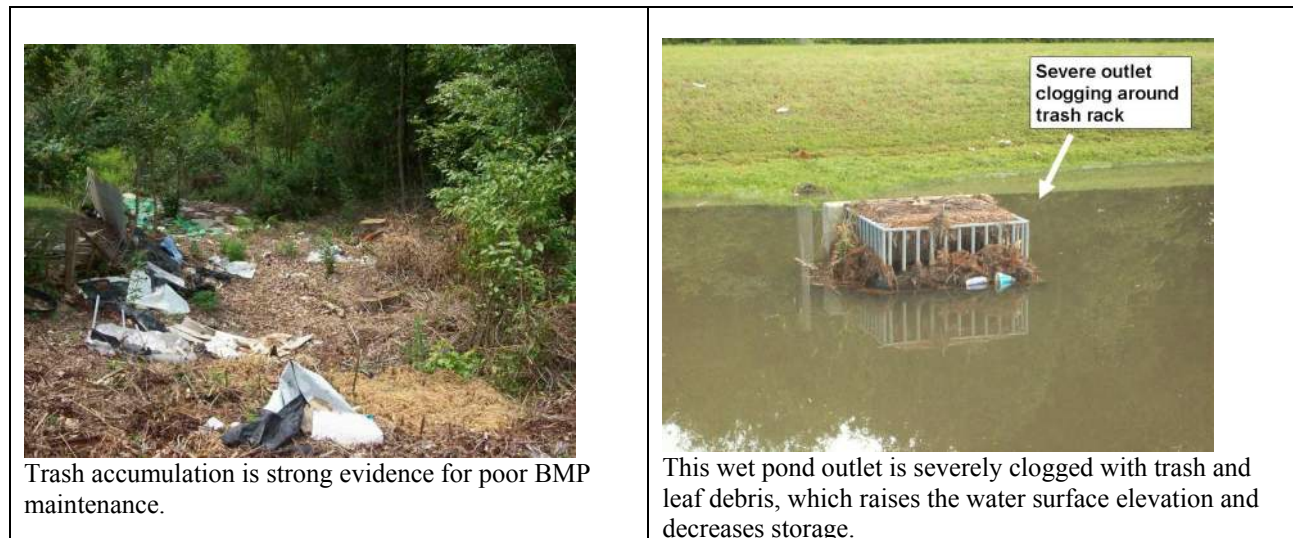
Trash accumulation is strong evidence for poor BMP maintenance.

This wet pond outlet is severely clogged with trash and leaf debris, which raises the water surface elevation and decreases storage.

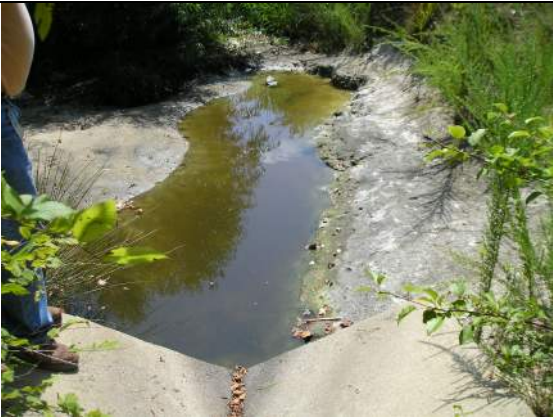
High velocity flow from the impervious channel caused significant erosion below the BMP and outlet protection is needed to protect the channel from further erosion.

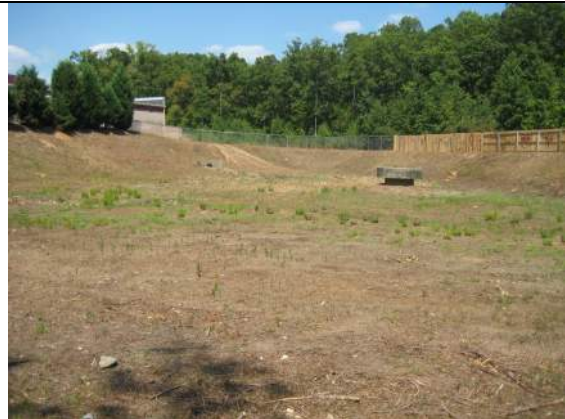
This pond has been “overly” maintained – nearly all vegetation was eliminated by excessive mowing practices.

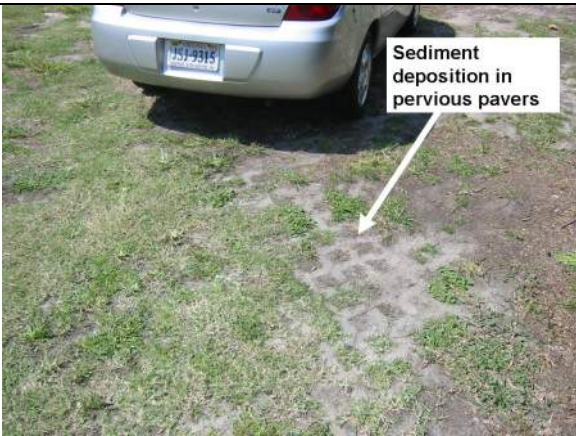
BMPs accumulate sediment and periodic sediment removal is necessary to combat sediment deposition. Sediment removal for BMPs, such as paver blocks, can be challenging.

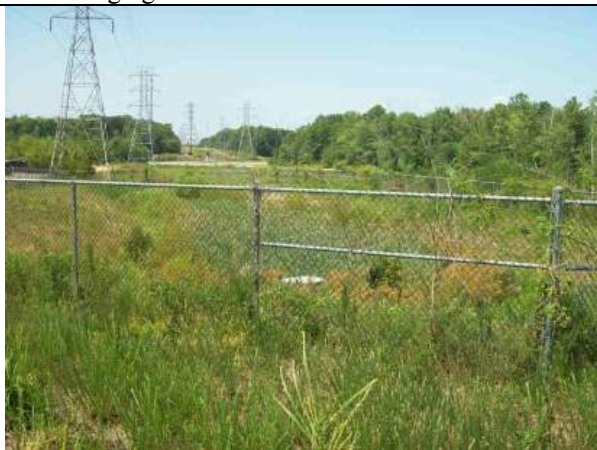
This fence was built around the BMP without any gate. Lack of maintenance access can be a deal breaker when it comes to BMP upkeep.

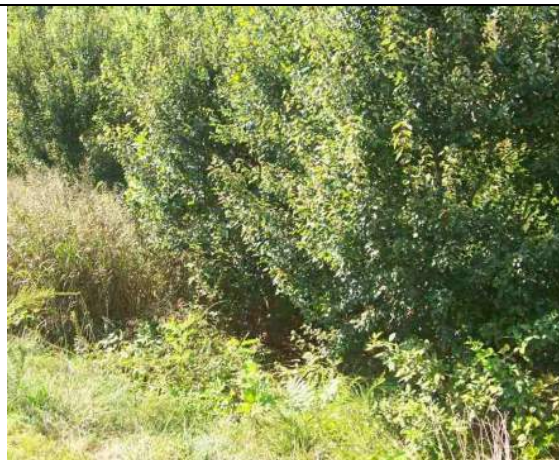
This detention pond became so over-run with vegetation that it disappeared and was invisible to the landowner, as well.

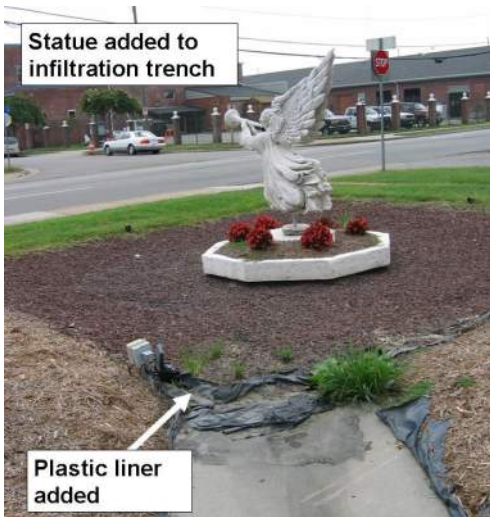
BMP modification can reduce the functionality. This infiltration basin was covered by a plastic liner and converted to a visual feature. The owner was unaware of the BMP's purpose and function.

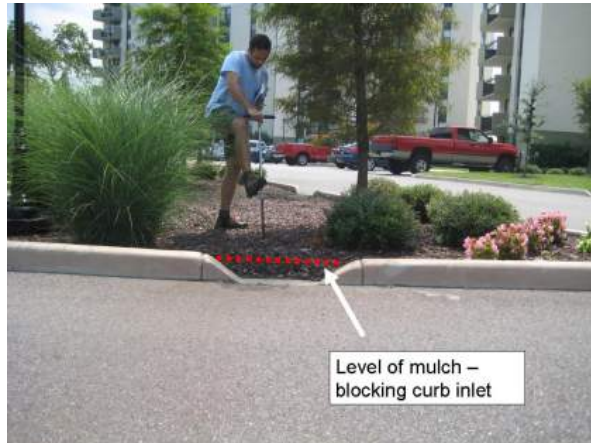
So much mulch was added to this bioretention that it is higher than the level of the inlet. The basic functions of a BMP need to be kept in mind when maintaining BMPs that also serve as landscaping.

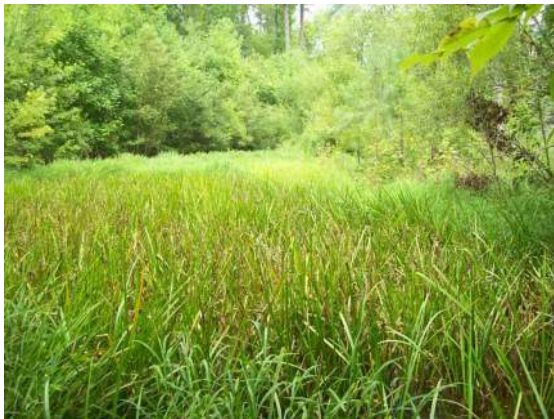
Vegetated BMPs can become dominated by a monoculture of invasives, if not maintained.

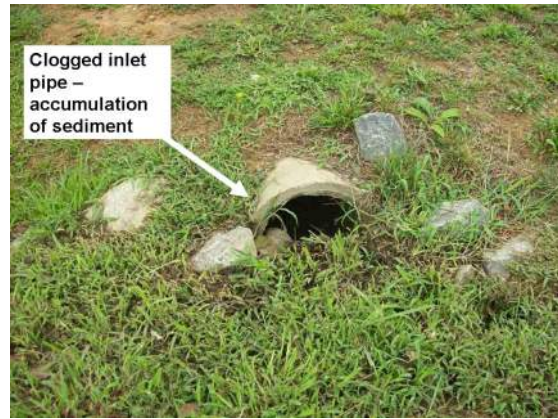
Inlet pipe sedimentation and vegetation accumulation is a common maintenance issue.

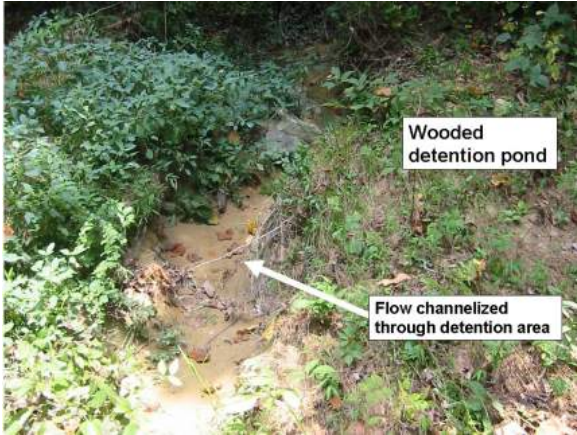
Wooded detention pond

Flow channelized through detention area

Runoff has channelized a pathway through the bottom of this dry detention pond.

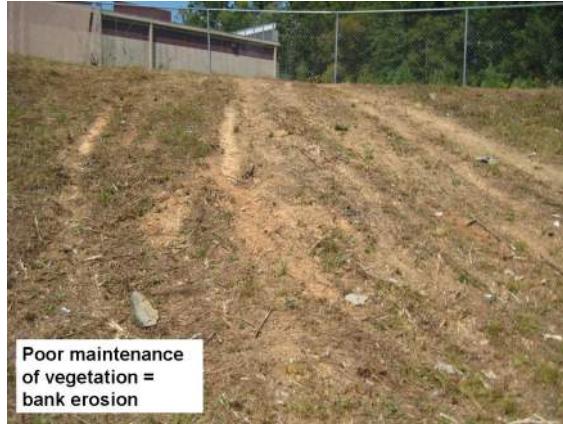
Poor maintenance of vegetation = bank erosion

Steep slopes coupled with poor vegetative cover is a recipe for erosion problems that can be difficult to remedy.

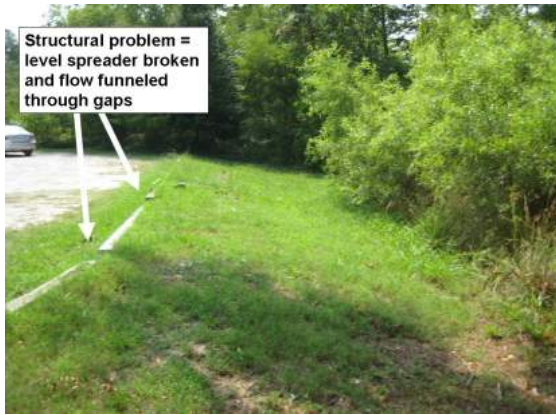
Structural problem = level spreader broken and flow funneled through gaps

Minor structural problems can circumvent the treatment mechanism, such as with this broken level spreader.

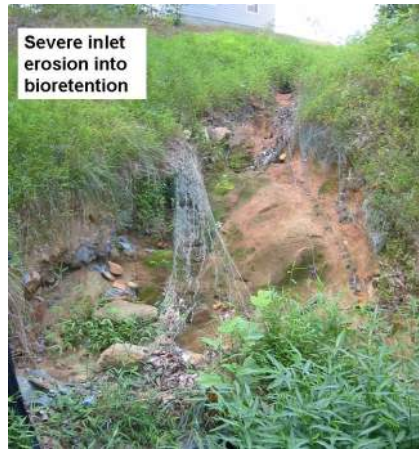
Severe inlet erosion into bioretention

Inlet channels can erode when channel lining is inappropriate or installed improperly.
